Consideration of damage caused by recent large earthquakes and earthquake-proofing in Japan and the USA

Department of Civil Engineering, Kitami Institute of Technology

Abstract

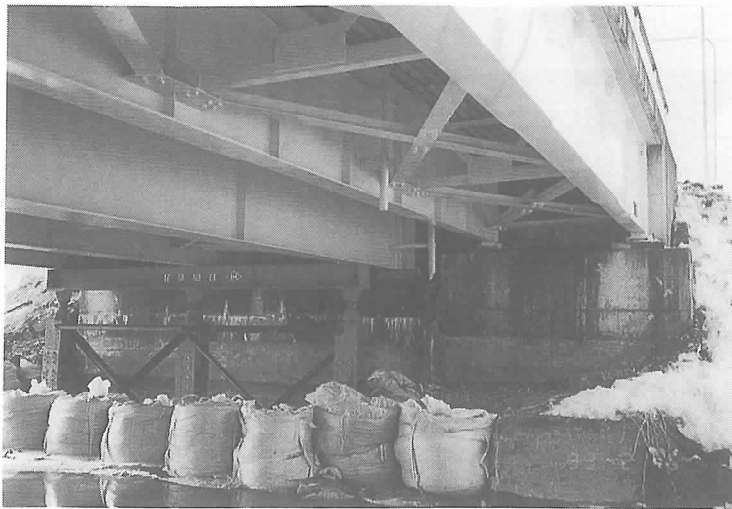
There was a great deal of significant damage to the supports of structures and deep piers (Photos 1 and 2). Particularly striking was the damage to relatively heavy T-shaped concrete girders. There was obvious damage due to displacement in the direction of the earthquake motion (Photos 4, 5, and 6). Cracks and other signs of damage were observed at the termination points of main reinforcing steel (Photo 3). This pointed to a clear need to further study the shear strength of columnar piers, since the maximum acceleration measured by strong motion recorders at the Kushiro Weather Observatory exceeded 900 gal [9].

Photo-1 Movement of the abutment pier and shore protection (compound beam bridge, constructed in 1966)

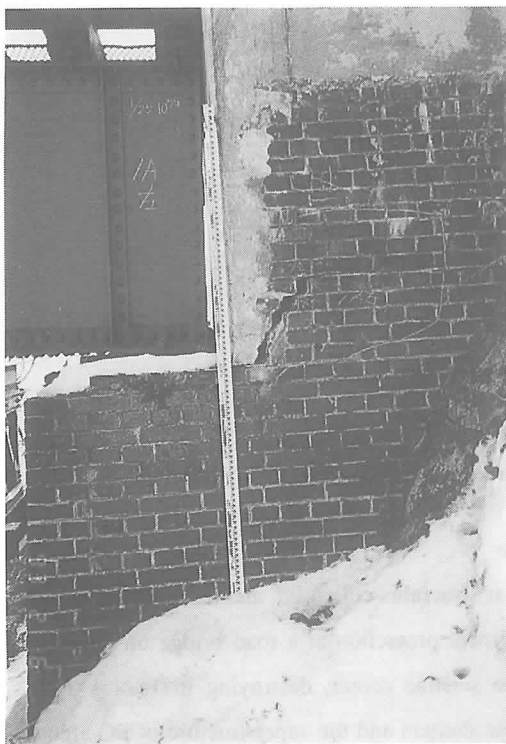
Photo-2 Crack and inclination of abutment

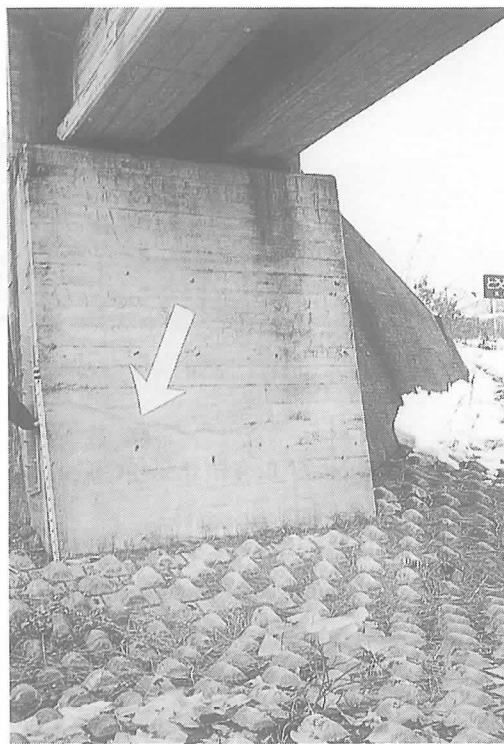
Photo-3 Crack at 50 cm above reinforcing steel girder, between Chokubetsu steel section decreases point on and Atsunai abutment (T-beam of RC, between Ikeda and Shoei)

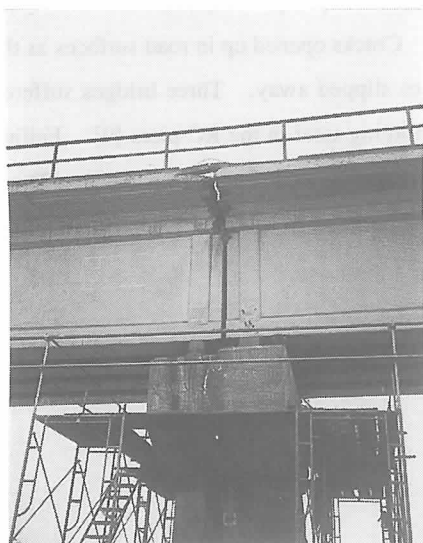
Photo-4 Broken shoe and concrete girder bridge (PCT: T beam of prestressed concrete bridge, between Hobetsu and Ikeda)

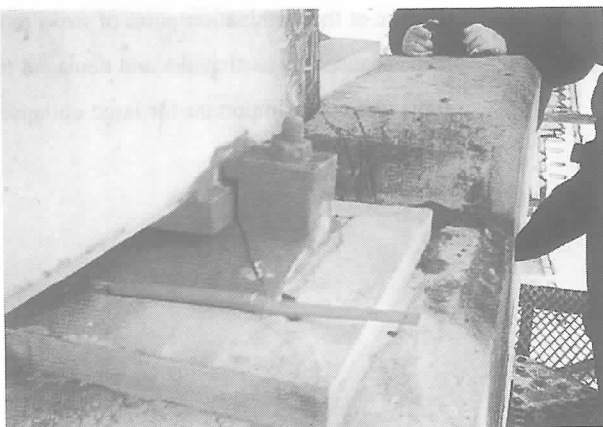
Photo-5 Broken side stopper of shoe (PC girder bridge, between Ineshi and Makubetsu)

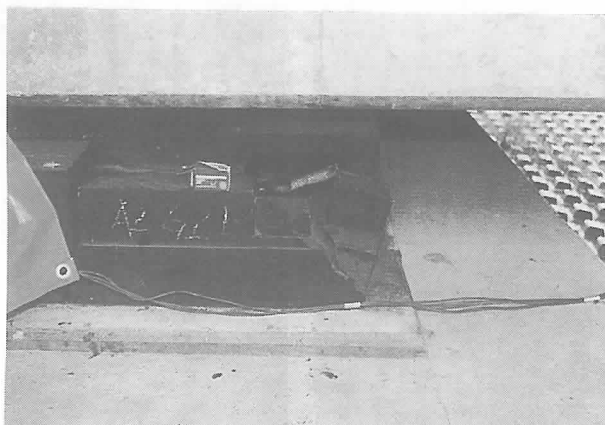
Photo-6 Broken shoe (PC box girder bridge, constructed in 1991, Urahoro)

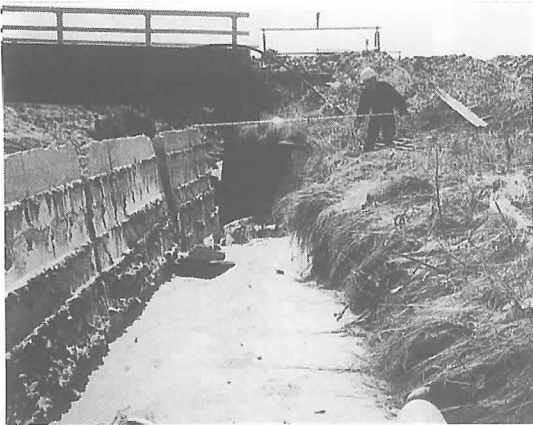
Photo-7 Moving and collapsing of retaining wall due to retreating tsunami (concrete retaining wall, Matsumae in Okushiri)

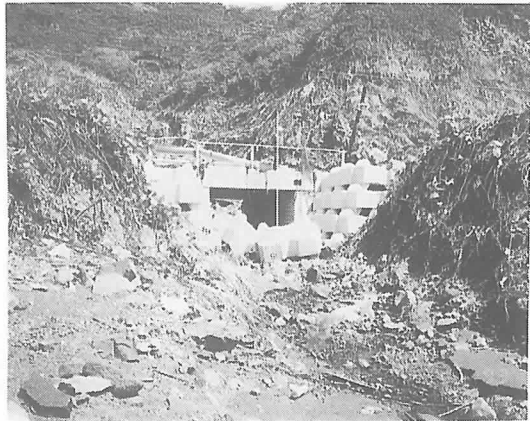
Photo-8 Damage to parapet and abutment (concrete girder bridge, Monai in Okushiri)

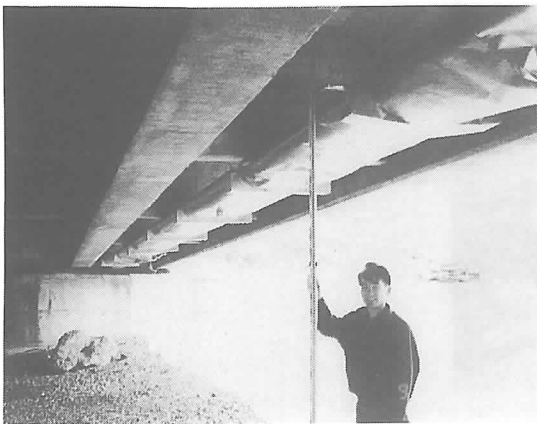
Photo-9 Deformation of steel plate covers of water supply pipe underneath caused by tsunami (concrete girder bridge, Shimamaki)

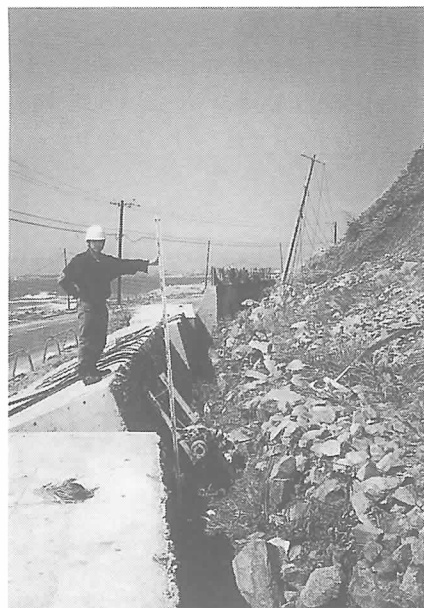
Photo-10 Collapsed road retaining wall caused by retreating tsunami (concrete retaining wall, Matsumae in Okushiri)

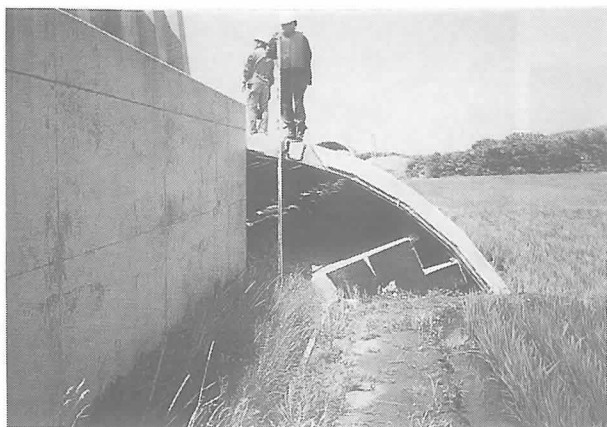
Photo-11 The collapsed snow shelter base wall of arch and the collapsed arch (PC arch structure Senjyozaka in Okushiri, just before completion in July 1993)

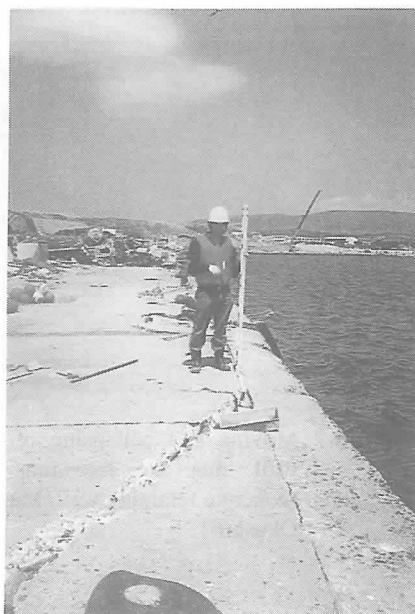
Photo-12 Crack and breaking on lighter's wharf by subsidence (concrete apron, Aonae in Okushiri)

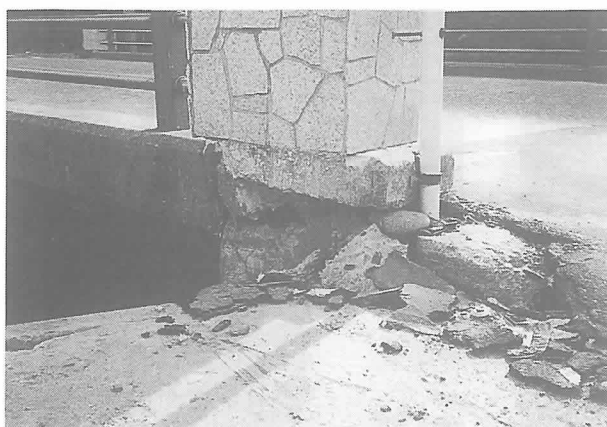
Photo-13 Broken concrete of abutment (concrete girder bridge, Okushiri in Okushiri town)

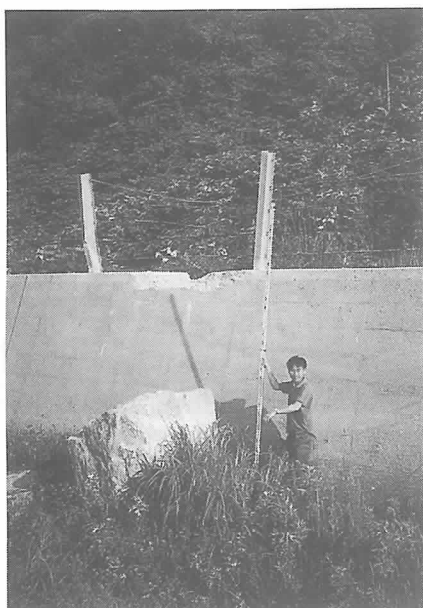
Photo-14 Falling stones caused by earthquake and damage to retaining wall (concrete retaining wall, Shimamaki)

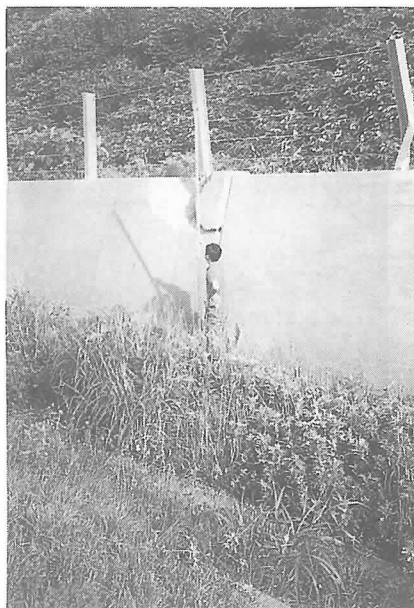
Photo-15 Broken root concrete of falling stone protection fall (concrete retaining wall, Shimamaki)

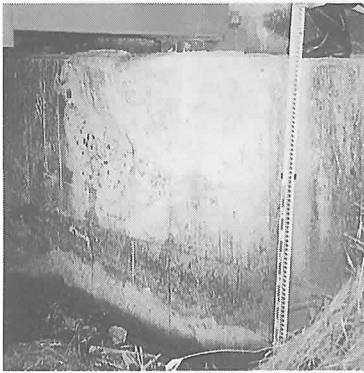
Photo-16 Failure of the anchor support, cracking, and scaling of the concrete abutment (road bridge, composite girder, Manmen in Bekkai town)

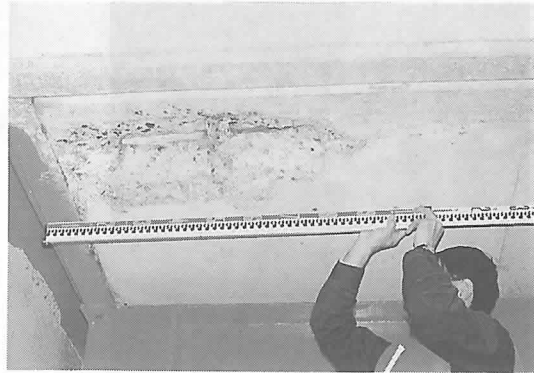
Photo-17 Failure and scaling of concrete, exposure of stirrup steel, and other damage were caused when the girder was crushed against the abutment (road bridge, composite girder, Furen in Bekkai town)

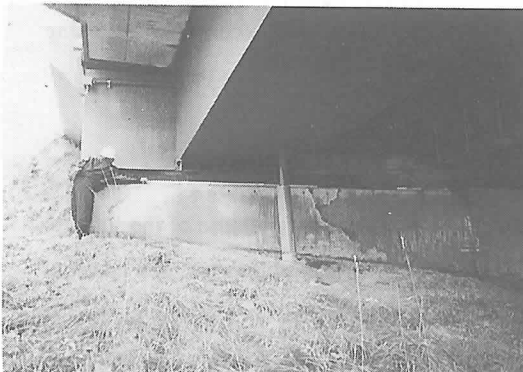
Gaps opened up between the road surface level and the subbase course subsidence at bridge approaches and on bridge floor slabs. As a result of collapse of the subbase course, cracking, slipping, and bulging of sections of bridge abutments was noted in many places. The damage to a composite girder road bridge at Mannen in Bekkai Town was failure of the anchor support as well as cracking and scaling of the concrete abutment. In another case (a composite girder road bridge at Furen in Bekkai Town) failure and scaling of concrete, exposure of stirrup steel, and other damage was caused by collapse of the girder onto the abutment (Photo 16 and 17). In the case of a 3-span continuous box section road bridge with two main girders (at Midorimachi in Nakashibetsu town), failure of anchor supports, concrete cracking, and concrete scaling occurred (Photo 18).

Photo-18 Failure of the anchor support, cracking, and scaling of the concrete abutment. The width of the abutment: 275 cm at the upper part and 460 cm at the lower part. (road bridge, 3 spans continuous, 2 main girders box section, Midorimachi in Nakashibetsu town)

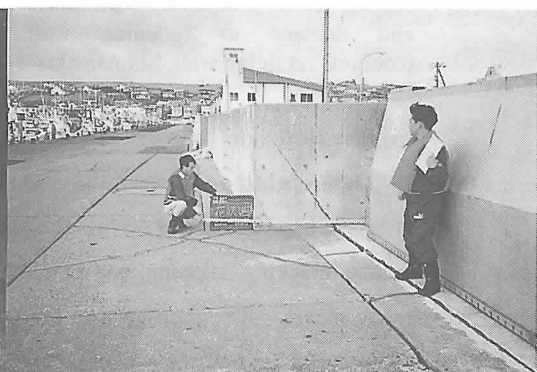
A tidal wave protection wall suffered cracking at the concrete base for the gates as well as shear cracks in the wall itself (at the fishing port in Hanasaki, Nemuro City). This leads to questions about the wall's ability and harbor institutions to withstand a tsunami event [9] (Photo 19 and 20).

Photo-19 Cracking at the concrete base for the gates and shear cracks on the anti-tidal wave quaywall itself (Fishing port, Hanasaki in Nemuro city)

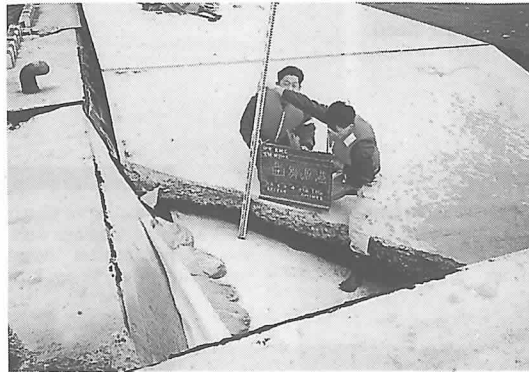
Photo-20 Wharf tilted and sank and broke the concrete plate of apron (fishing port, Habomai in Nemuro city)

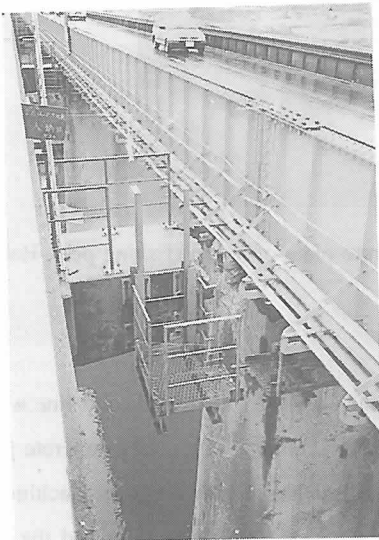
The most severe damage occurred characteristically along the soft line which was northwest line from Matsugaoka to Ruike in Hachinohe City. The concrete piers of a steel road bridge built in 1931 (at Naganawashironai Funawatashi in Hachinohe City) were caused to tilt over by about 20 cm in the upstream direction, and the pier tops were crushed (Photo 21). Damage to the concrete piers and the bridge superstructure resulted from it coming into contact with a neighboring pedestrian bridge built in 1972. The motion of the bridge was restrained by the presence of the pedestrian bridge, leading to inclination of the bridge piers standing in the river channel.

Photo-21 Concrete pier of steel girder bridge tilted and damaged a part of concrete pier of pedestrian bridge by crashing onto each other (road bridge: constructed in 1931, pedestrian bridge: enlarge a construction in 1972. Kumanodou – Naganawa-shironai Funawatasi in Hachinohe city)

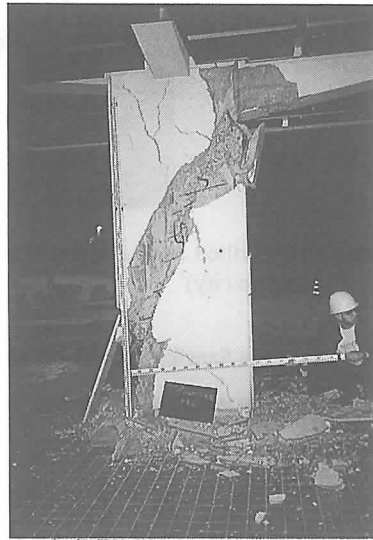
The concrete structure of a high school building (the first floor of a 3-story high school building in Hachinohe City) was damaged by shearing of the pillars and walls where stirrups and longitudinal reinforcing steel were deformed to the extent that they reached yield. This structure had suffered from past large earthquakes: the Tokachi-oki earthquake (18th May, 1968; Magnitude 7.9) and the Kushiro-oki earthquake. Several corroded sections of reinforcing steel were noted in sections damaged by the Sanriku Haruka-oki earthquake, indicating that cracks had been induced and reinforcing

concrete weakened by the past large earthquakes. Some cracks certainly seemed to have been caused in earlier earthquakes [9] (Photo 22).

Photo-22 Concrete destroyed, broken stirrups, deformation and yield of longitudinal steel at recessed steel section past of RC pier (the first floor of 3-story high school building in Hachinohe city)

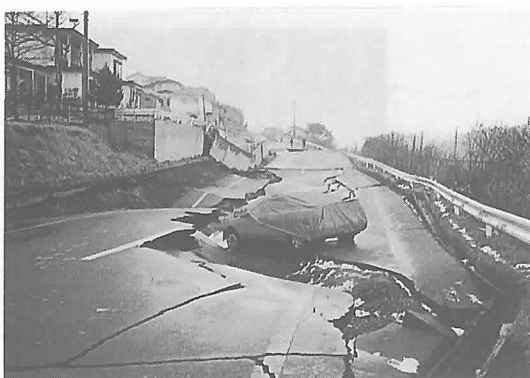
Institution of road and railroad were damaged on the northwest line (Photo 23). If the institutions such as transportation and lifeline construct crossing soft line, the carefulness designs are need.

Photo-23 Collapse of a road embankment subbase caused an L-shaped concrete retaining wall to slide 3.5 m and subside by 2.5 m (at Matsugaoka in Hachinohe city)

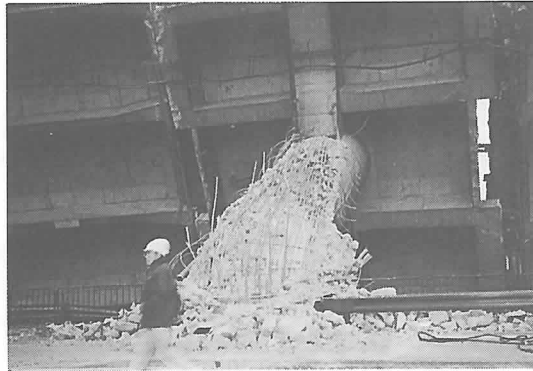
Expressway piers and girders (of a PC bridge constructed in 1969 at Fukae Honjo-cho, Higashinada-ku, Kobe) failed and collapsed. Stirrups in RC columns failed, as did pressure welds in main reinforcing bars. The girders forming the superstructure were heavy, consisting of PC concrete, and the piers were high. It appeared that large perpendicular inertial forces resulted from the large amplitude of the earthquake motion. The bridge clearly reached its ultimate state (Photo 24).

Photo-24 Expressway piers and girders failed and collapsed (PC bridge constructed in 1969, at Fukae Bonjyochyo, Higashinada Ward in Kobe city)

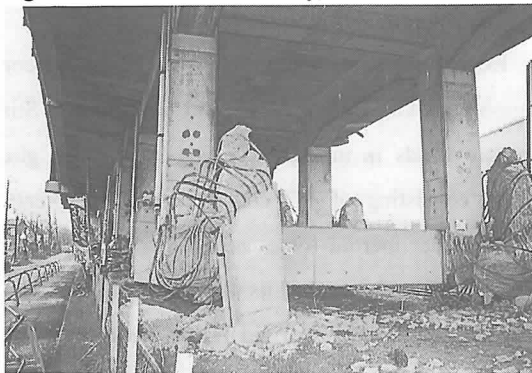
Reinforced concrete rigid frame bridge piers of the Bullet Train trackbed (near the Mukogawa River in Nishinomiya City) suffered widespread and severe scaling of the overhead structure. Some piers were destroyed. Stirrups failed and the longitudinal reinforcing steel yielded and was deformed by the very strong inertial forces (Photo 25).

Photo-25 Concrete destroyed, stirrups failed and the longitudinal reinforcing steel yielded and deformed at recessed part of RC pier (express railway bridge, PC girder, near Mukogawa river in Nishinomiya city)

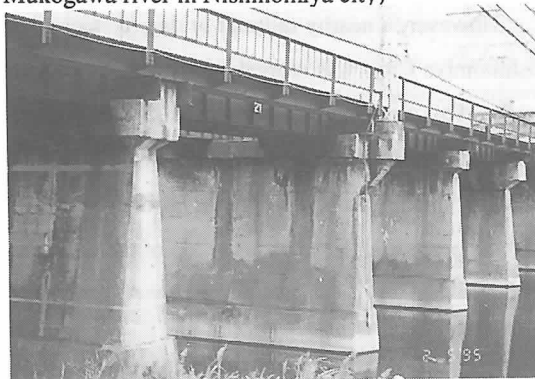
However, a nearby railroad bridge (a steel girder bridge over the Mukogawa River in Nishinomiya City) was scarcely damaged, despite having been in service for more than 60 years. This bridge was returned to service immediately after the earthquake. It had a short span and steel girder, and the low height of the piers means the inertial forces were probably small. Additionally, the girders were restrained in the direction of the bridge axis and perpendicular to it by the top of the concrete piers [9] (Photo 26).

Photo-26 Undestroyed RC pier (railway bridge, steel girder, constructed in 1926, Mukogawa river in Nishinomiya city)

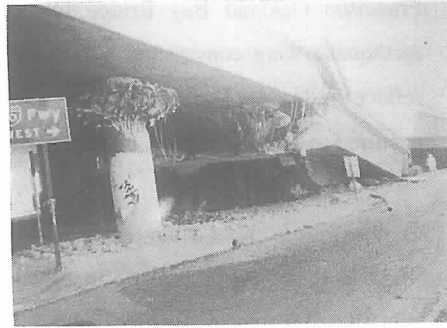
The damage to bridge piers at the I-10 La Cienega and Venice site, where cores completely disintegrated, hoop reinforcement ruptured, and longitudinal reinforcement buckled, suggests an explosive or brittle failure mode in some cases (Photo 2).

Photo-28 Damaged bridge piers - the cores completely disintegrated at I-10 during the Northridge earthquake.
