# **A discussion of one of the large natural disasters to have occurred in northern Japan since 2000, and the efficacy of the disaster prevention and recovery measures taken**

Hiroshi Sakurai, Kitami Institute of Technology,  
Kaneyoshi Okada, Kitami Institute of Technology,  
and Noboru Saeki, Hokkaido University

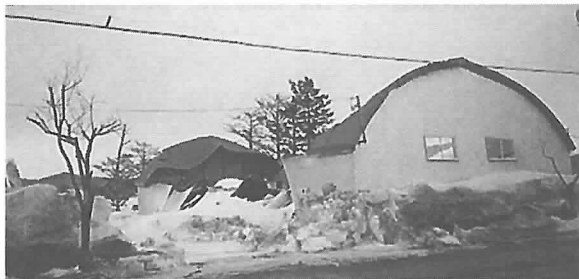
On January 13, 2004, an extraordinary developing and stagnating low atmosphere pressure system eventually reached 964 hecto-Pascal, producing the record snow fall of 170 cm in the Okhotsk district. Such a snowfall occurs only once every 100 years on the Sea of Okhotsk coast and in the Kitami district. Several warehouses collapsed when the weight of the snow on their roofs exceeded the design values. These roofs had shapes that prevented the snow from sliding off (Photograph 1). The road system was cleared of snow only in a relatively few districts, which caused about one month of traffic confusion.

**Photograph 1** An agricultural warehouse in the Kitami district that collapsed under a heavy load of snow in January, 2004. (Saroma-cho Sakae, along National Highway Route 333)

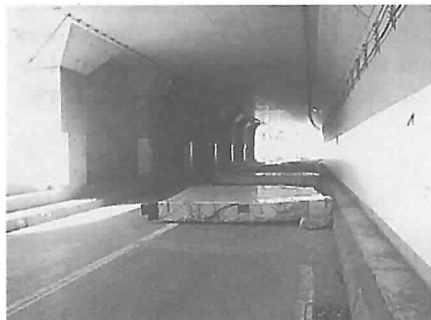
**Photograph 2** This concrete shelter wall on National road route 229 in Kamoenai (near Omori Bridge) was toppled by the strong wind and waves generated by Typhoon 18.

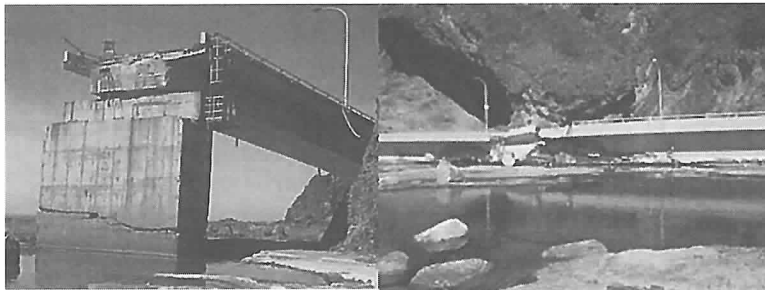
September in 1954, felling more trees, turning over more trucks, etc. In Kamoenai, tidal flooding destroyed the girder support beams between 4 spans of the Omori Bridge (Photographs 6, 7) and the girder fell, destroying the bridge. A pier suffered a large crack (Photographs 3, 4, 5). The steel reinforcing bars in the wall of the nearby shelter that faces the seashore were overwhelmed by the wind and waves (Photograph 2).

**Photographs 4, 5** The PC girders of the fallen spans of the Omori Bridge on National Road Route 229. (Excessive compressive stress destroyed the girders when the support beams fell). A large crack destroyed this pier on the Omori Bridge.

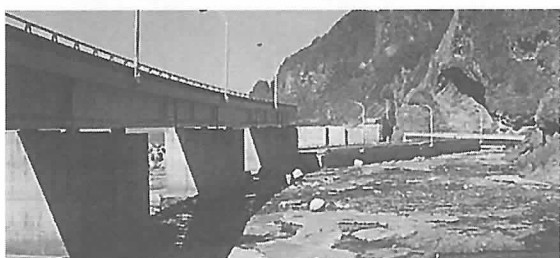
**Photograph 3** The broken girders and piers of Omori Bridge (completed October, 1985) on National Road Route 229. (The piers between 4 spans and the girders fell only on the Kamoenai side, to the southeast.)

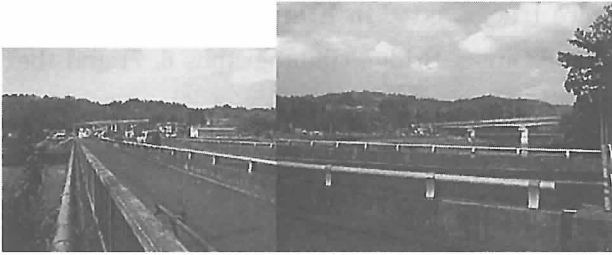
**Photographs 8, 9** An important traffic route along the Uono river at Wanazu in Kawaguchi town, near the epicenter of the main shock (about 3.5 km in the direction opposite that shown in the photograph). A northwestern view of National Road Route 17 from Wanazu Bridge. Bridges for the Kanetsu Expressway and Japan Railway (JR) Joetsu Line can be seen on the left. The beam on the Uonogawaha Bridge (JR Joetsu Shinkansen Line) can be seen in the background.

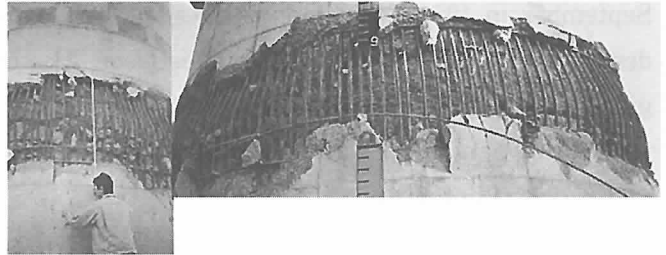
**Photographs 12, 13** Wrapped parts of steel hoops came off at the same height level. The concrete cover on the steel reinforcing bars was damaged and suffered scaling at the termination points of the main steel reinforcing bars.

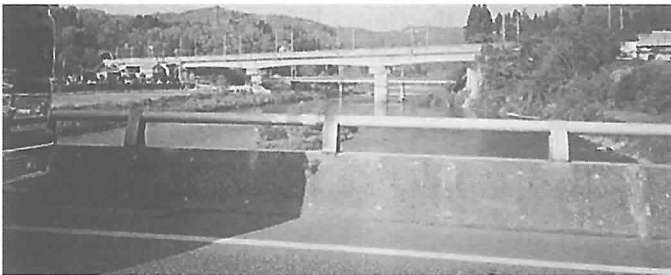
**Photograph 10** The damage occurred at the termination points of the main steel reinforcing bars for the two circular piers on the Uonogawa Bridge beam (JR Joetsu Shinkansen Line). The photograph was taken from Wanazu Bridge on National Road Route 17 where it crosses the Uono river.

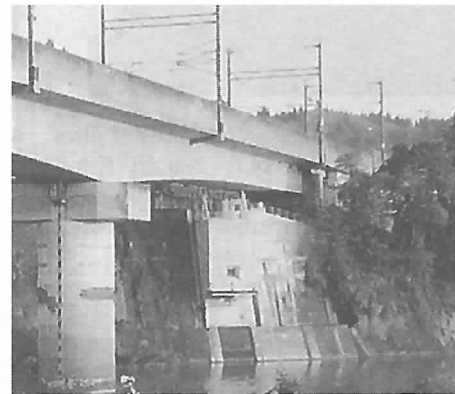
**Photograph 14** Parts of the rigid-frame elevated structure suffered shear failure. They are shown here being repaired among the blue sheeting and trees.

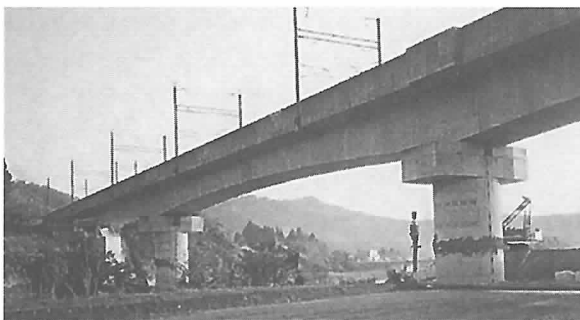
**Photograph 11** The damaged termination points of the main steel reinforcing bars in the piers of Uonogawa Bridge (JR Joetsu Shinkansen Line) (P1, P2).

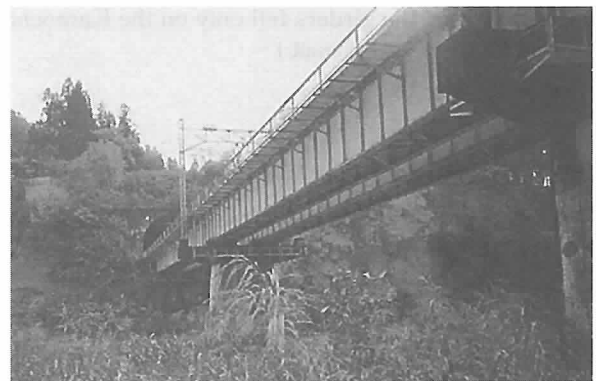
**Photograph 15** This plate girder bridge on the JR Joetsu Line is in fairly good condition, but a bolt securing a railroad tie fell out.

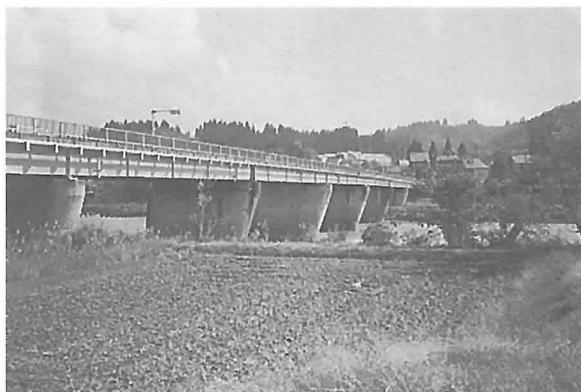
**Photograph 16** A crack appeared in the pier for Wanazu Bridge on National Road Route 17 (completed in 1954) and the edge of the main steel girder was damaged, but traffic flow was immediately restored.

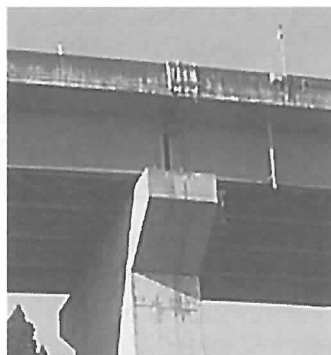
**Photograph 23** The concrete edges of these girders were only slightly damaged in the earthquake.

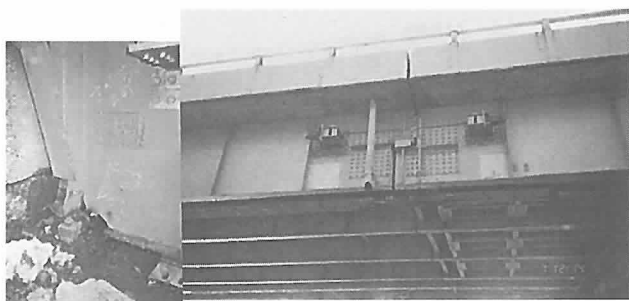
**Photographs 17, 18** Installed after Great Hanshin-Awaji Earthquake, this fallen girder arrestor proved effective during the Niigata Prefecture Chuetsu Earthquake. The damage to the edge of the main steel girder was possibly aggravated by corrosion and many years of use.

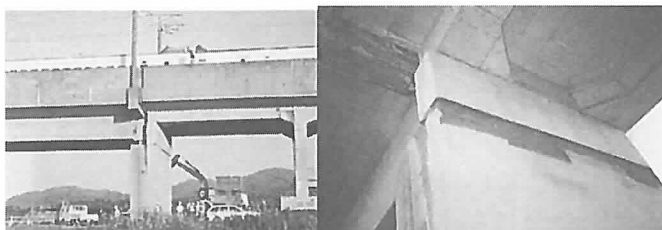
**Photographs 25, 26** The concrete scaling at plumb down of the reverse side of the bridge abutment was scraped at the derailment site (Photograph at left). The center of the upper part of the RC pier on Higashi-oh-shin-e Bridge in the same site (photographed from the west side). It blows concrete into the shave part which drops scaling be in scrape (November 7-8, 2004).

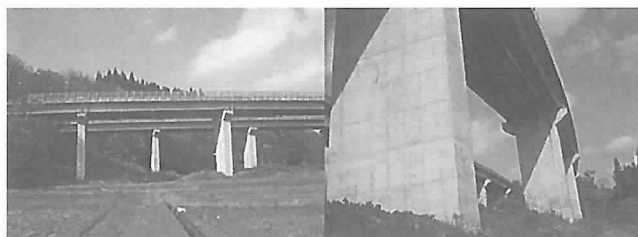
**Photographs 21, 22** The piers of the Kanetsu Expressway are in fairly good condition.

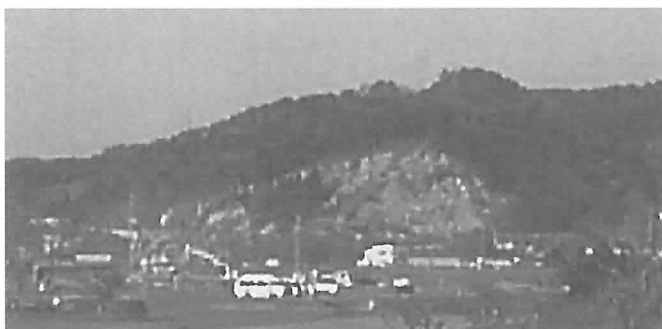
**Photograph 27** The collapsed cliff where a boy was miraculously rescued from a car. Two others died.

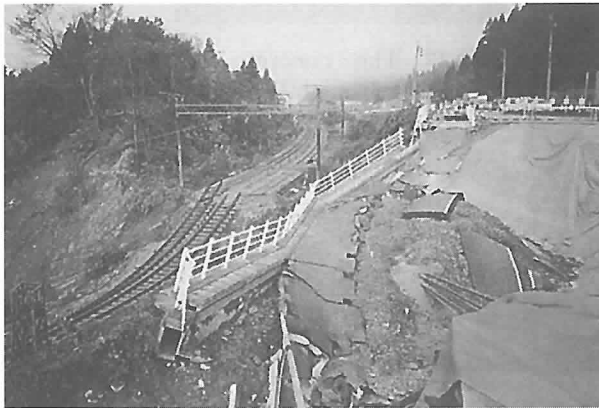
**Photograph 29** The collapsed cliff beside National Road Route 17 and the JR Joetsu Line.

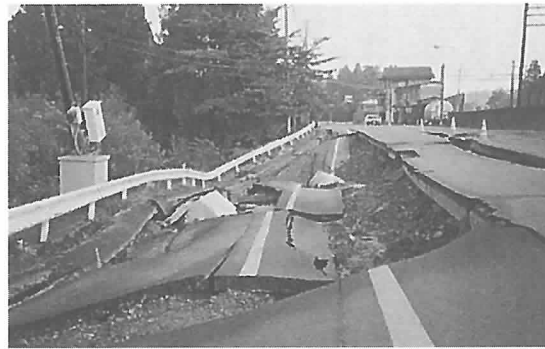
**Photograph 31** Sections of the prefecture regional road route in Ojiya City collapsed and suffered extensive damage to the pavement, sub-base, course, and sub-grade.

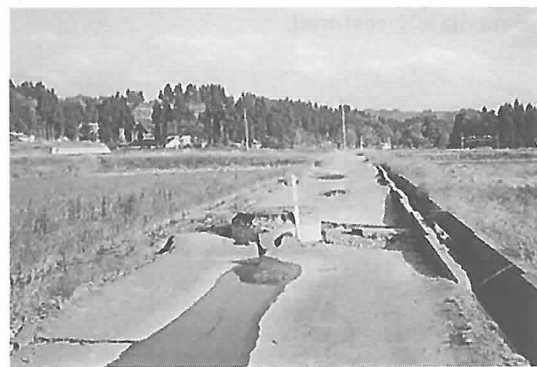
**Photograph 32** Quick repairs were needed because of the extensive damage to agricultural water irrigation systems, field access roads, drainage facilities, etc., in this major rice producing area. But next season's harvest may still be affected.

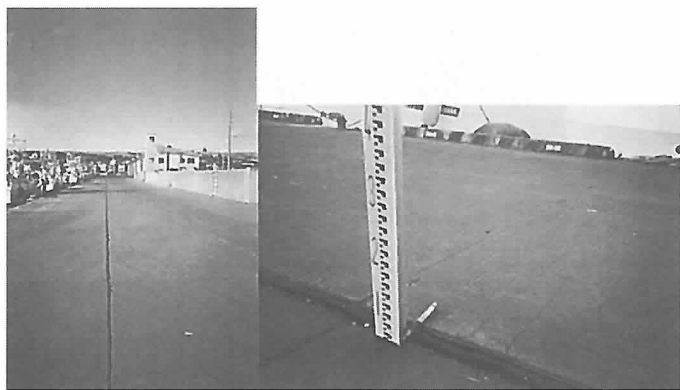
**Photographs 34, 35** Hanasaki port in Nemuro City (embankment at right). The wharf levels differ by only a few centimeters.

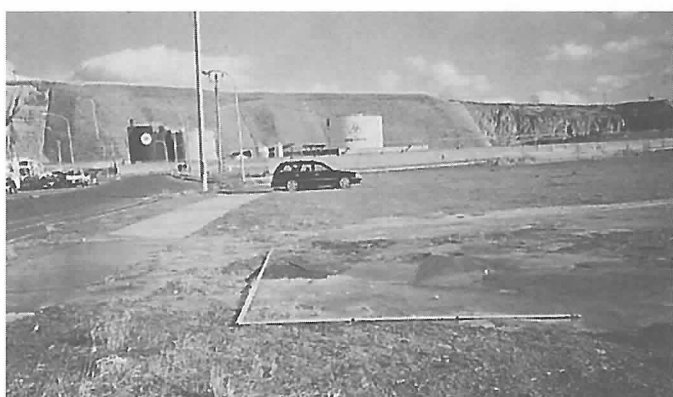
**Photograph 36** Liquefaction at the wharf in Hanasaki port, Nemuro City. No real damage occurred because there were no buildings at the site.

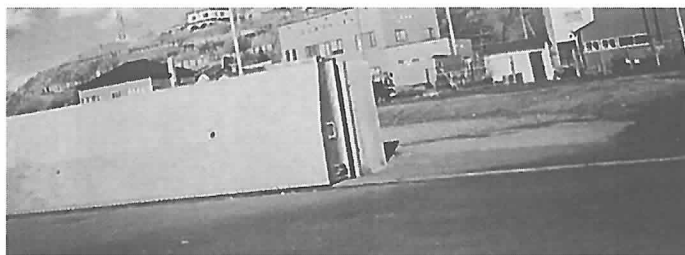
**Photograph 37** The basic functions of the embankment gate of the anti tidal wave quay in Hanasaki port, Nemuro City were not damaged by the Kushiro Oki Earthquake (29th November in 2004), but were damaged by the Hokkaido Toho Oki Earthquake in 1994. An aftershock (December 7, 2004) of the Kushiro Oki Earthquake also did no damage to the gate but only because heavy snow protected it according to one report.

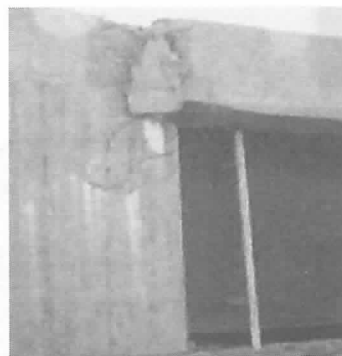
**Photograph 42** Cracking and support failure by crustal deformation from volcanic activity along the Doou Expressway.

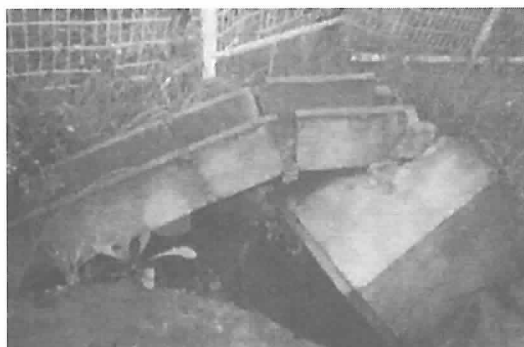
**Photograph 40** Road drain damaged by crustal deformation from volcanic activity.

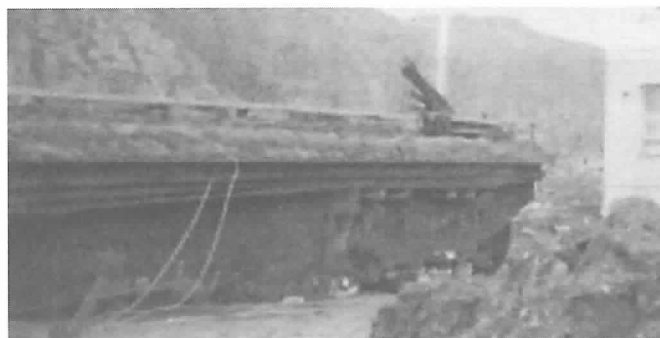
**Photograph 43** RC-beam for road bridge on route 230, washed away by a mudflow.

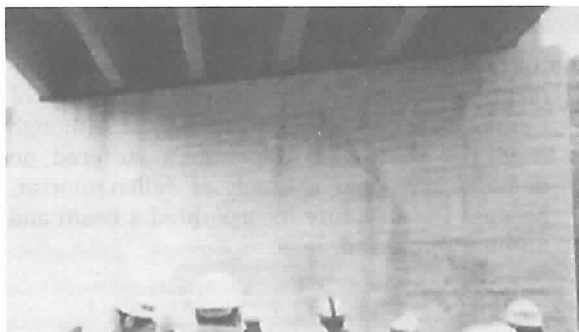
**Photograph 41** Bridge abutment damaged by crustal deformation from volcanic activity along the Doou Expressway.

Muroran Main Line of JR Hokkaido Co. Ltd, and various Hokkaido prefecture and municipal roads, etc., were damaged by crustal deformation (Photograph 41). Examples of upward movement, cracking, and support failure are shown in Photograph 42. Structures along the shore of Lake Toya to the north of Konpira-yama Crater were washed away by volcanic ash mudflows. The damage was exceptionally intensive down slope of the nearby volcanic craters. Volcanic-ash mudflows caused particularly serious damage to National Highway Route 230 near the Nishiyama River in the Lake Toya hot spring resort. The RC beam of the Konomi Bridge on National Highway Route 230 was detached and pushed several tens of meters downstream toward Lake Toya by volcanic-ash mudflows from the Nishiyama River (Photograph 43). Mudflowed into the 1F classrooms of the Toyako-Onsen

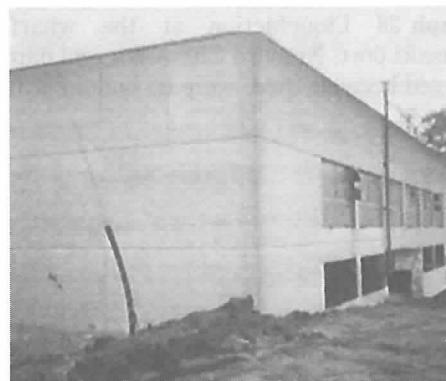
**Photograph 44** First floor classroom of elementary school damaged by a mudflow.

elementary school located near the river, destroying windowpanes and frames. The Mizuumi-Dokusyono-Ie, a wooden-frame mortar structure used as a community center by nearby residents and children, was completely destroyed (Photograph 4)
