Damage survey of 2008 Wenchuan earthquake in different regions

Junqiang Zhu^{a*}, Jitao Yao^b, Qianying Ma^b

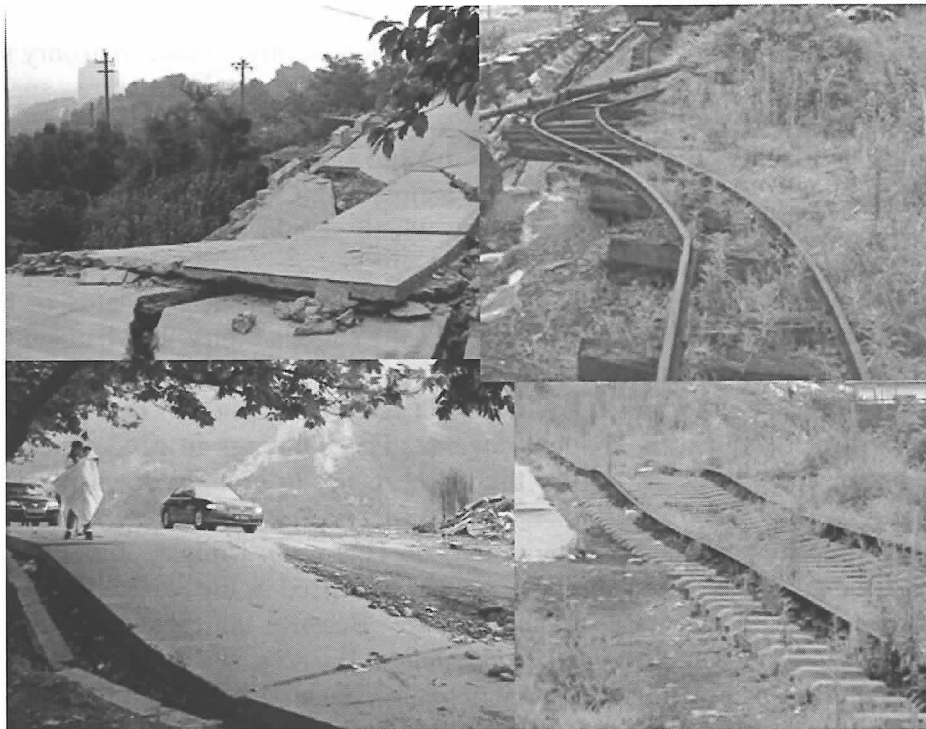
Fig.15. Destruction of roads and rail in Hanwang landslides, and mud-rock flows. These geological disasters not only caused the collapse of many buildings and houses, causing heavy casualties, but also a large number of roads, railways, bridges, communications and other infrastructures have been destroyed.

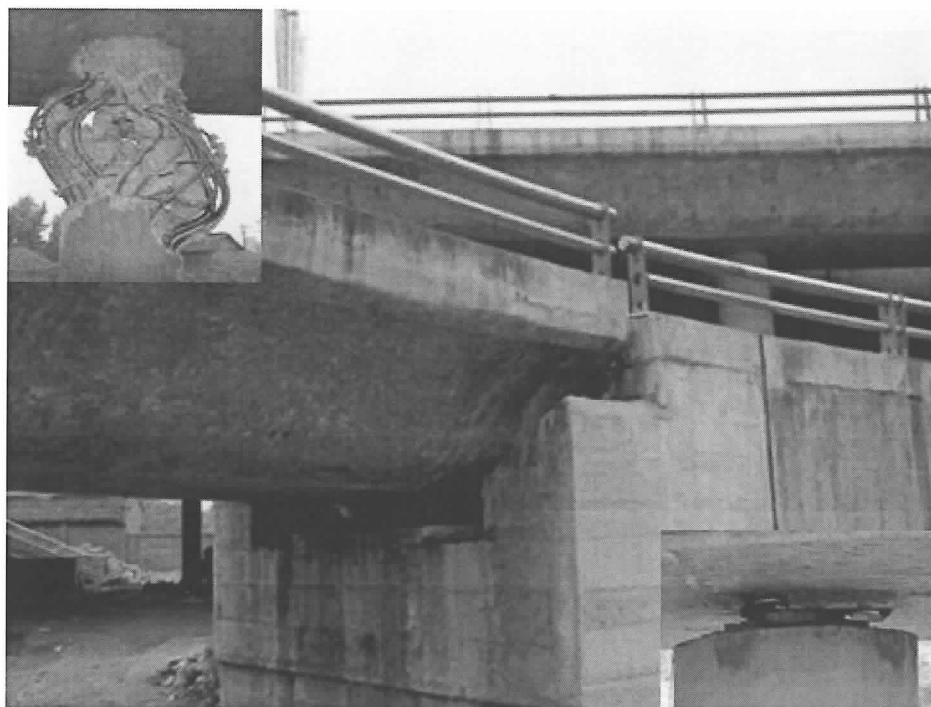
Fig.16. Destruction of roads flyover overpass in Mianyang

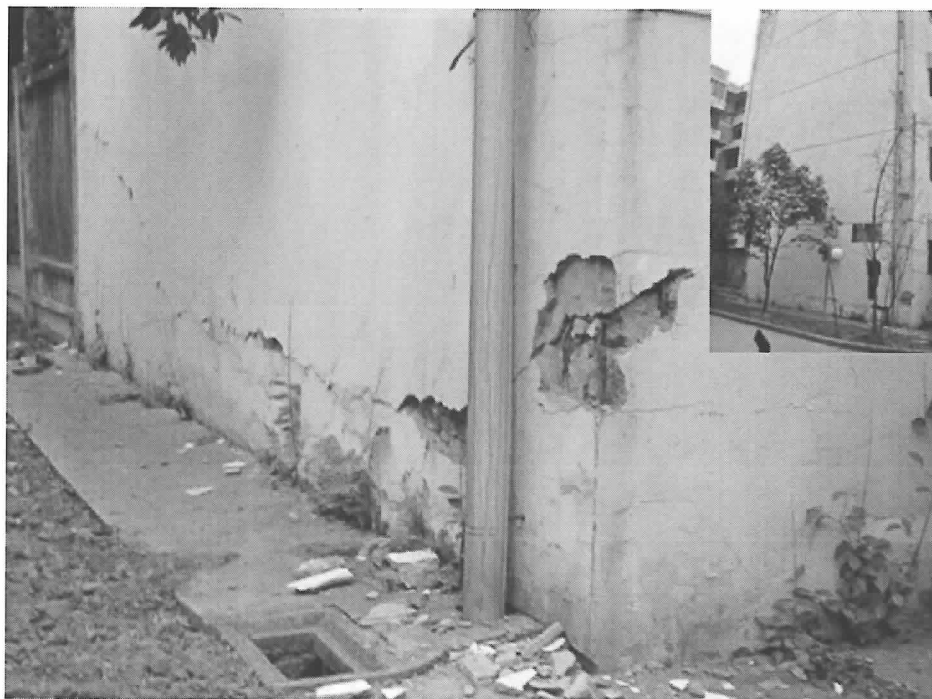
Fig.23. Level cracks in the masonry structure at the bottom in Mianzhu

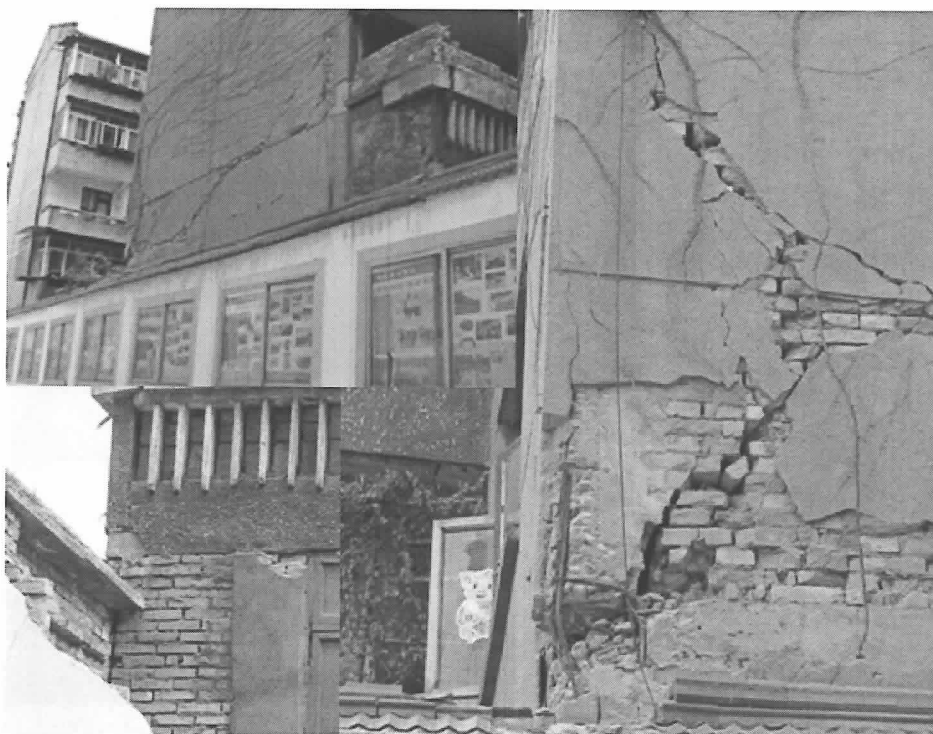
Fig.24. Wall damage of masonry structure with a surrounding wall in Mianzhu

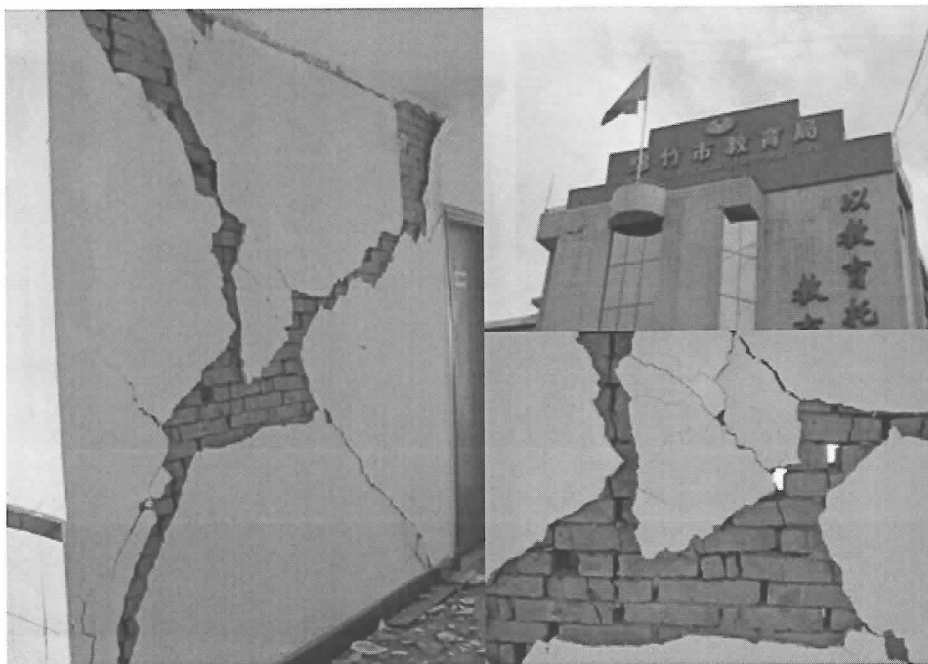
Fig.25. Wall damage of masonry structure in Mianzhu

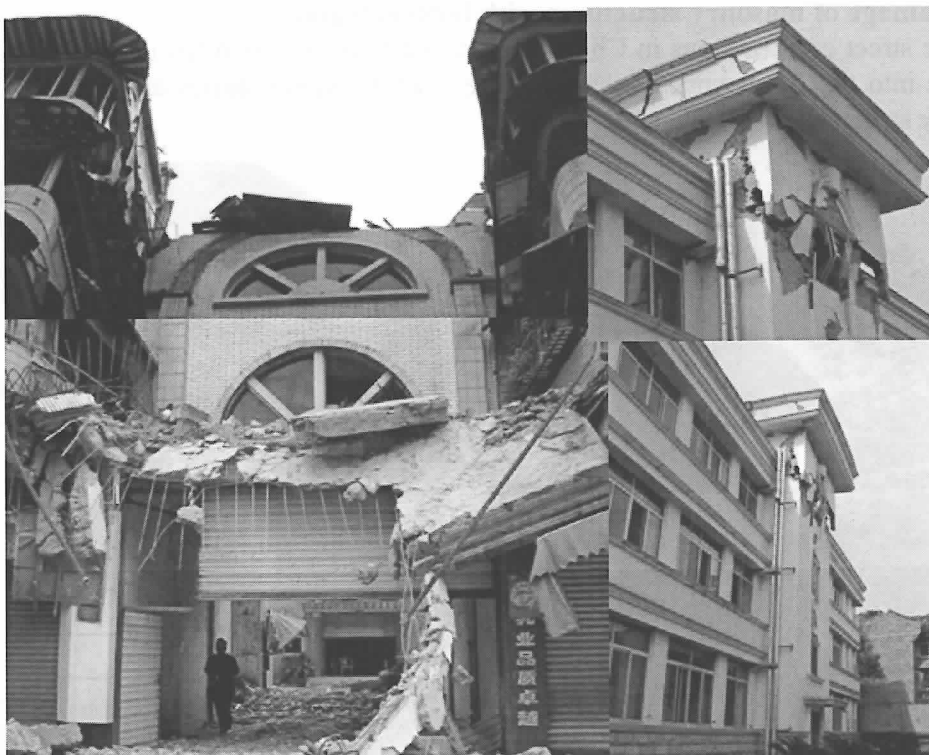
Fig.29. Secondary disaster caused by protruding parapet and staircase damage in Mianzhu

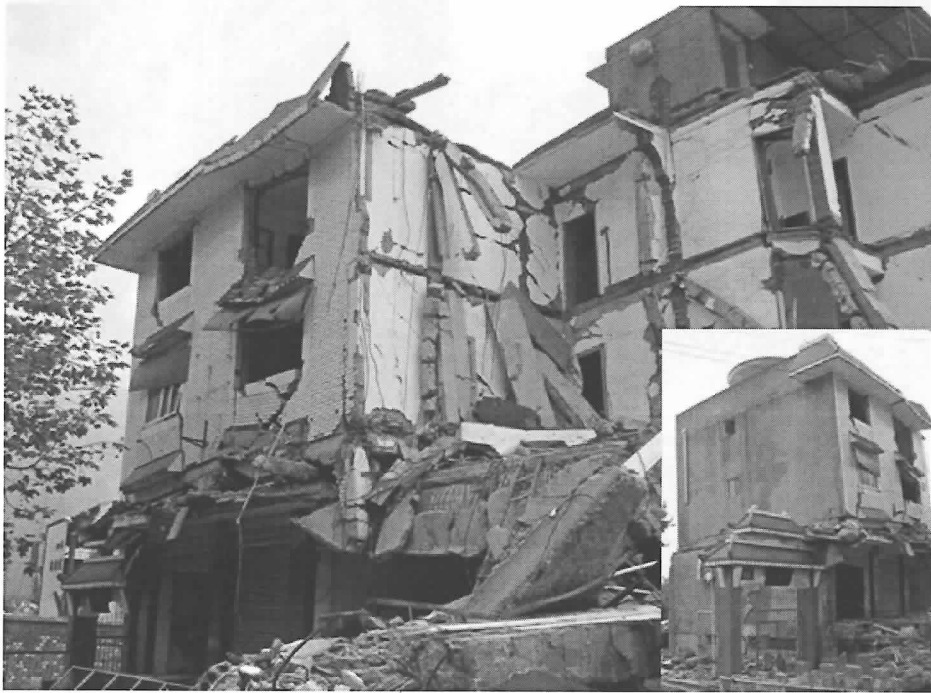
Fig.31. A damage of masonry structure with bottom frame in Hanwang

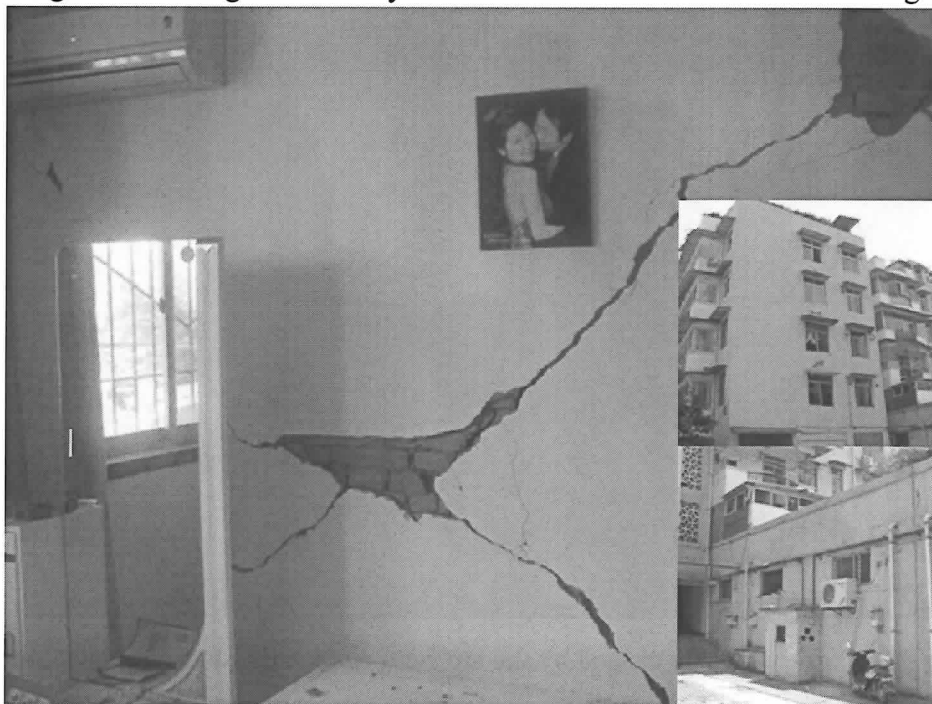
Fig.32. Wall damage in second floor of masonry structure with bottom frame in Mianzhu

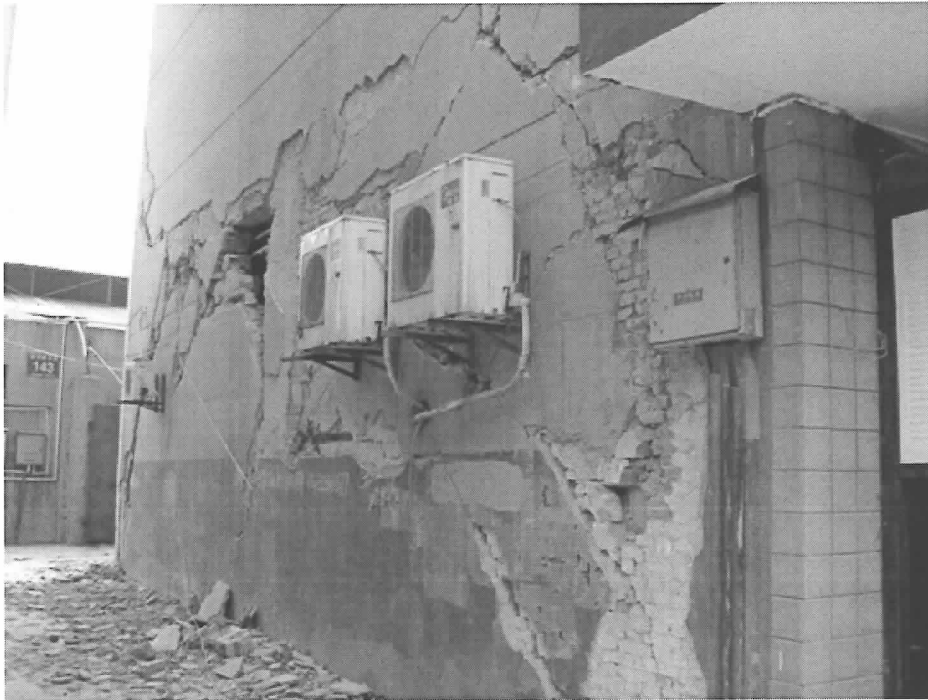
Fig.33. Wall damage in second floor of masonry structure with bottom frame in Mianzhu

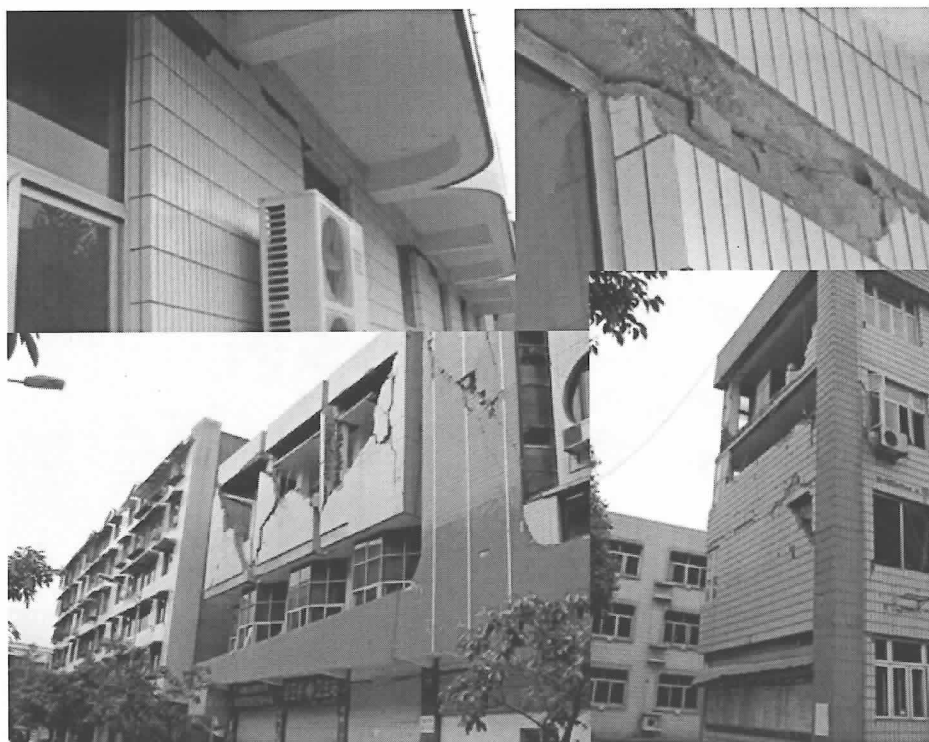
Fig.37. Wall damage of frame structure in Mianzhu

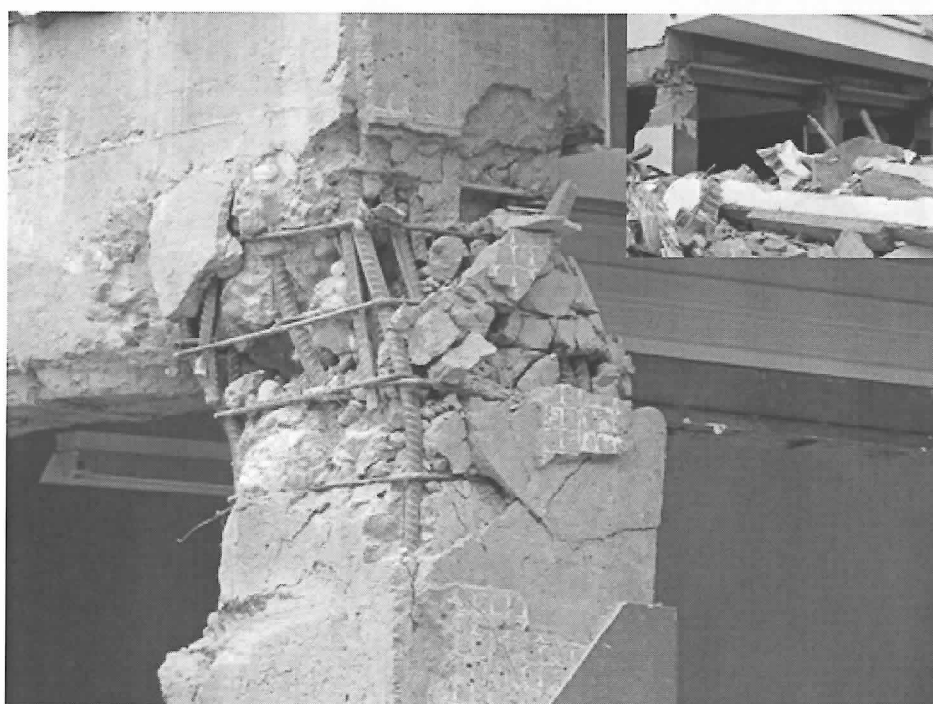
Fig.39. Column damage of frame structure in Hanwang

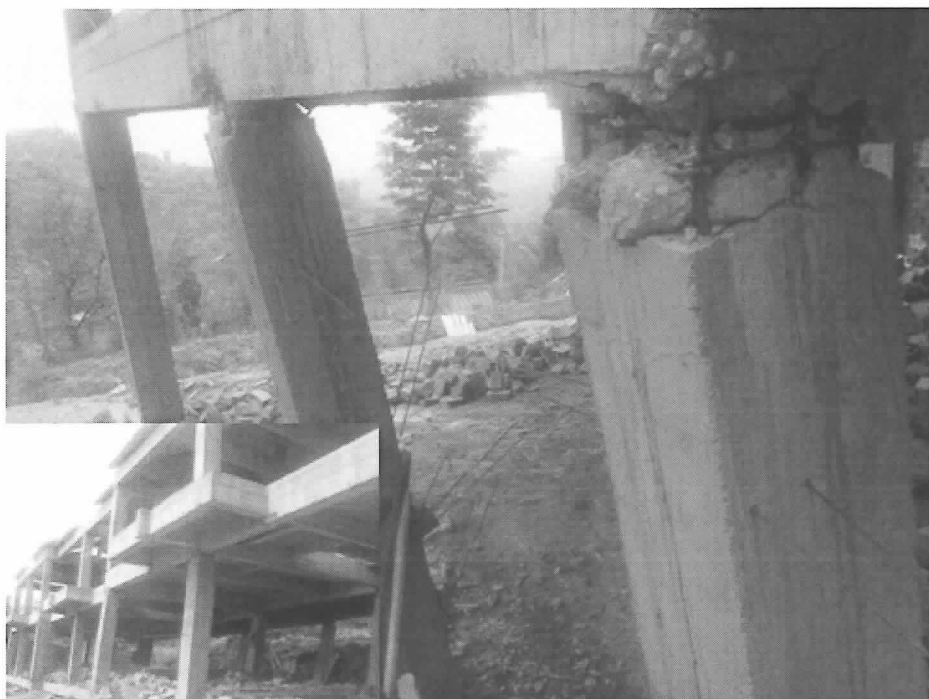
Fig.40. Column damage of frame structure in Jiulong

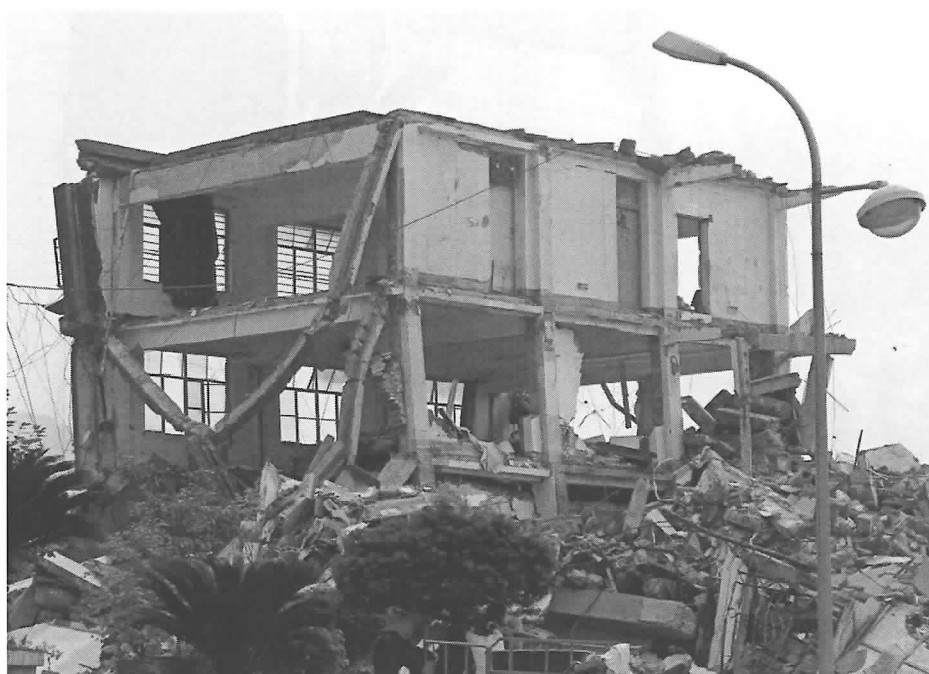
Fig.41. Damage of frame structure in Hanwang

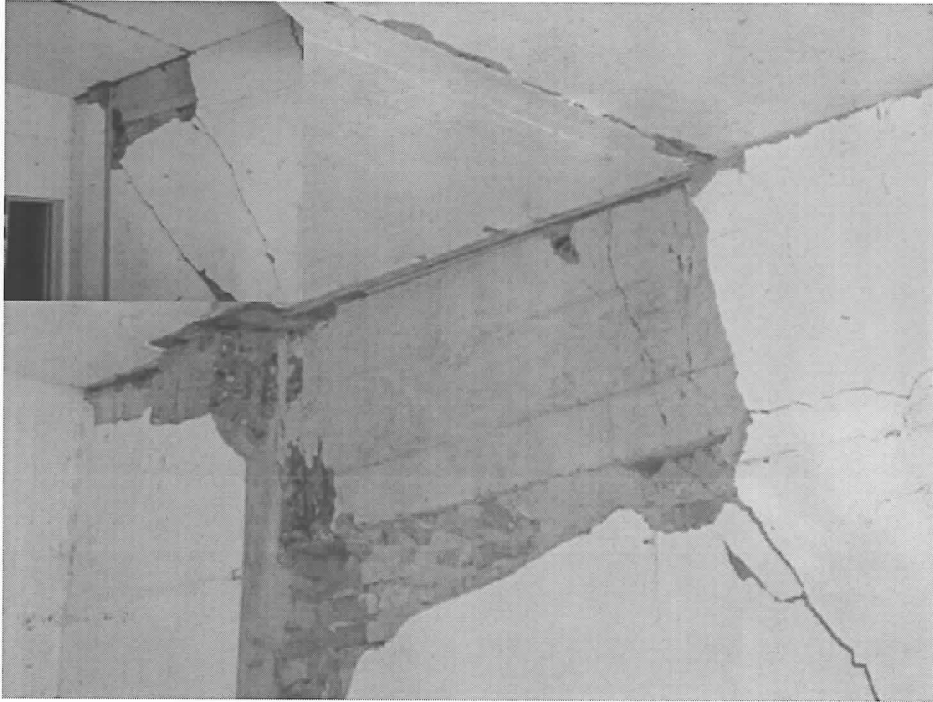
Fig.42. Wall damage of frame structure in Hanwang

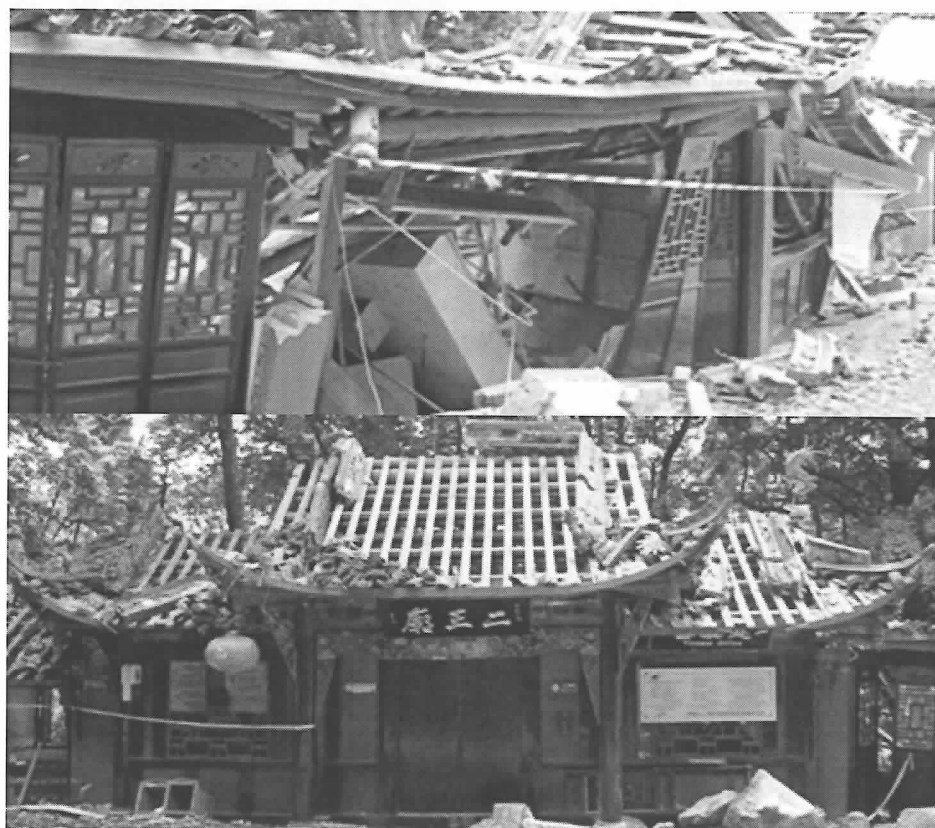
Fig.47. Damage of wooden structure in Dujiangyan

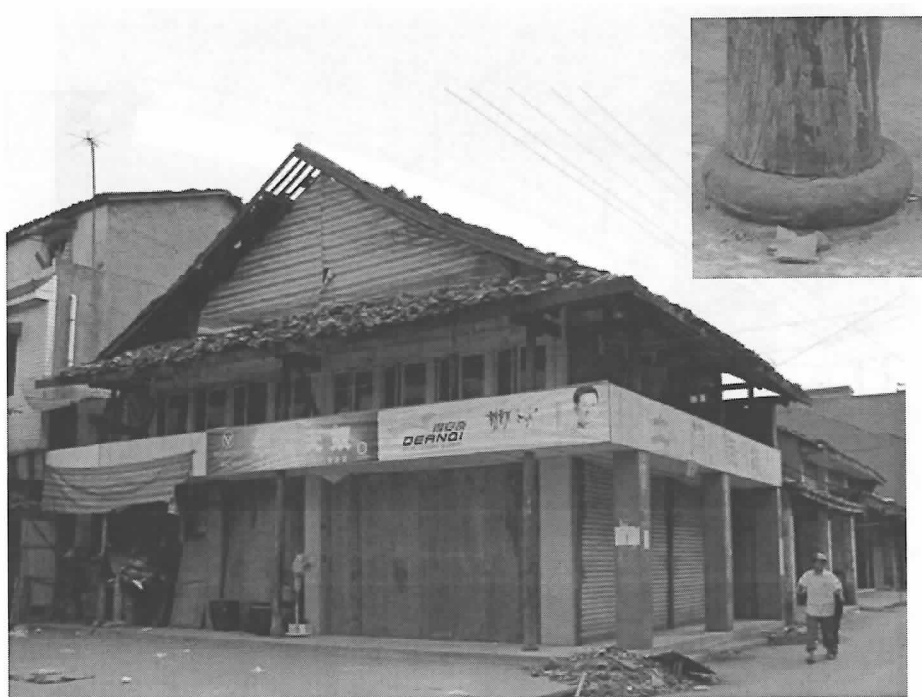
Fig.48. Damage of wooden structure in Tumen

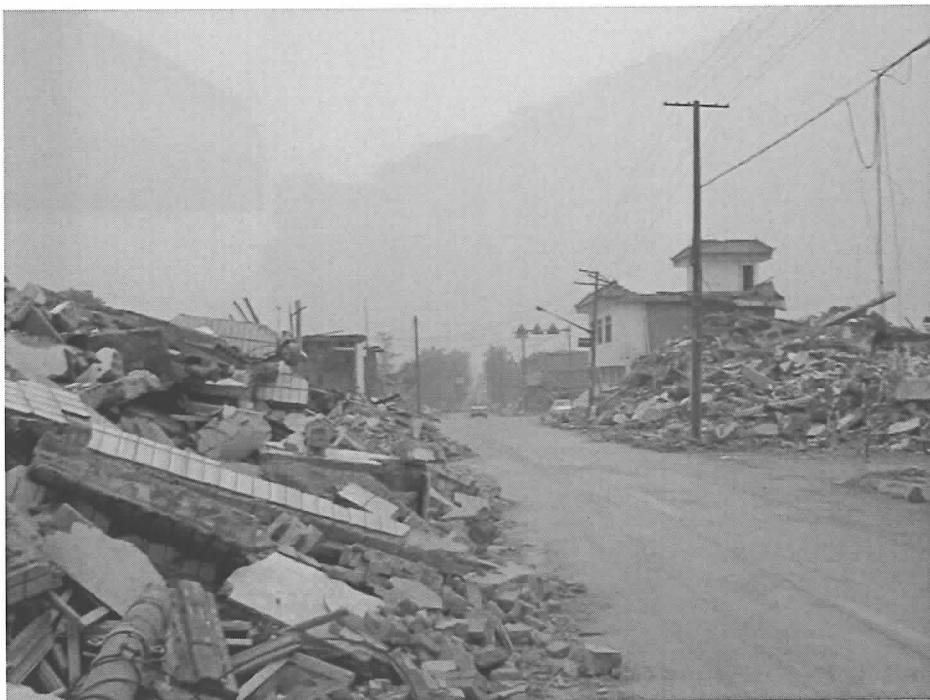
Fig.53. Damage of rural housings in Jiulong

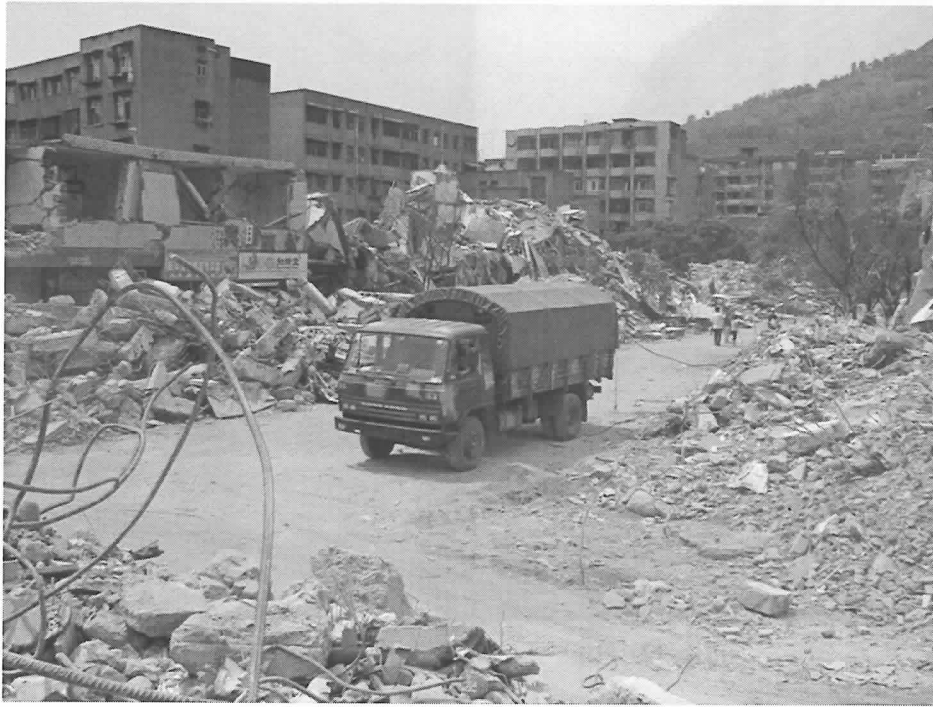
Fig.54. Damage of rural housings in Hanwang

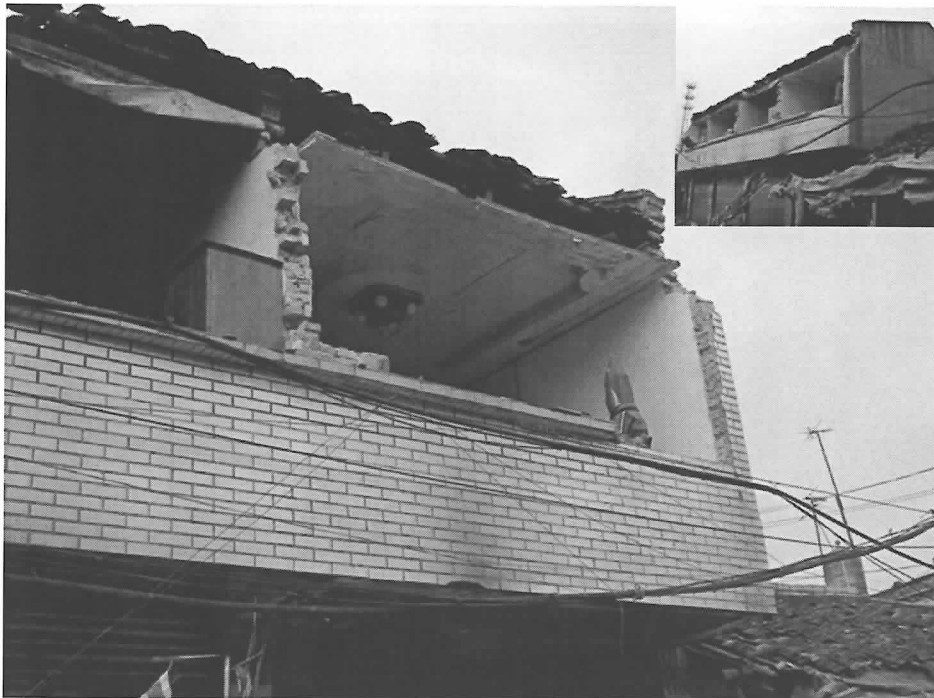
Fig.55. Damage of rural housings in Tumen

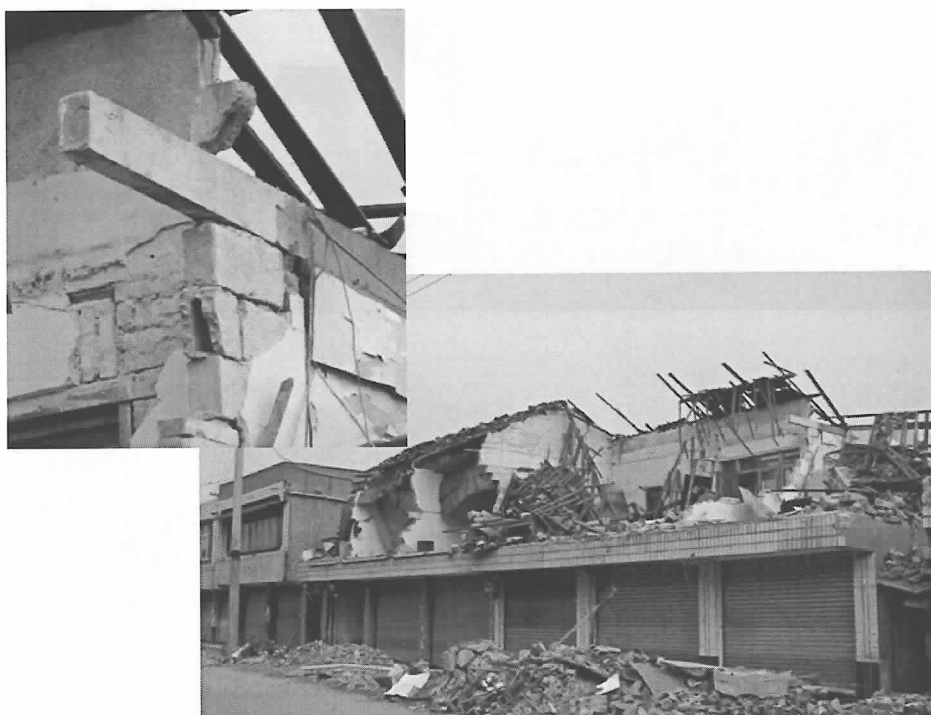
Fig.56. Damage of rural housings in Tumen

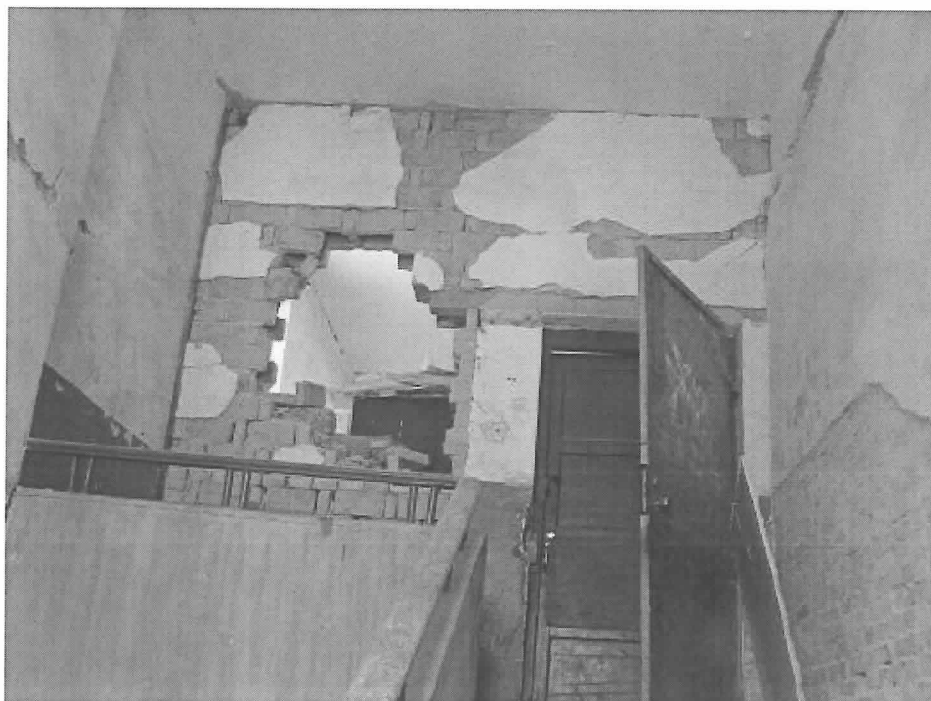
Fig.61. Damage of filled wall

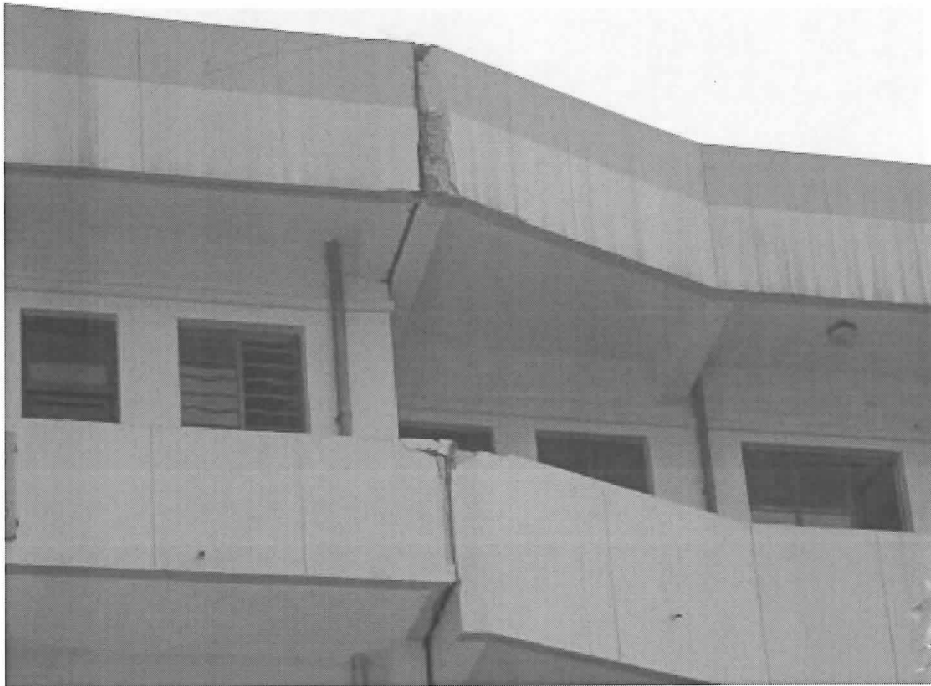
Fig.67. Damage of seismic joint

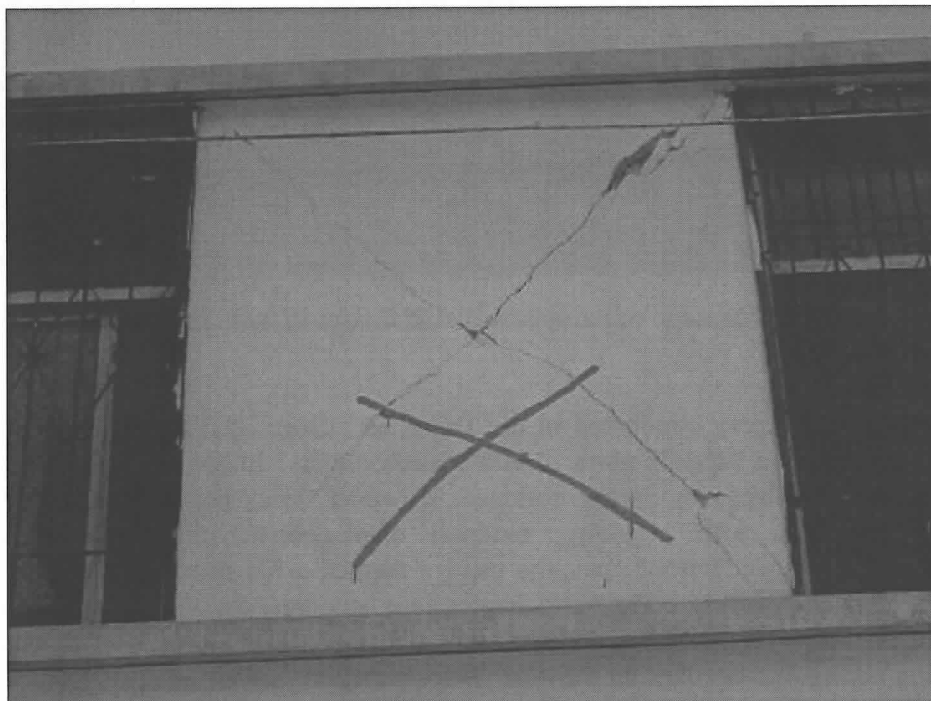
Fig.68. Damage of wall between windows

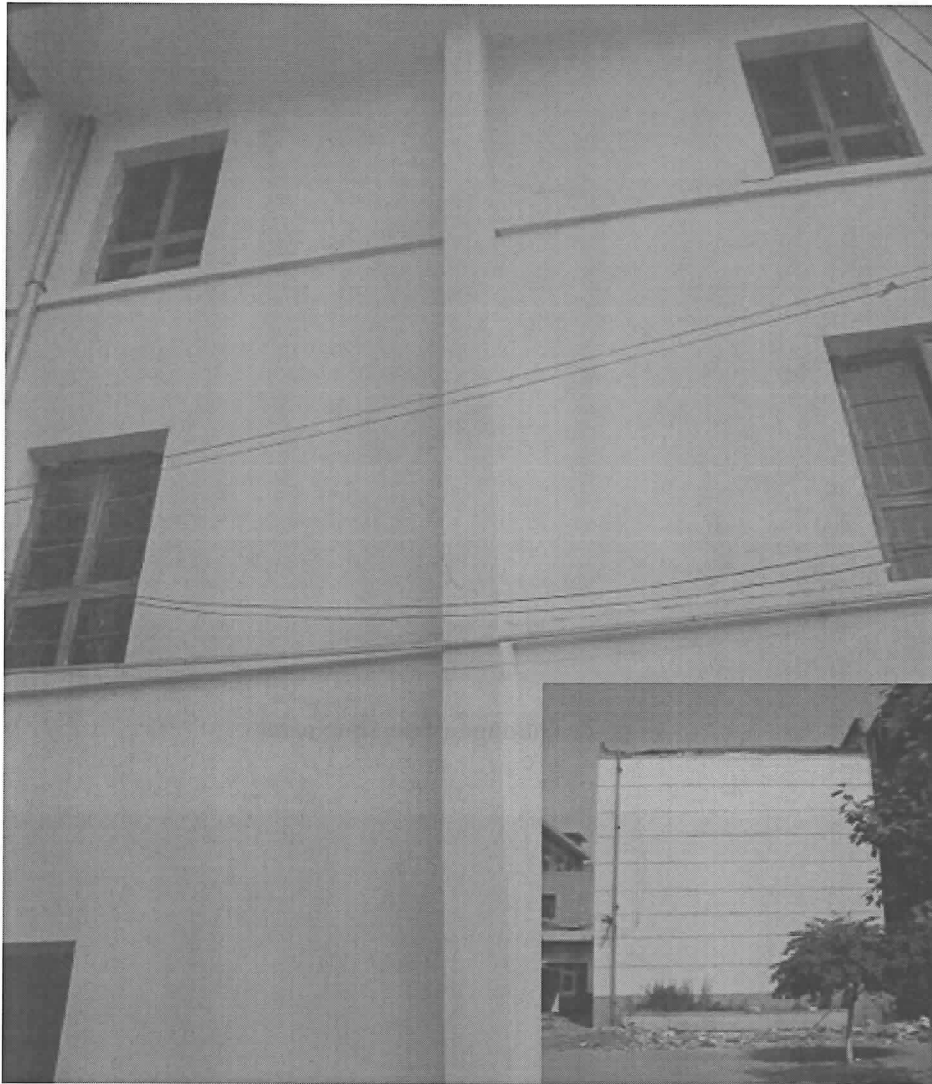
Fig.69. Damage of parapet wall and cracks in wall and column

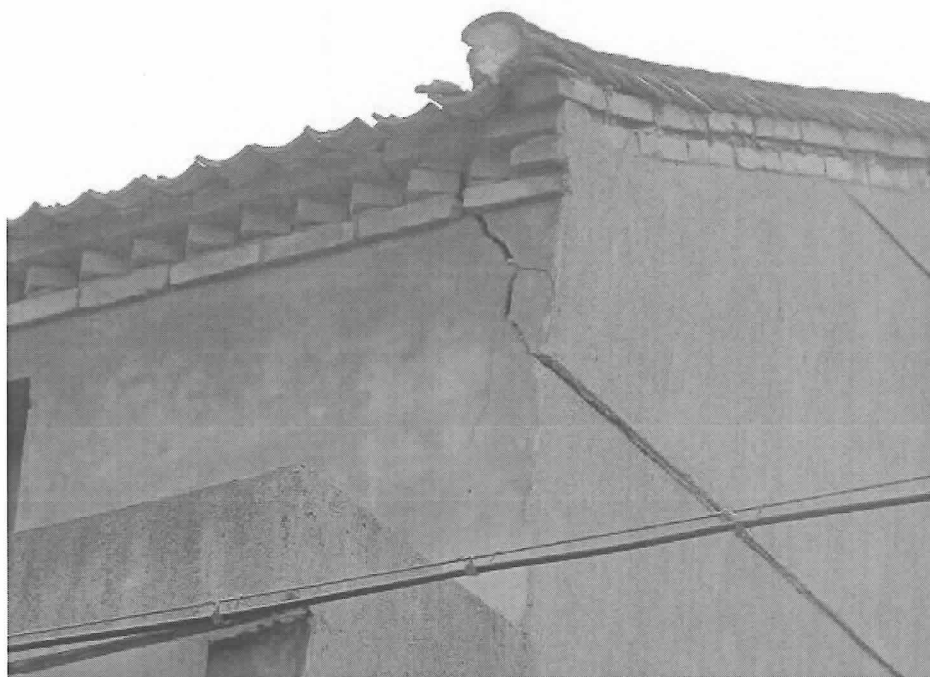
Fig.70. Gable cracks

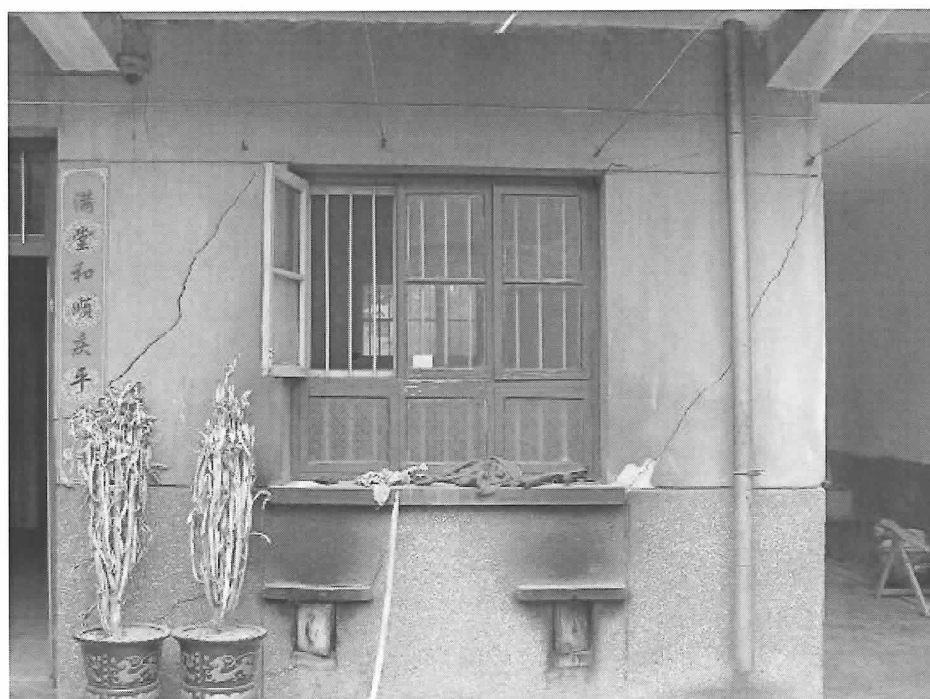
Fig.71. Cracking wall in front of the house

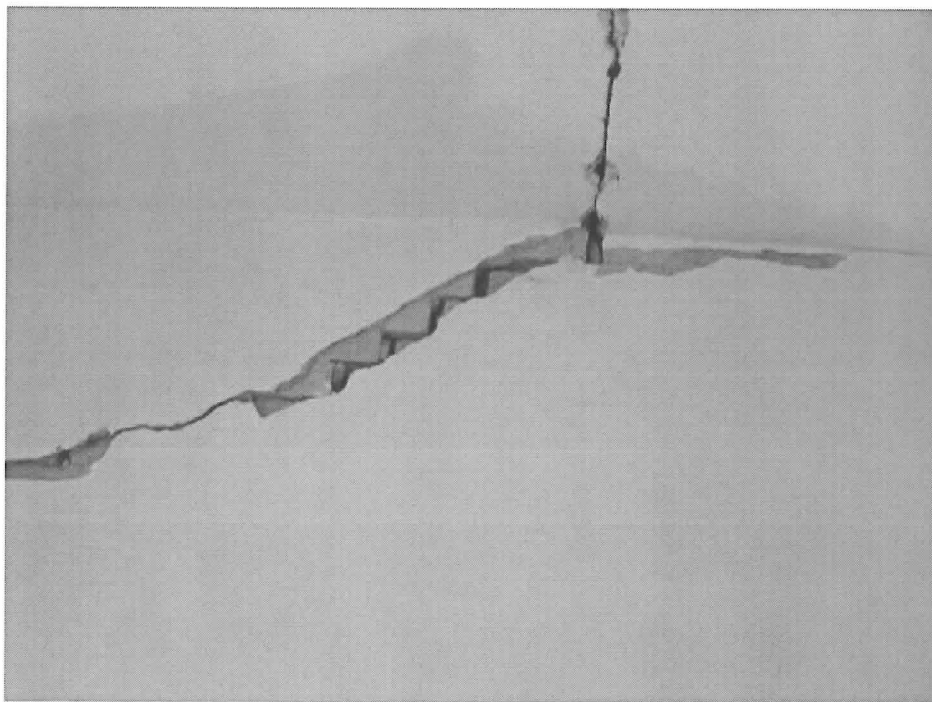
Fig.72. Cracked load-bearing wall and precast slab floor

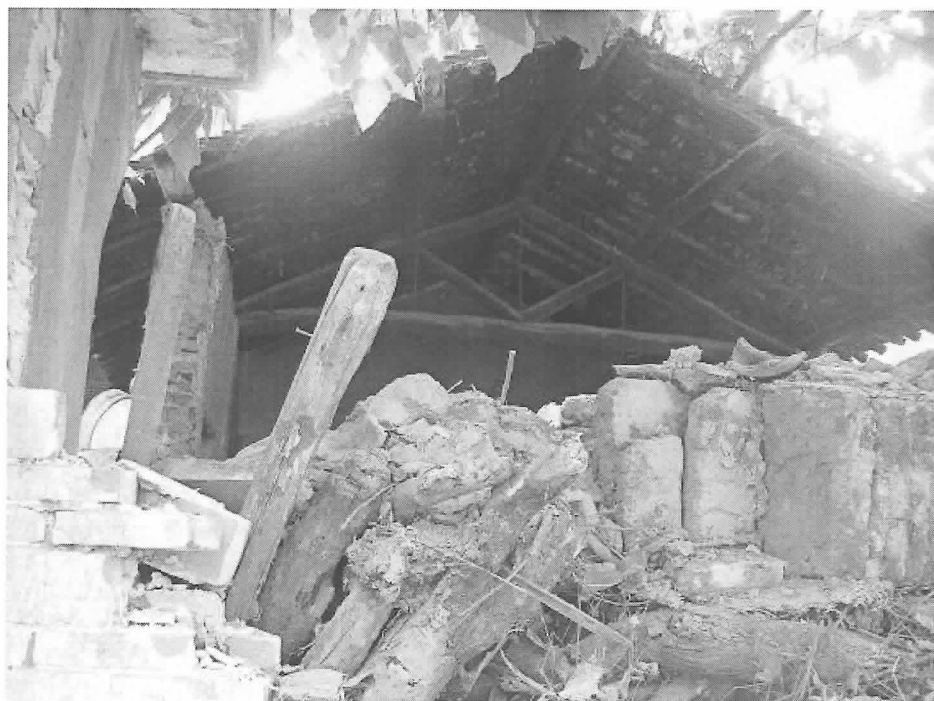
Fig.73. Collapsed adobe house

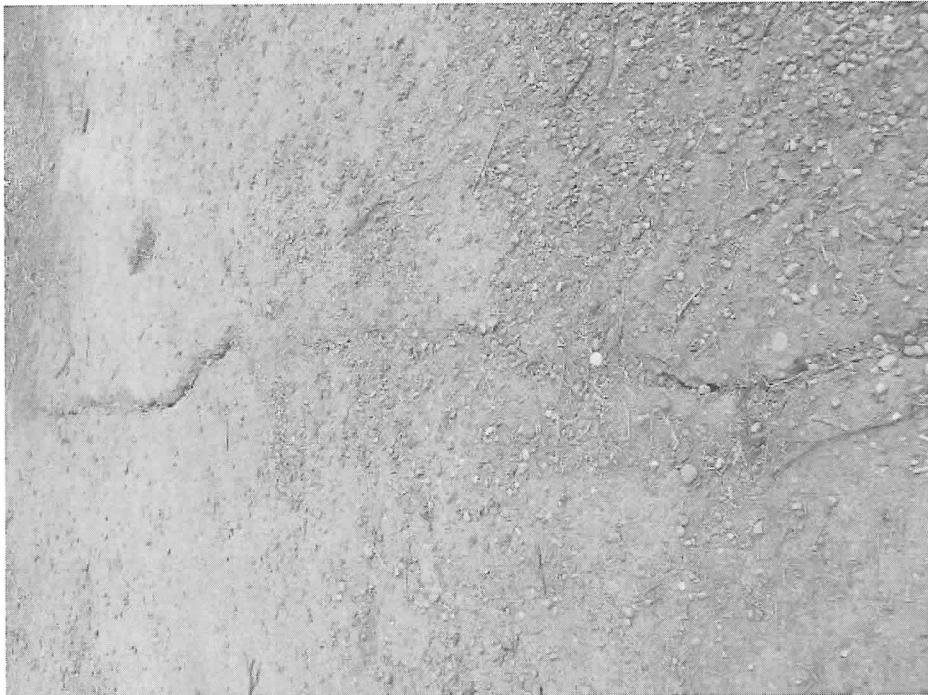
Fig.74. Ground fissures generated by the earthquake

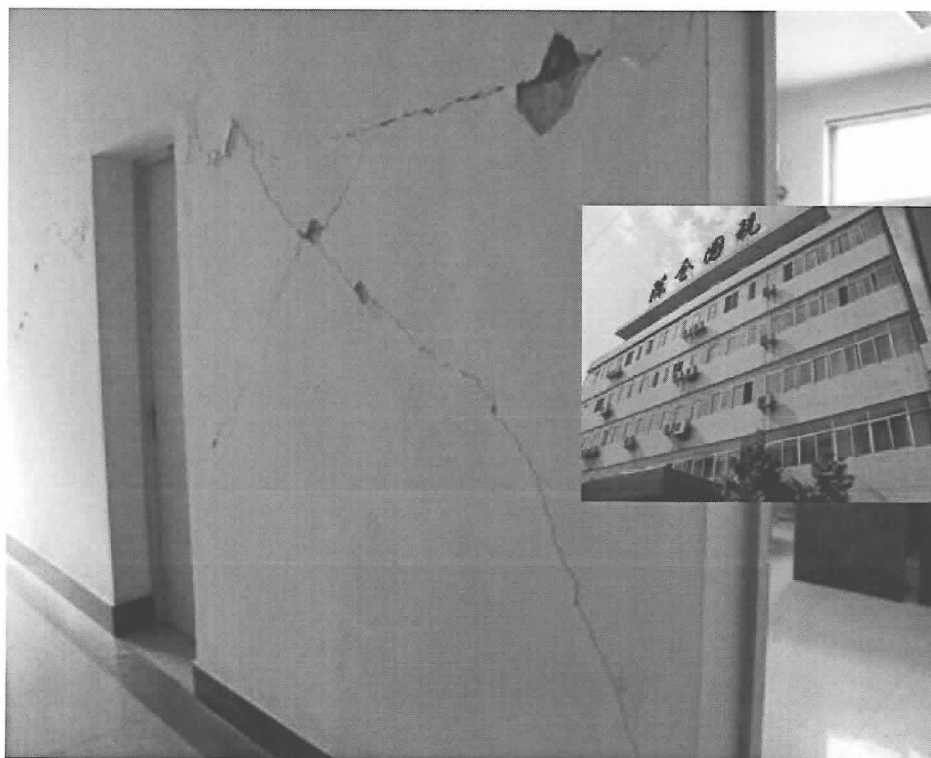
Fig.76. Inner longitudinal wall cracks of an inland revenue department office building

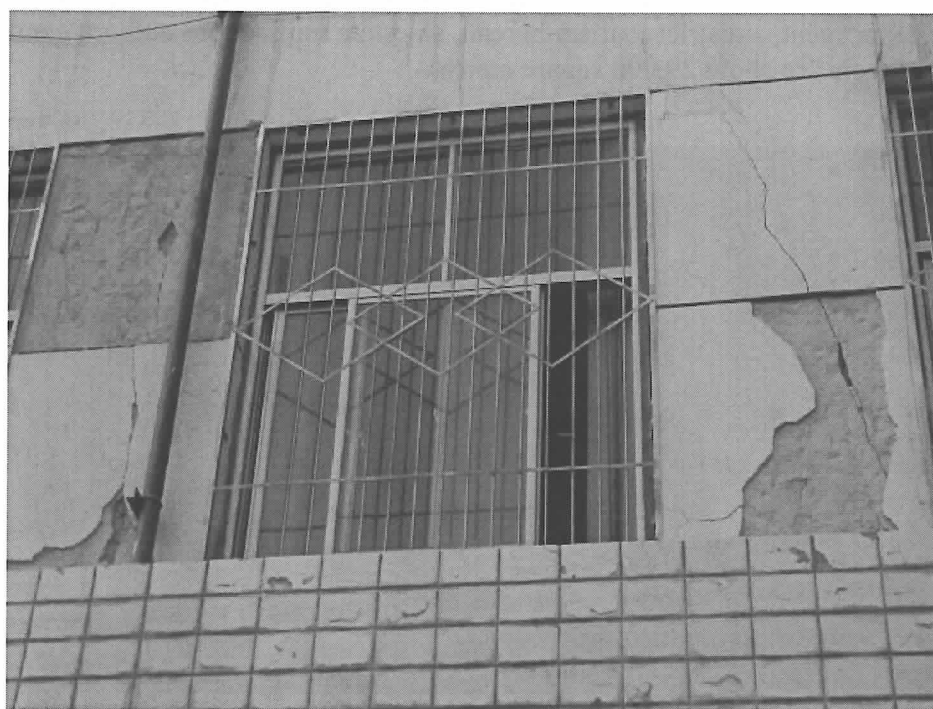
Fig.77. Exterior wall cracks of a district tourism bureau office building

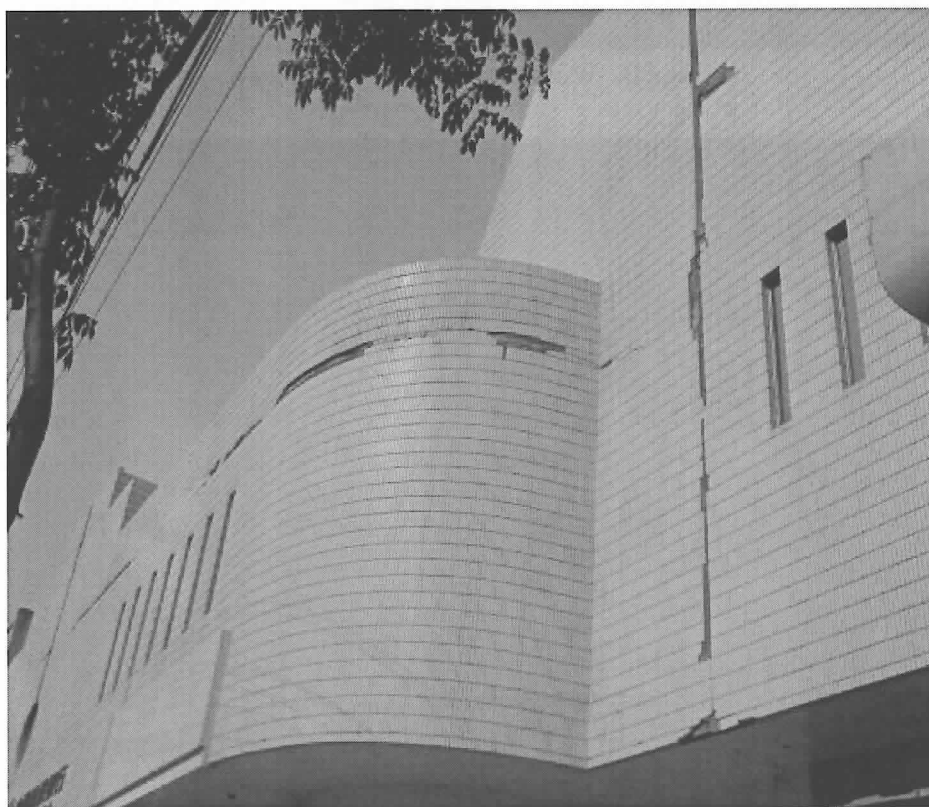
Fig.79. External wall damage of a bank office building

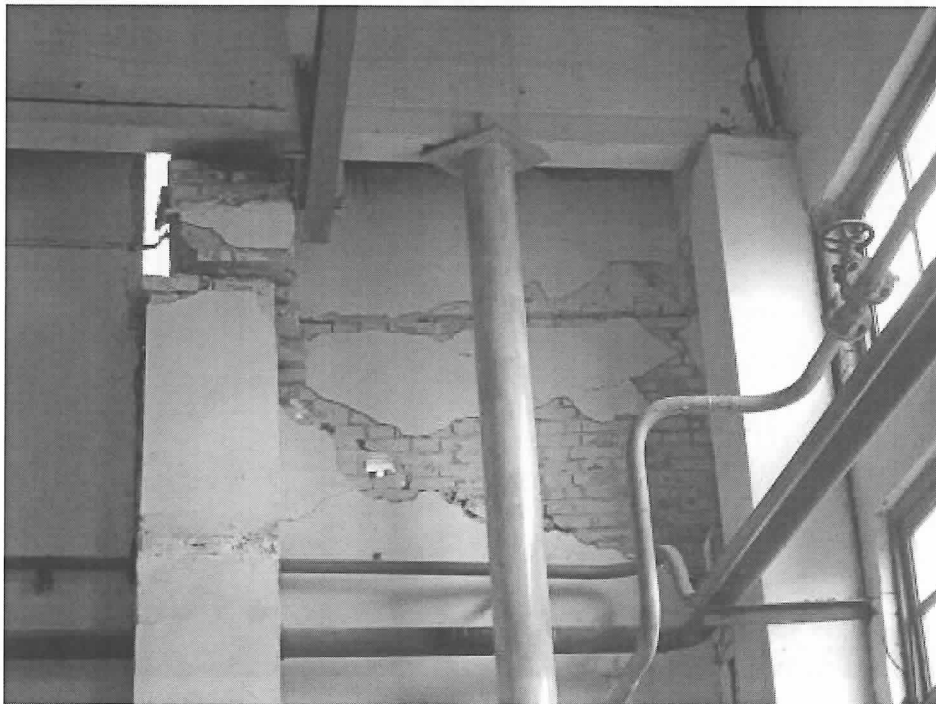
Fig.81. Crack and dislocation in top of brick column of wind resistance gable
