Damage survey of 2008 Wenchuan earthquake in different regions

Junqiang Zhu^{a*}, Jitao Yao^b, Qianying Ma^b

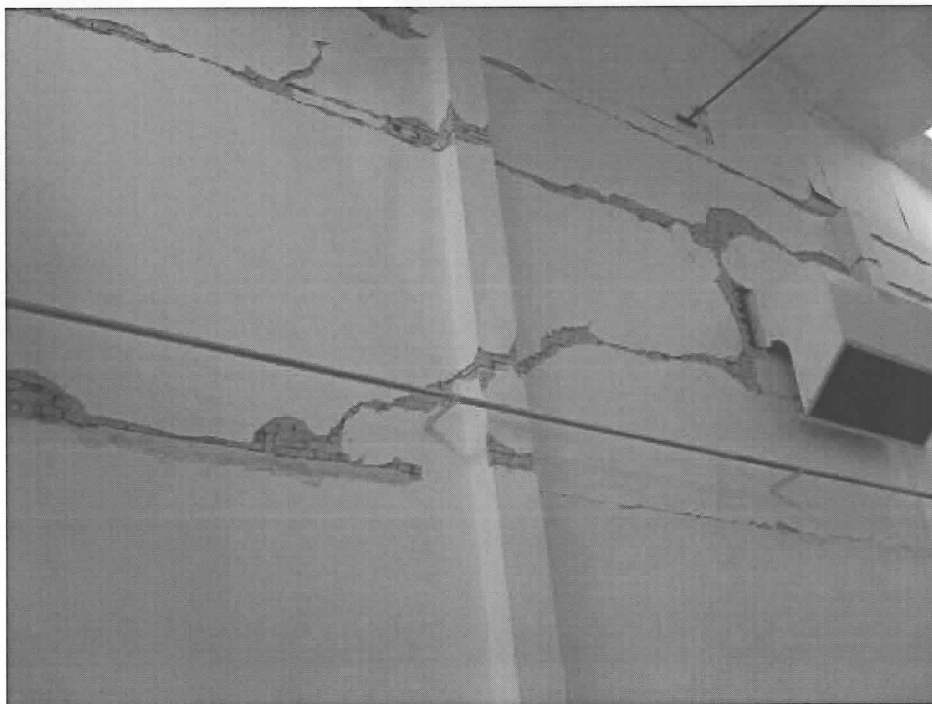
Fig.82. Cracks of wind resistance gable

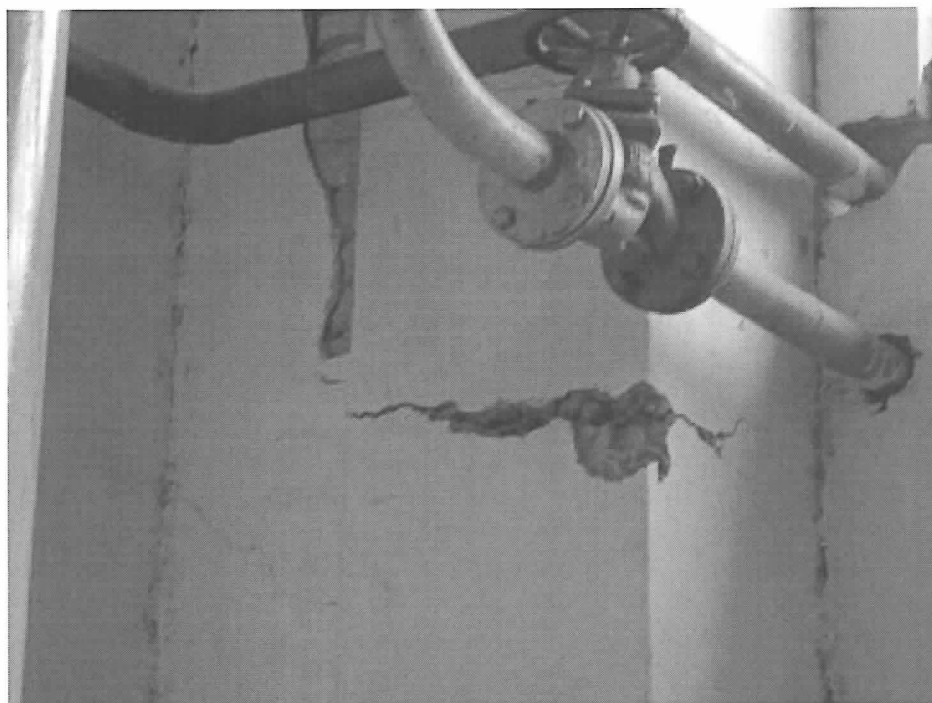
Fig.83. Damage of frame bent column

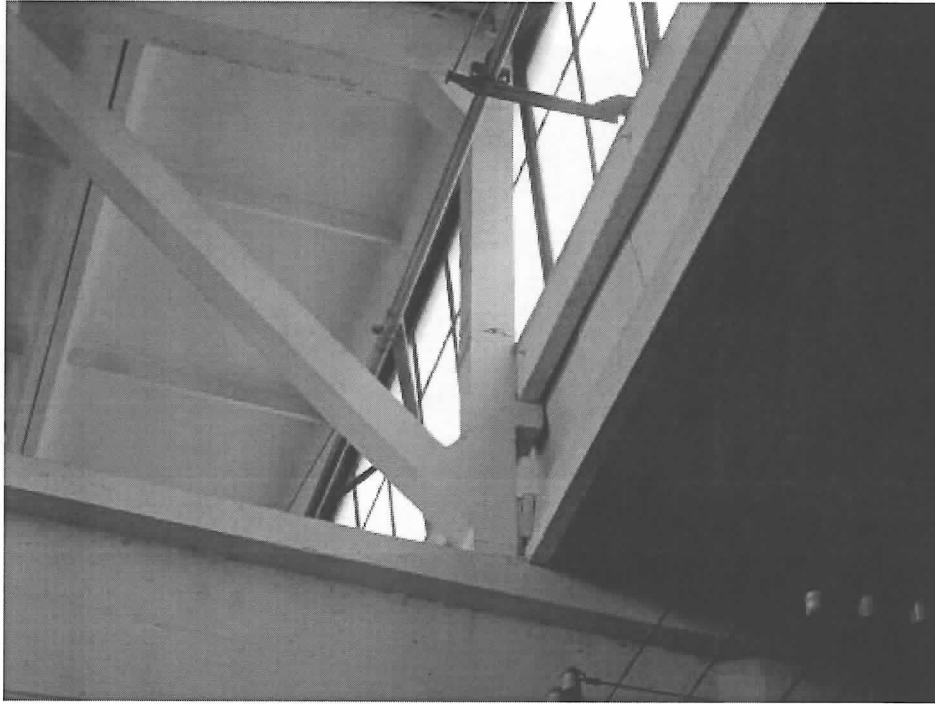
Fig.84. Frame column cracking of sunroof

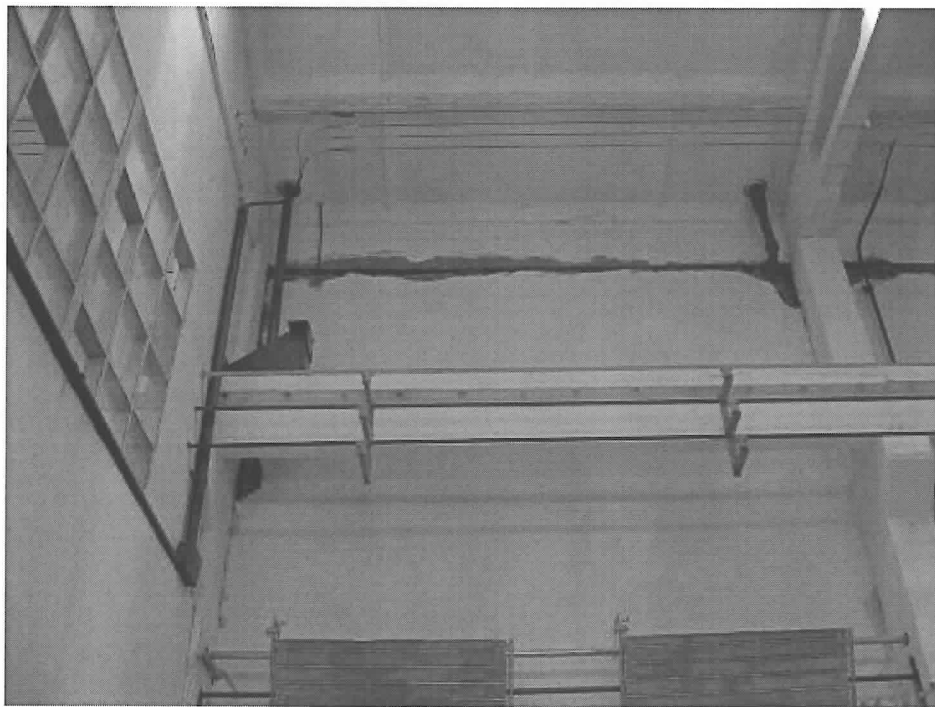
Fig.85. Horizontal crack bottom the beam of longitudinal wall

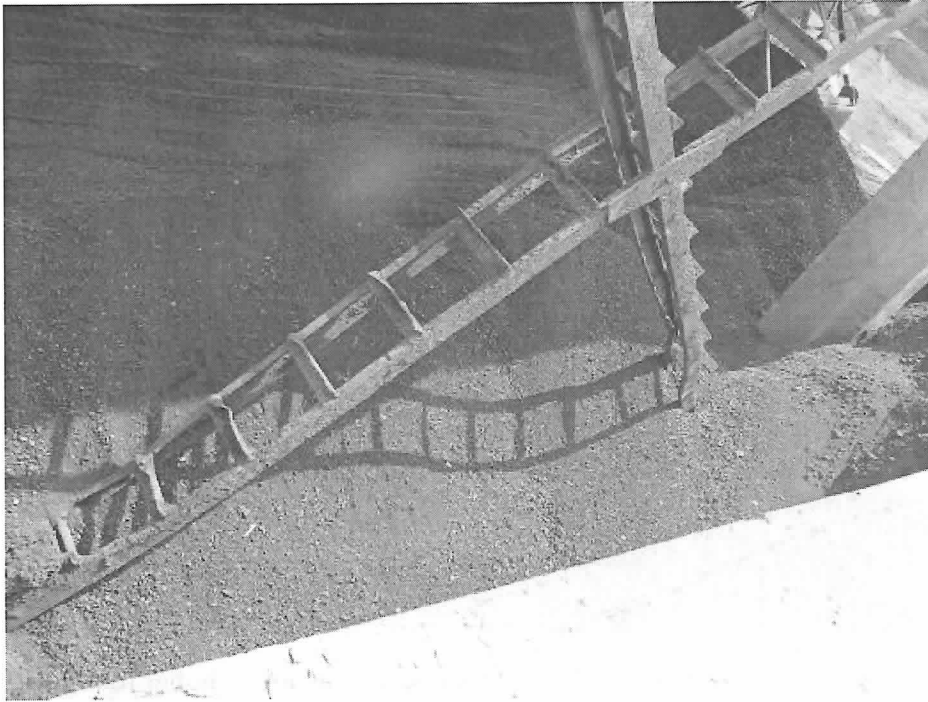
Fig.86. Support bulking between columns of storage of coal factory buildings in a beer company

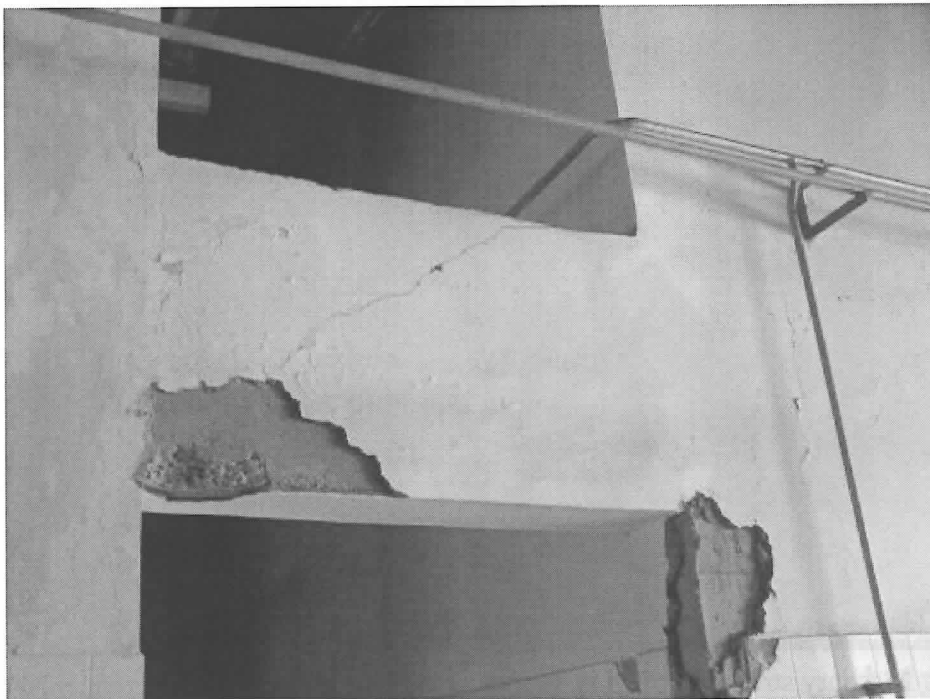
Fig.87. Short beam shear failure of a workshop

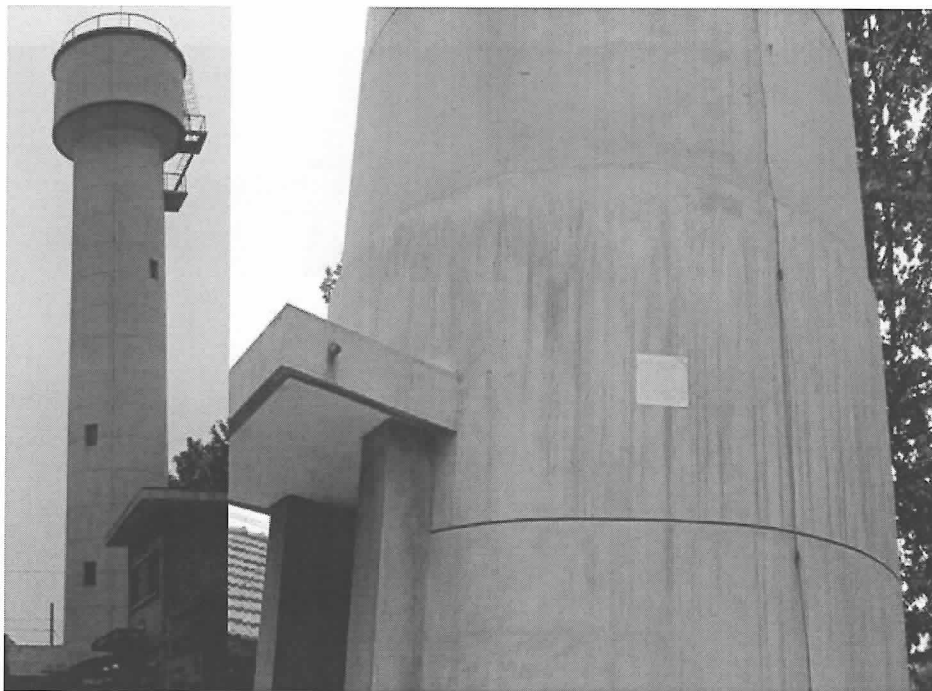
Fig.89. Masonry structure tower is 33 meters high 15 meters circumference, 700mm of wall thickness. There are a number of circular cracks from bottom to top; interval of them is about 3 meters, crack width decrease with height, no vertical cracks.

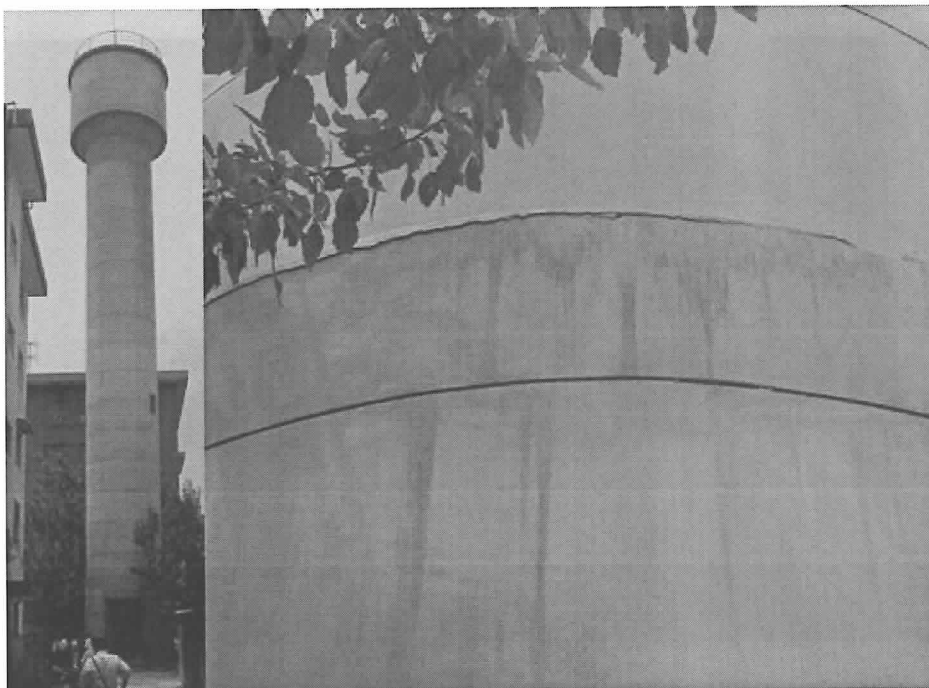
Fig.90. Masonry structure tower is 30 meters high. There is one circular cracks at the site of 6 meter from bottom.

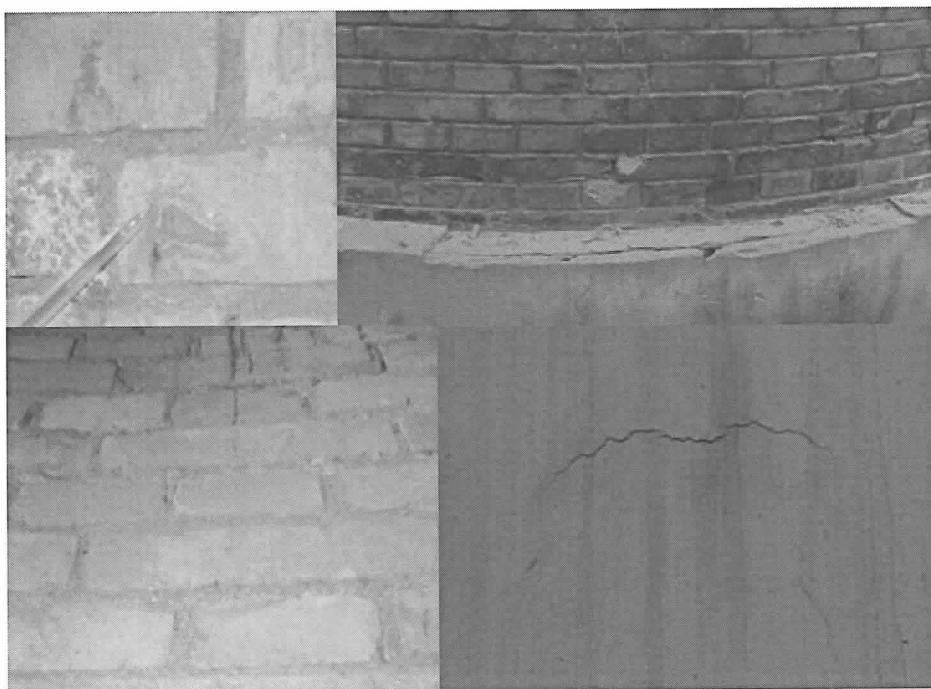
Fig.91. Masonry structure tower with 6 ring beams is 30 meters high, There is one circular cracks at the site of 1 meter from bottom, There are diagonal cracks and vertical cracks between first and second ring beam.

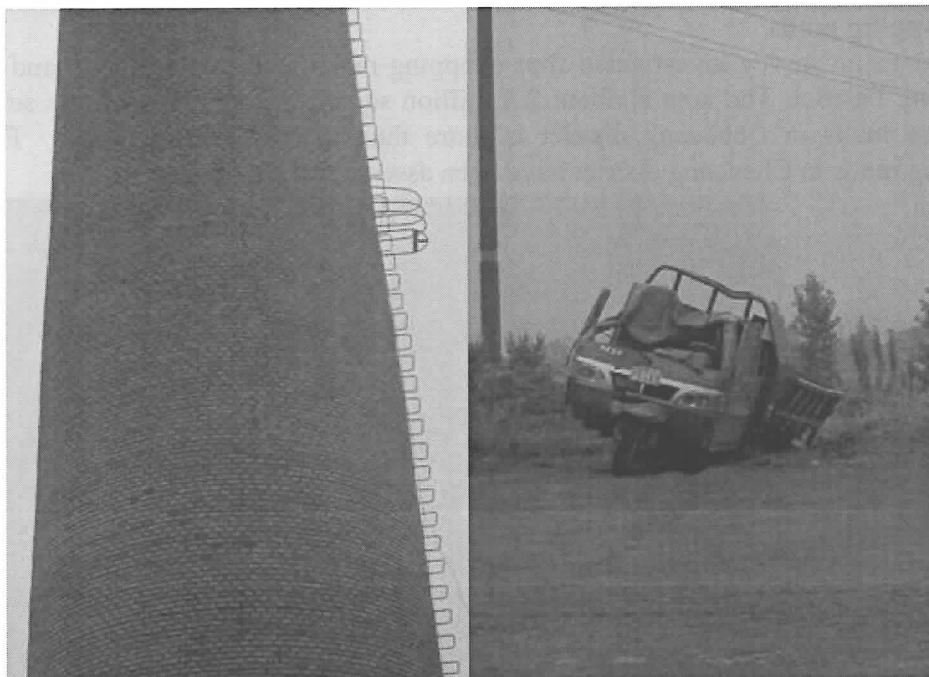
Fig.94. Brickfield masonry structure chimney is 58 meters high. 15 meters long at the top fell down and damage the tractor parting beside it. Remainder has vertical permeability cracks of 20 meters long from the top.

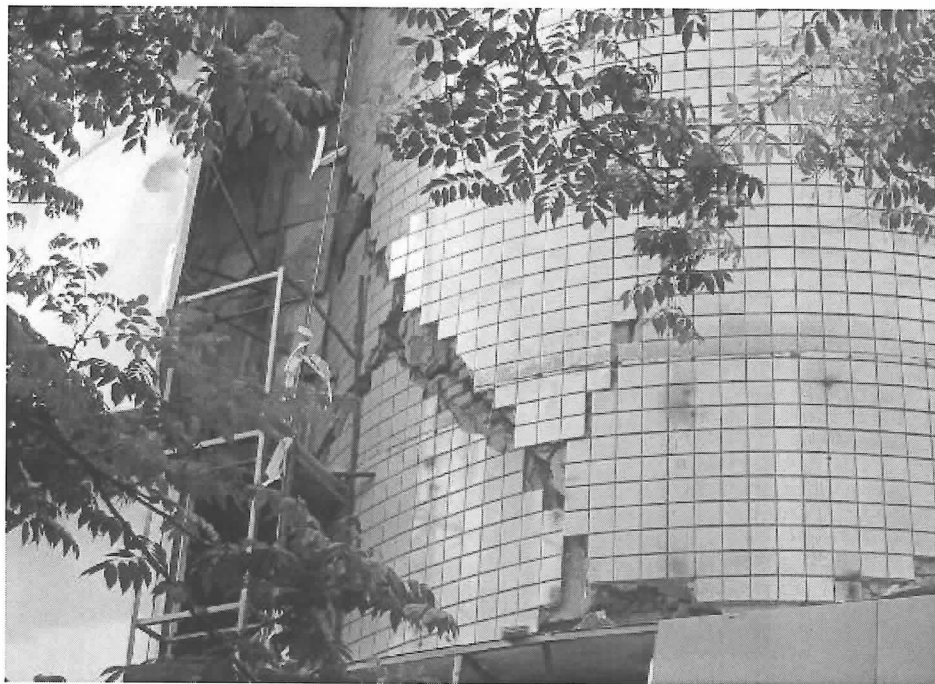
Fig.97. Stair hall arc wall damage of a shop in Chencang district

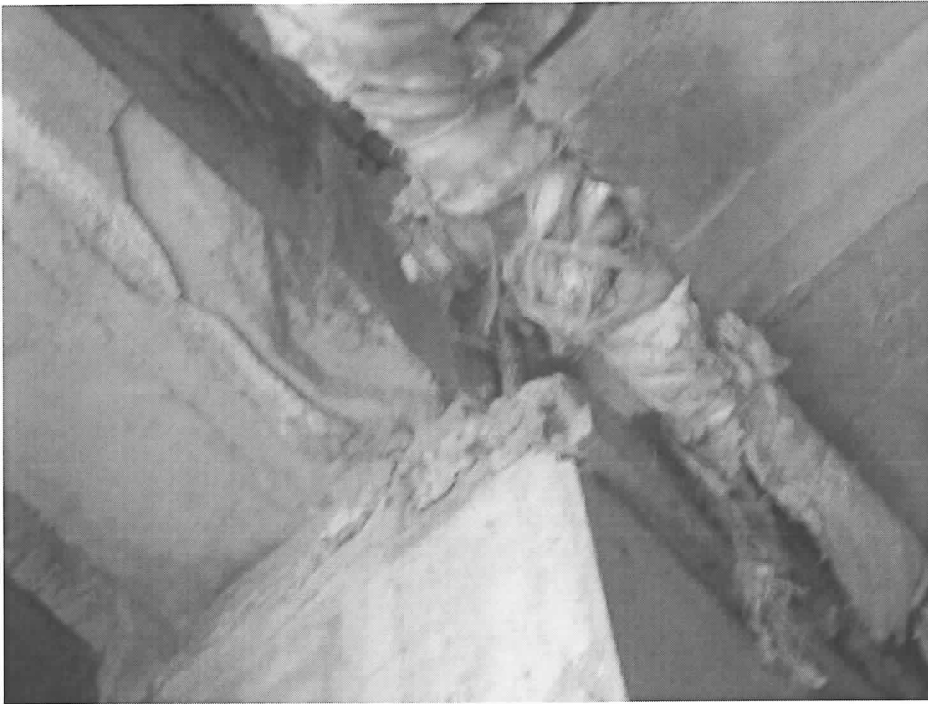
Fig.98. Column yield near node zone, steel drums outside, and has been out of work.

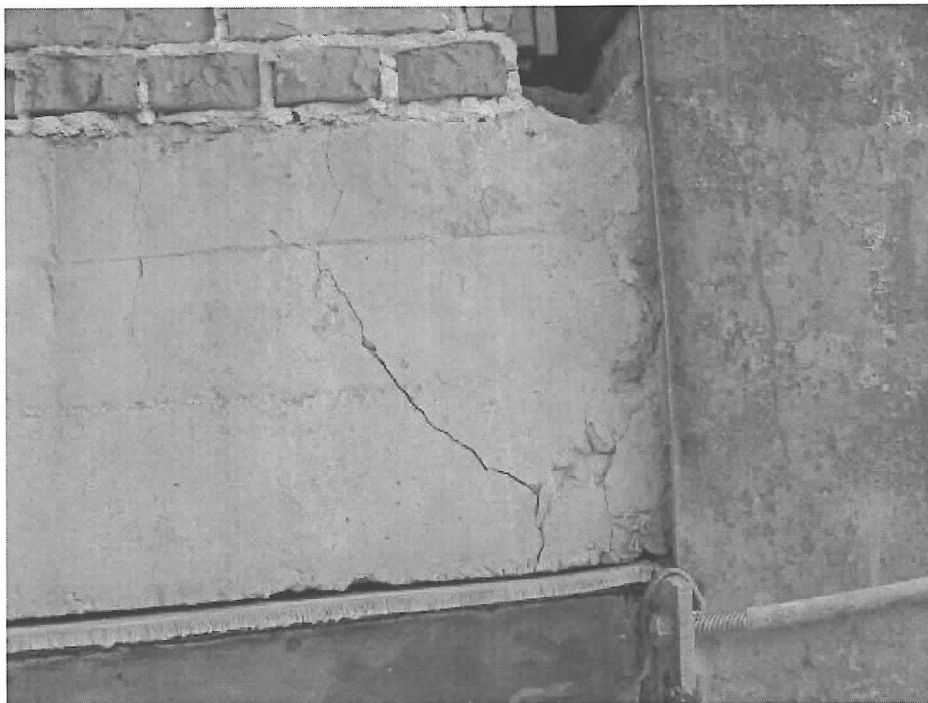
Fig.99. Shear failure at the end of beam

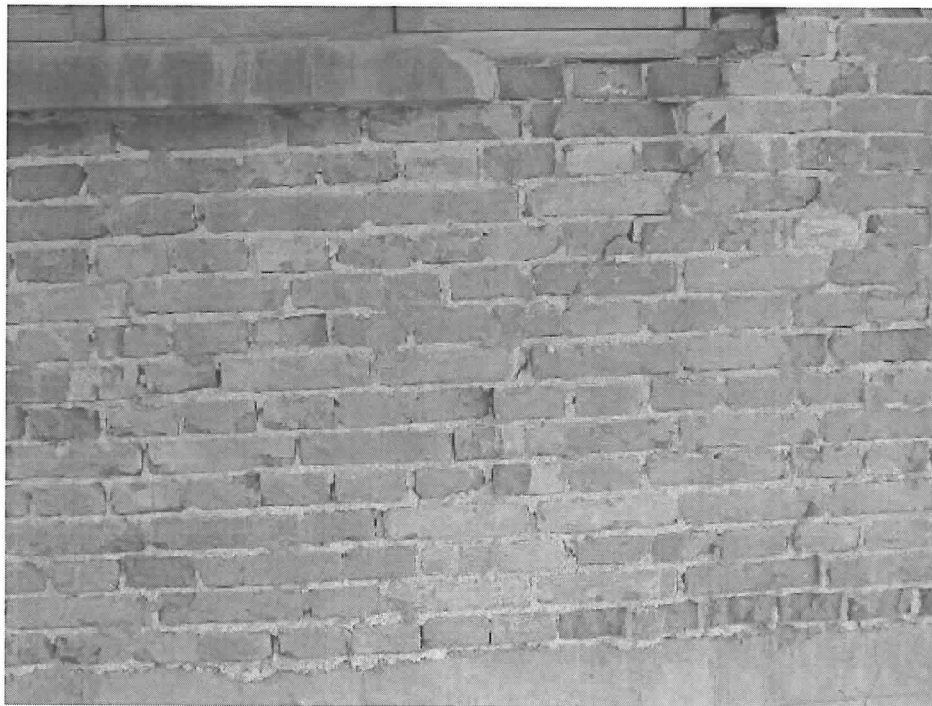
Fig.100. Filled wall crushed

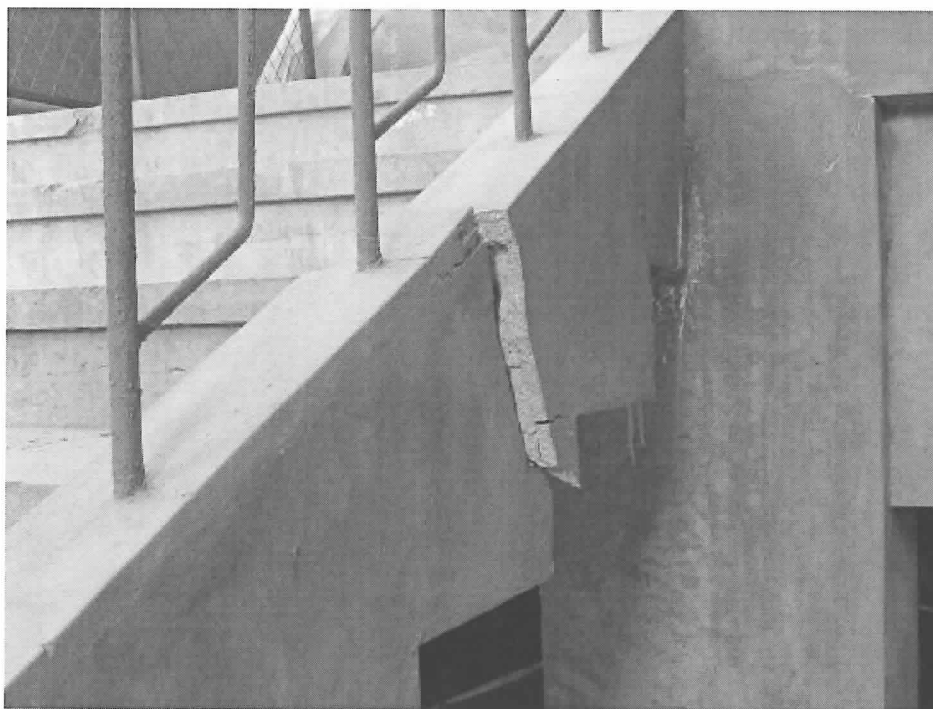
Fig.101. Snap broken of staircase

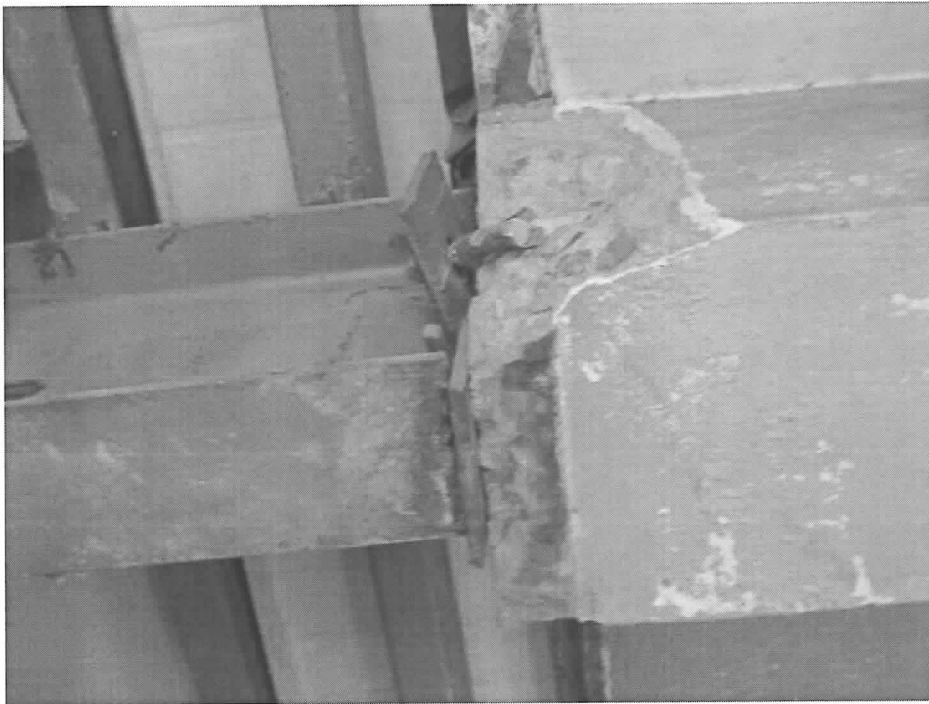
Fig.102. Snap broken at the connection between steel beam and RC beam

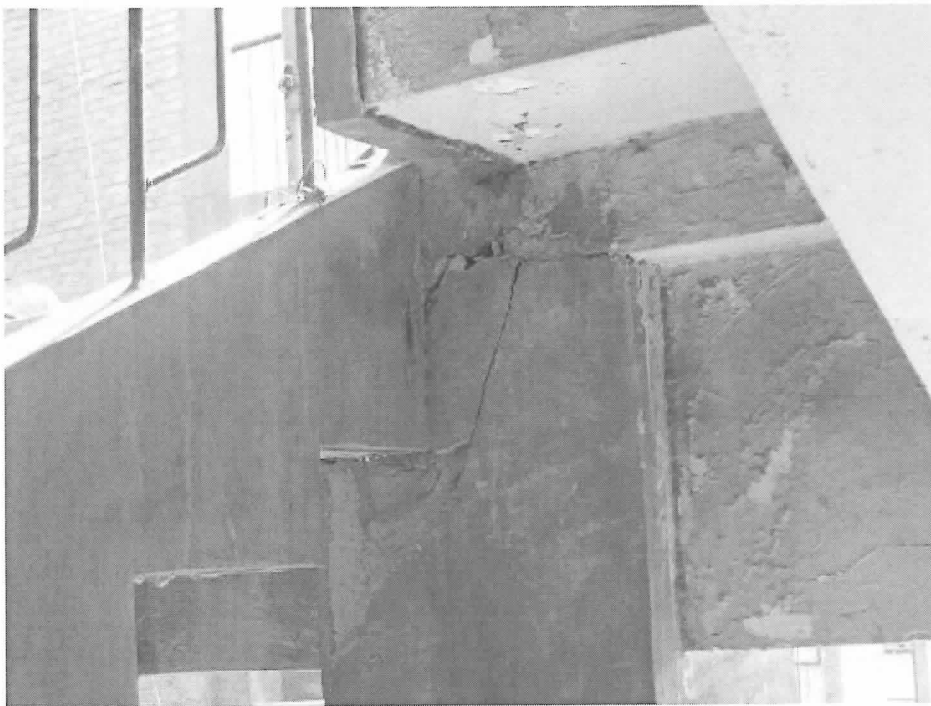
Fig.103. Damage of constructional column

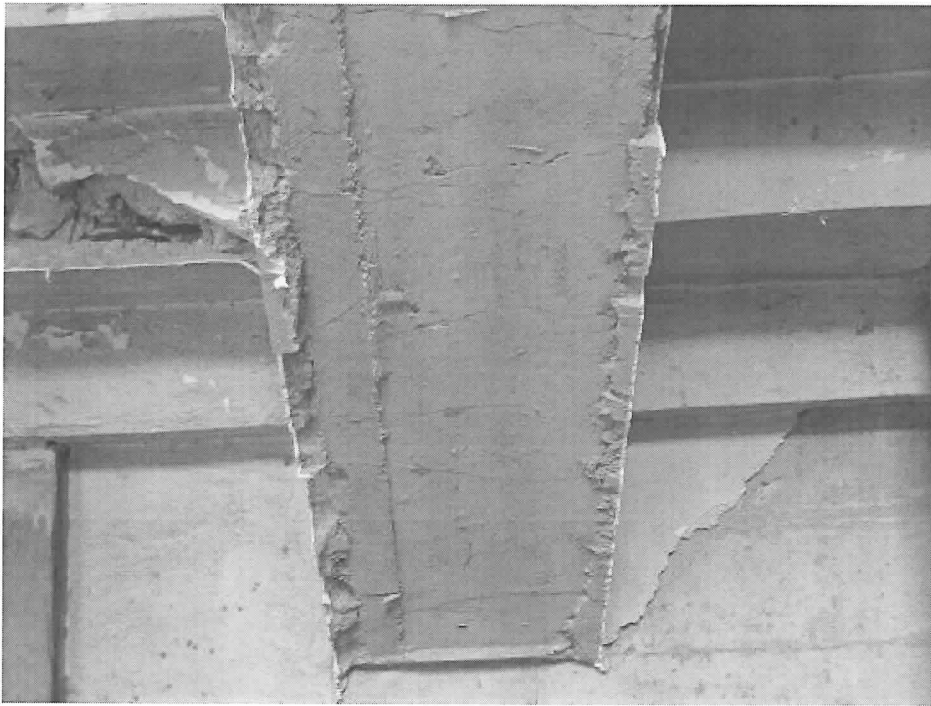
Fig.104. Many horizontal cracks appeared at the bottom of the stair beam

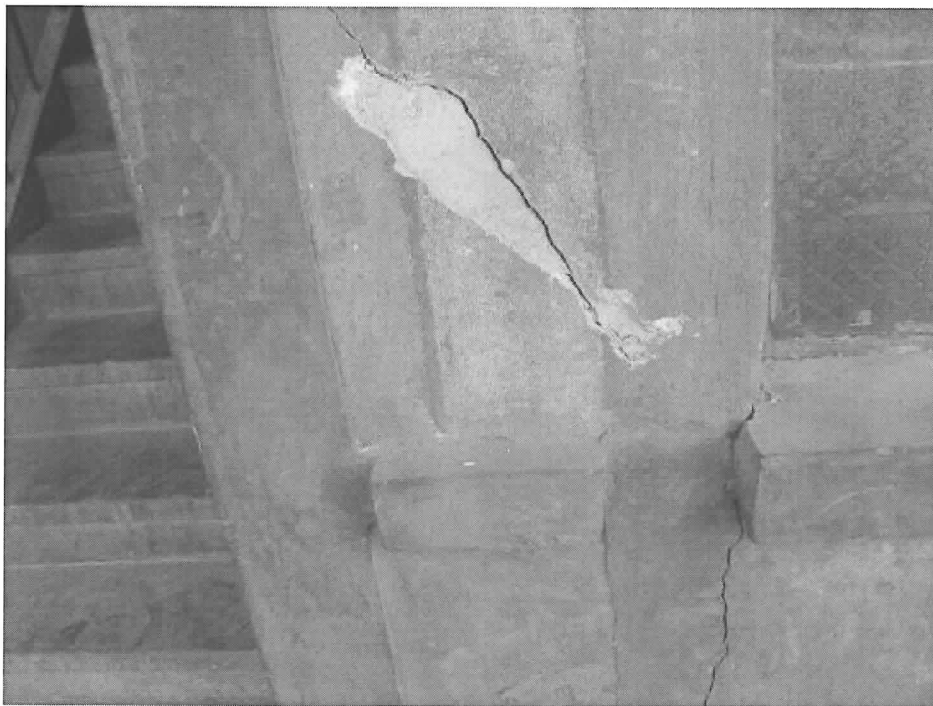
Fig.105. Shear failure at the stair column of the third floor

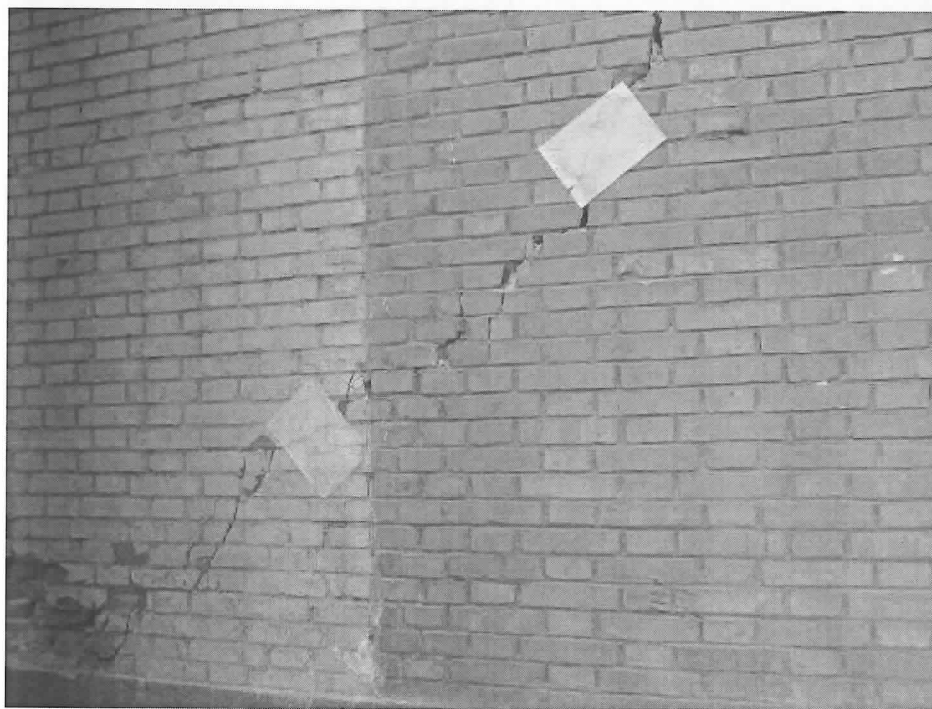
Fig.108. Damage of south outer wall

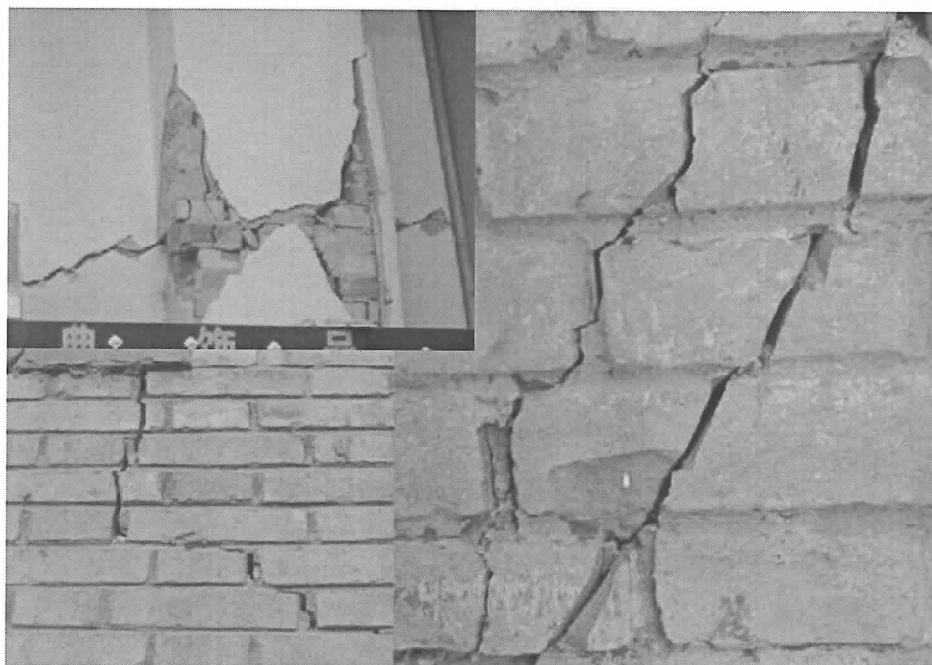
Fig.109. Damage of brick wall and column

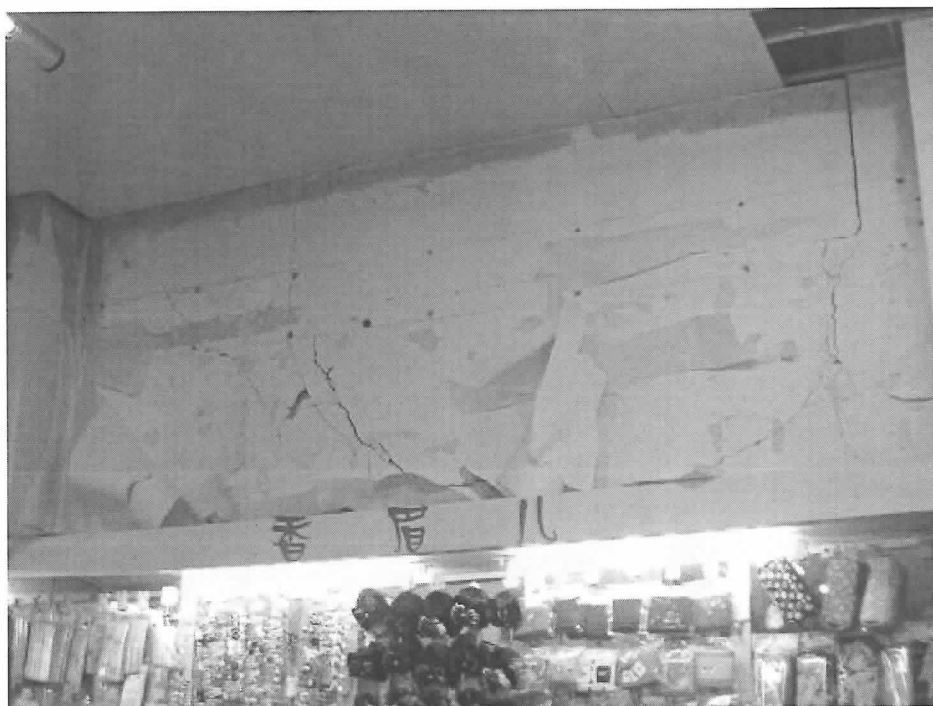
Fig.110. Damage of brick interior wall

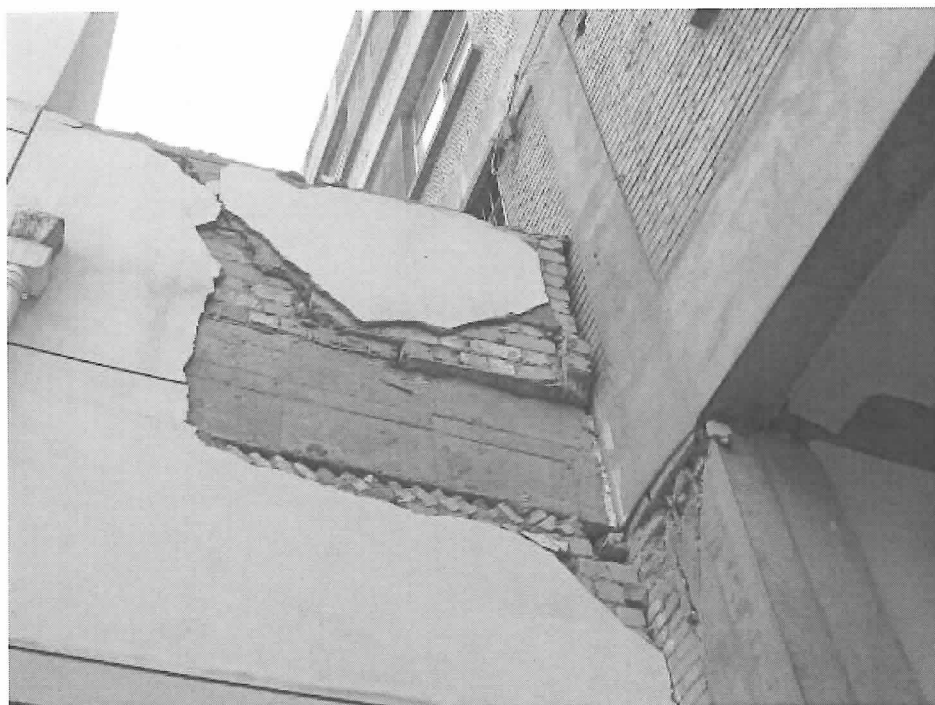
Fig.111. Frame structure damage of a restaurant in Chencang district

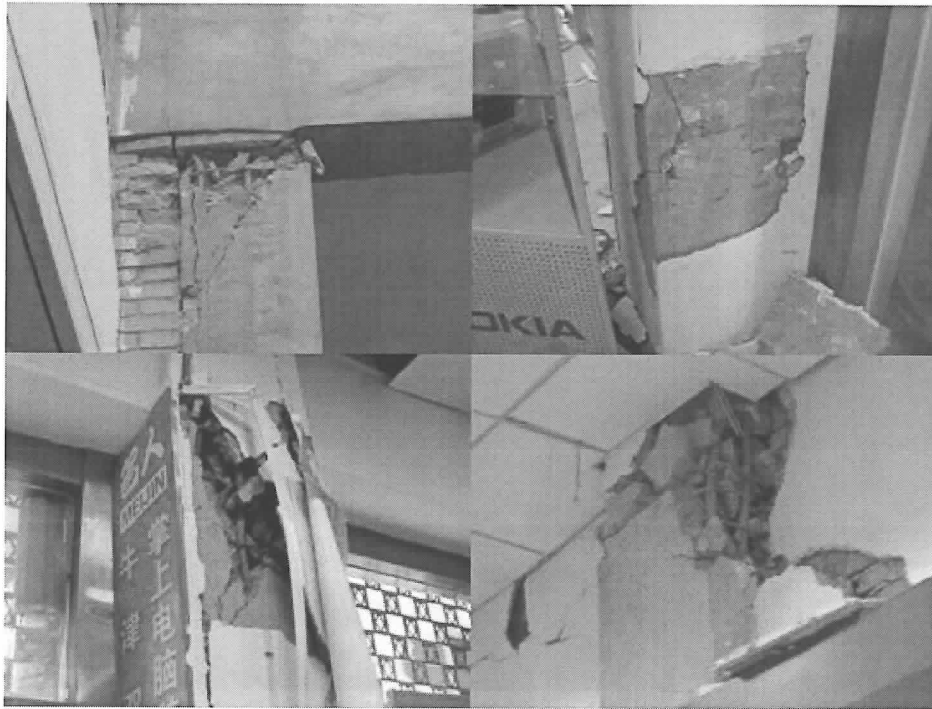
Fig.112. Column damage

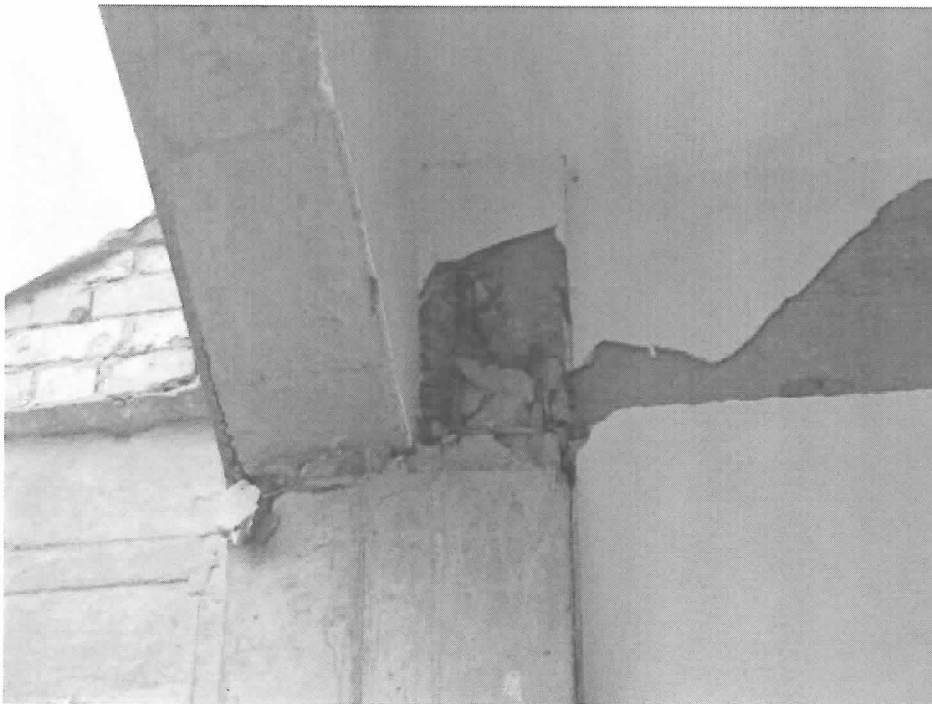
Fig.113. Joint damage

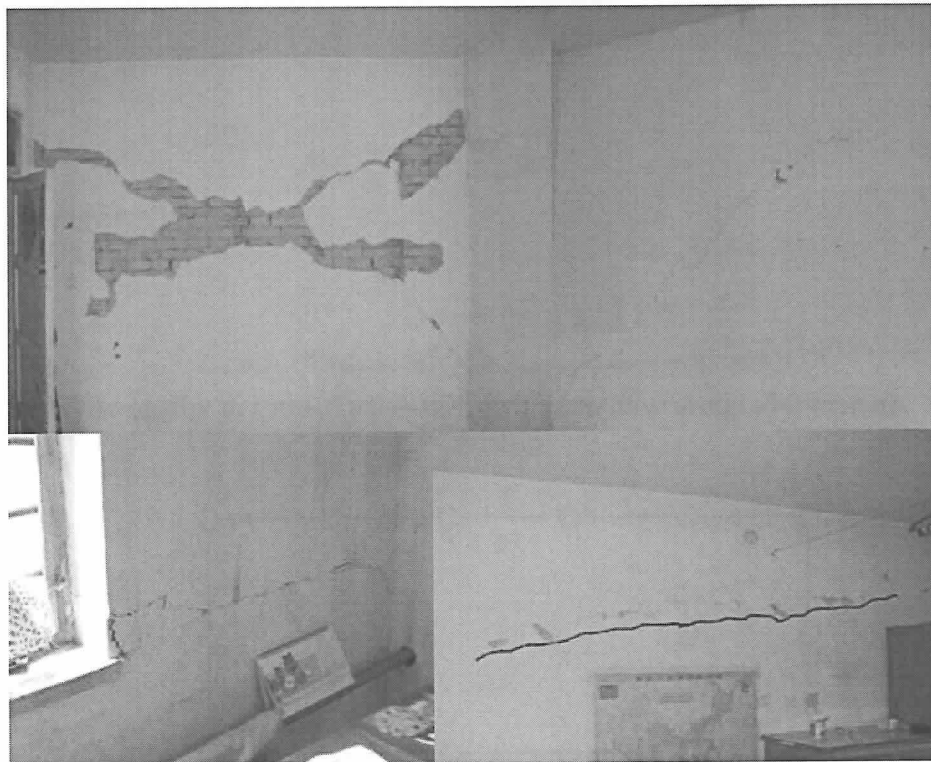
Fig.115. Cracks of brick interior wall

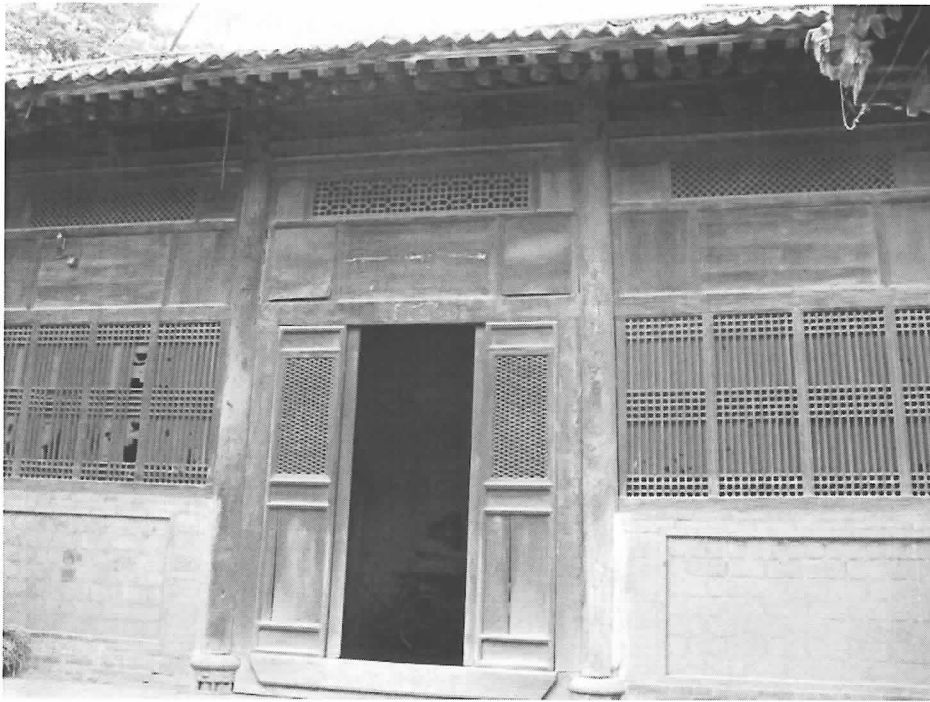
There is almost no damage in this house shown in Fig.116. The house is wood structure, is supported by 16 wooden pillars, and is surrounded by rammed earth wall mixed with wheat straw. The wall didn't support the weight of the entire roof, but 16 wood pillars bear the load. Wooden structure is a good toughness, high seismic performance of buildings.

Fig.116. Ancient folk house with more than 120 years history in village of Chencang district.
