# **A discussion of one of the large natural disasters to have occurred in northern Japan since 2000, and the efficacy of the disaster prevention and recovery measures taken**

Hiroshi Sakurai, Kitami Institute of Technology,  
Kaneyoshi Okada, Kitami Institute of Technology,  
and Noboru Saeki, Hokkaido University

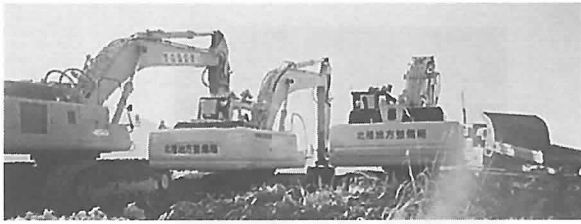
**Photograph 28** The radio controlled construction machine that was used the rescue work.

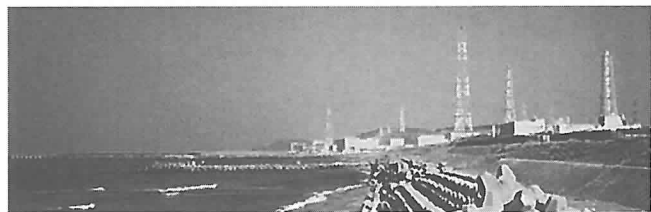
**Photograph 33** After the earthquake, the Kashiwazaki nuclear power plants were able to quickly resume normal operations because the plants were designed using dynamic analysis and adequate measures had been taken to prevent liquefaction and other earthquake related problem.

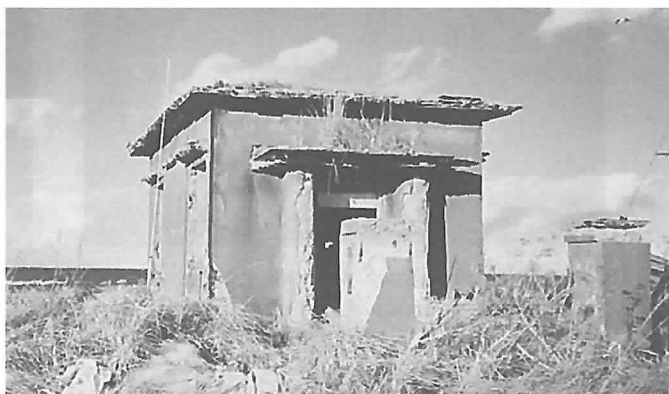
**Photograph 38** The Northern Territories communications system of the former Department of Communications is a cultural asset. Although it is 100 years old, the system suffered no damage, not even a crack or fallen mortar, because the structure incorporated a beam and an inner bulkhead.
