Damage survey of 2008 Wenchuan earthquake in different regions

Junqiang Zhu^{a*}, Jitao Yao^b, Qianying Ma^b

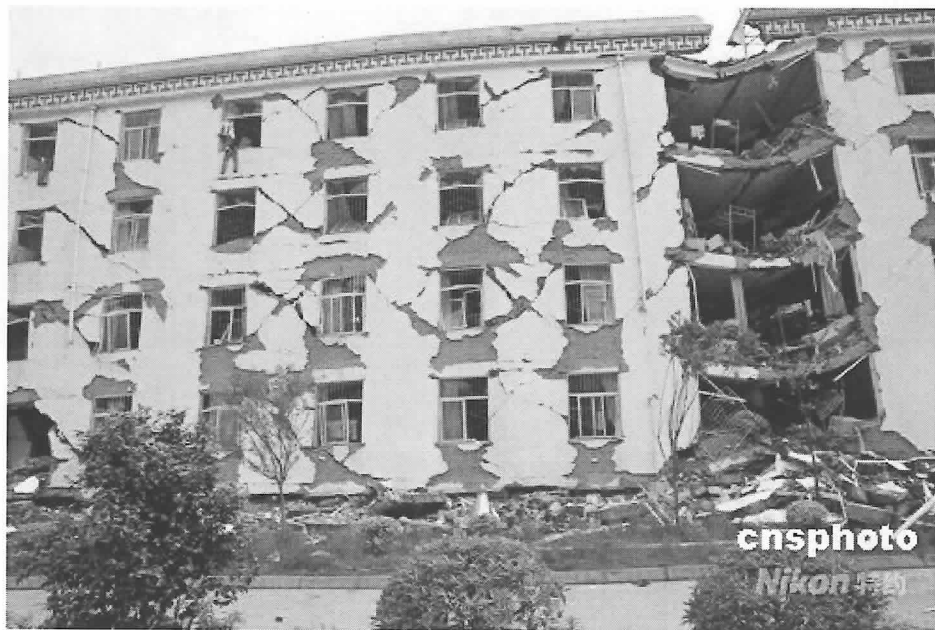
Fig.5. Collapsed building of Wenchuan [4]

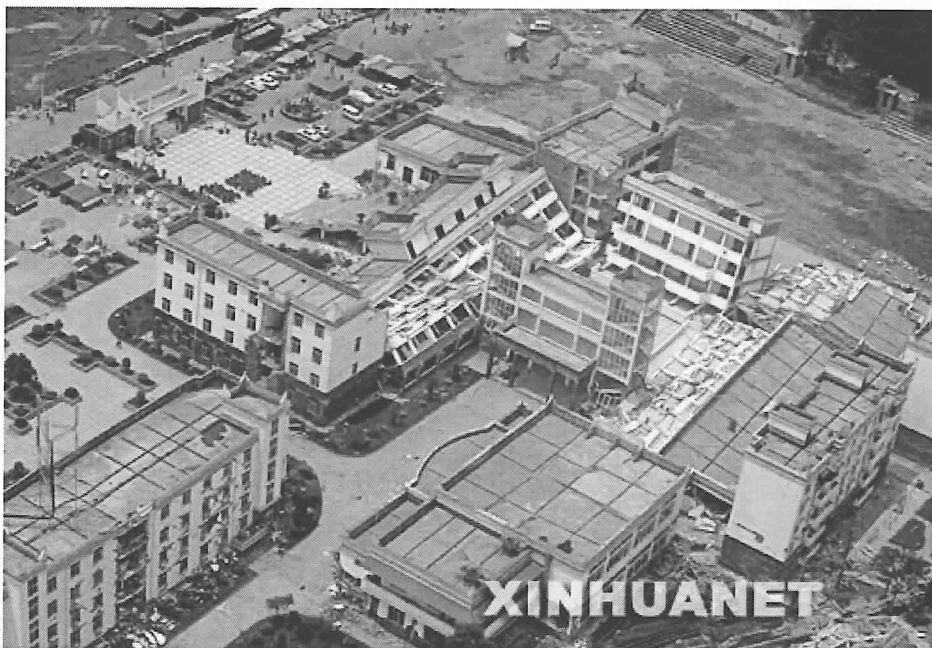
Fig.6. Collapsed building of Wenchuan [5]

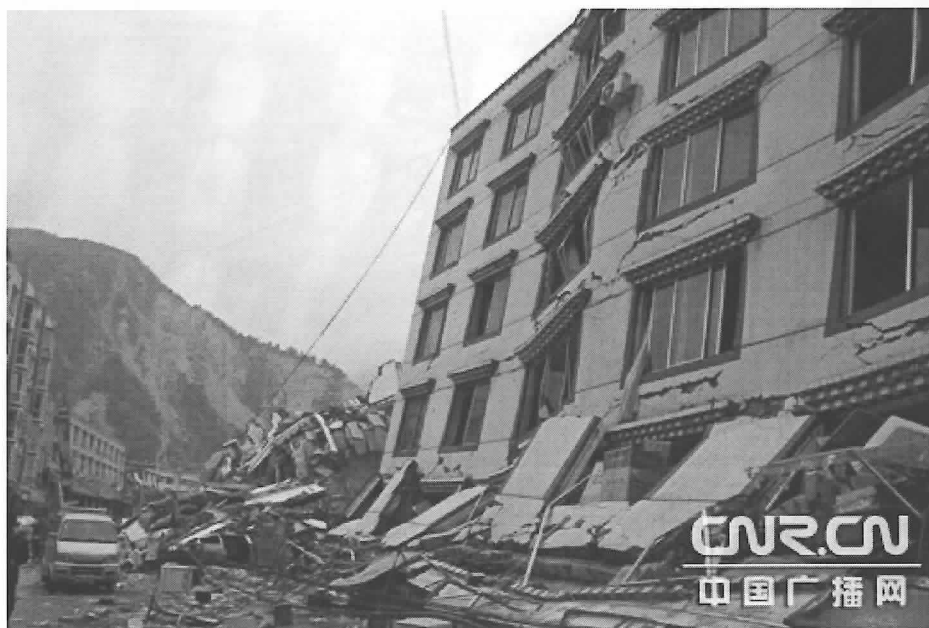
Fig.7. Collapsed building of Wenchuan [6]

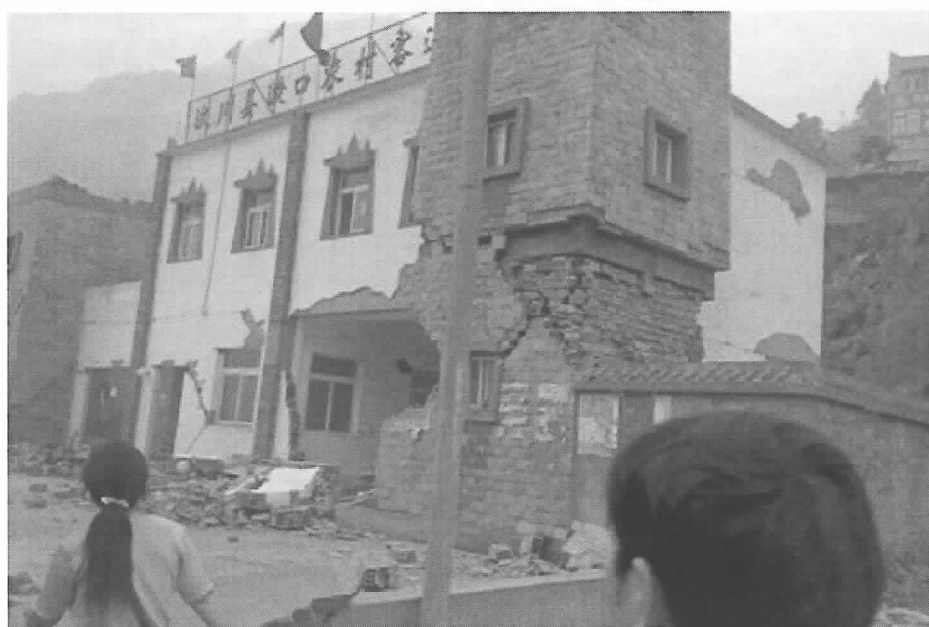
Fig.8. Collapsed building of Wenchuan [7]

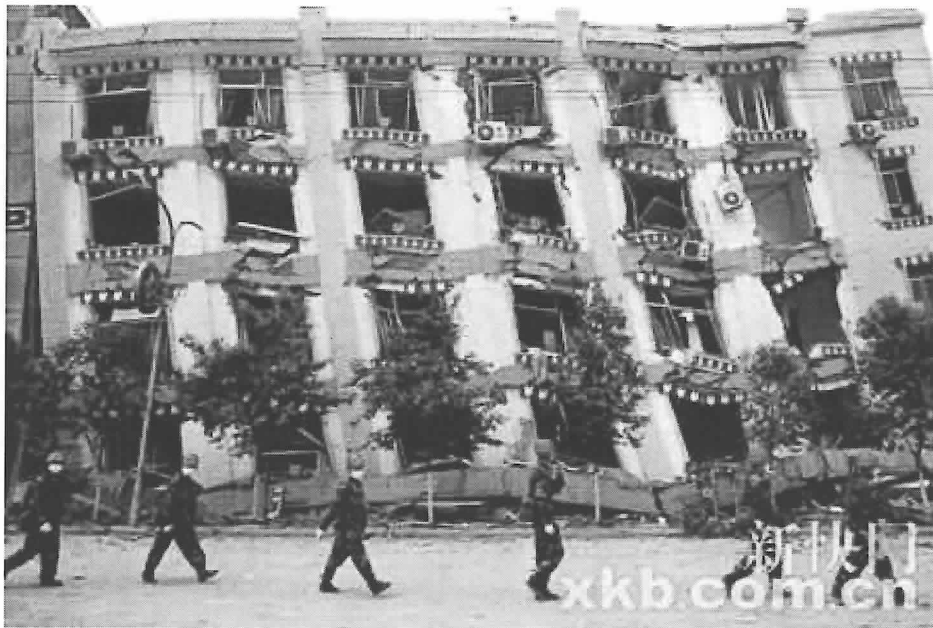
Fig.9. Collapsed building of Beichuan which is another epicente. [8]

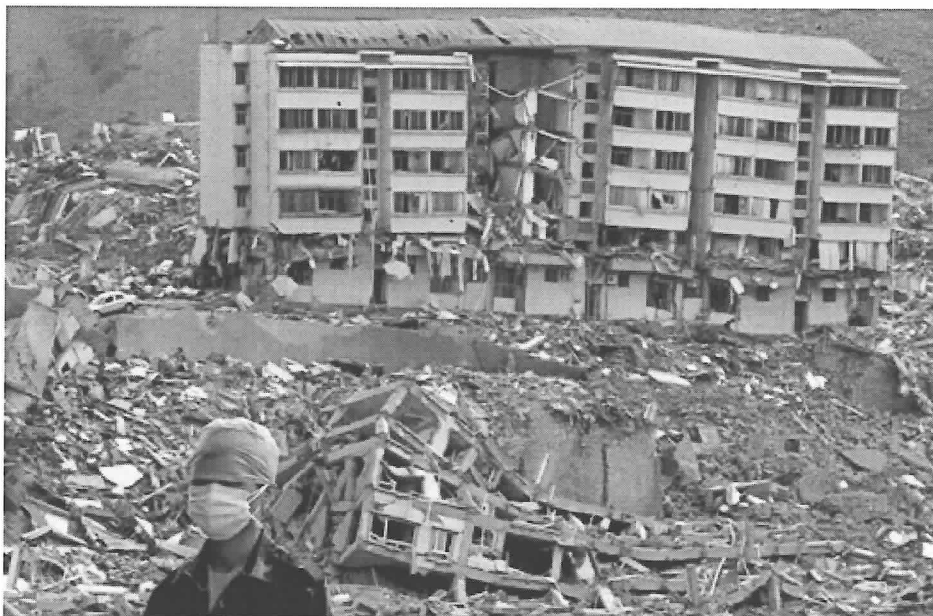
Fig.10. Collapsed building of Beichuan [9]

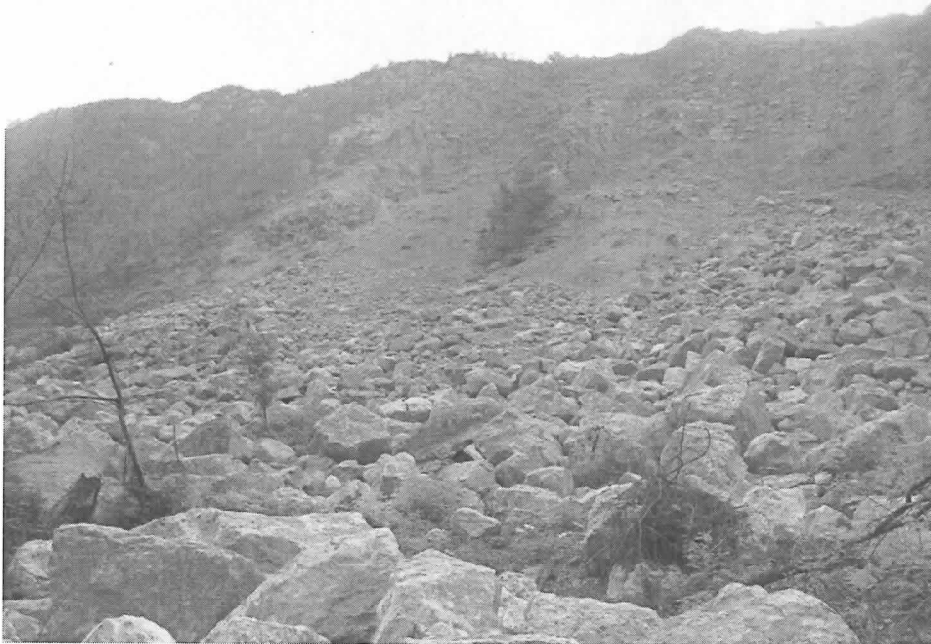
Fig.13. Landslide in Jinhua town

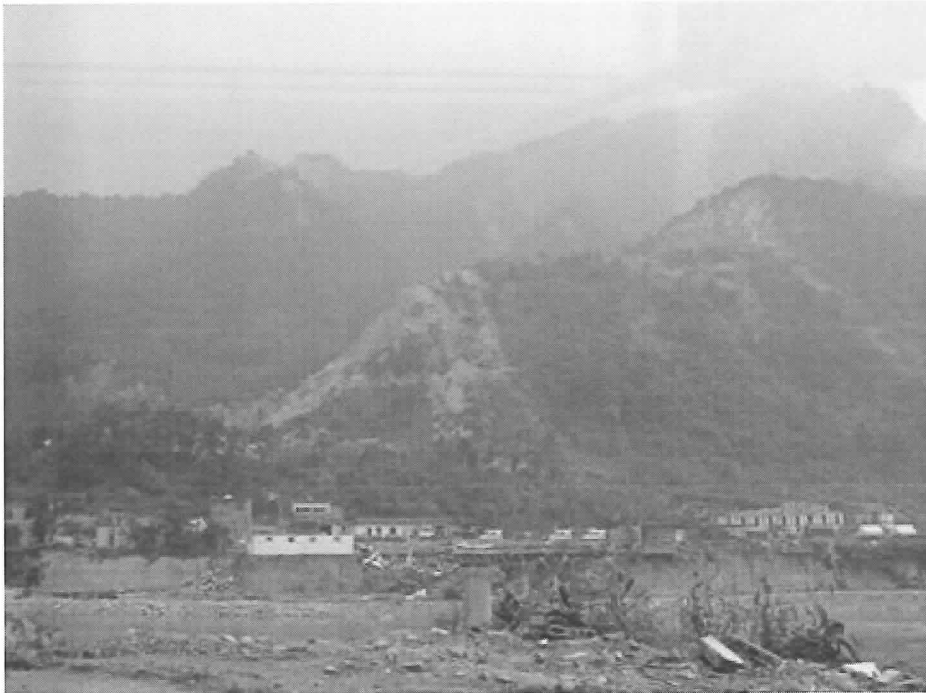
Fig.14. Fault zone in Hanwang

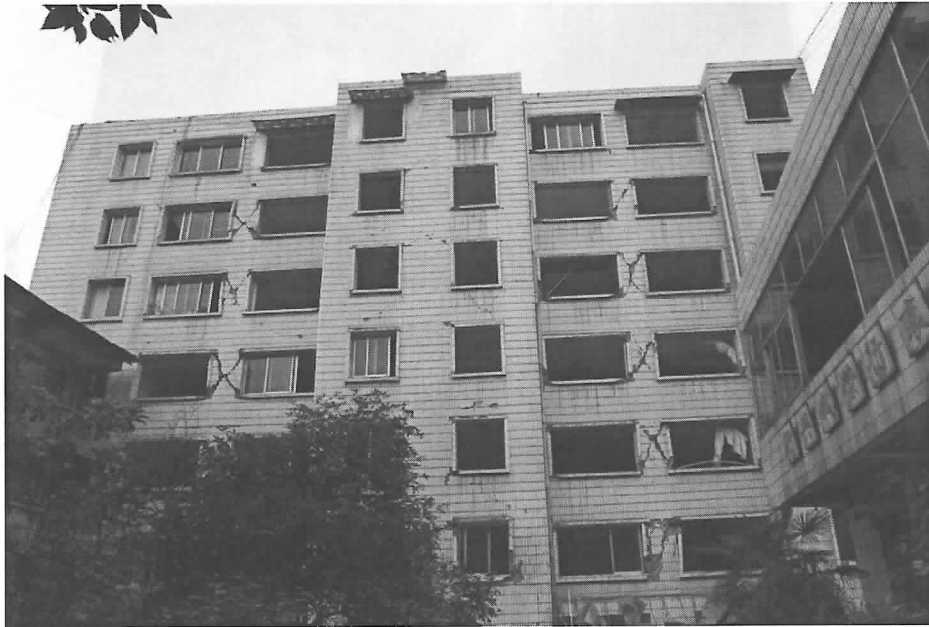
Fig.17. Destruction of masonry structure in Hanwang

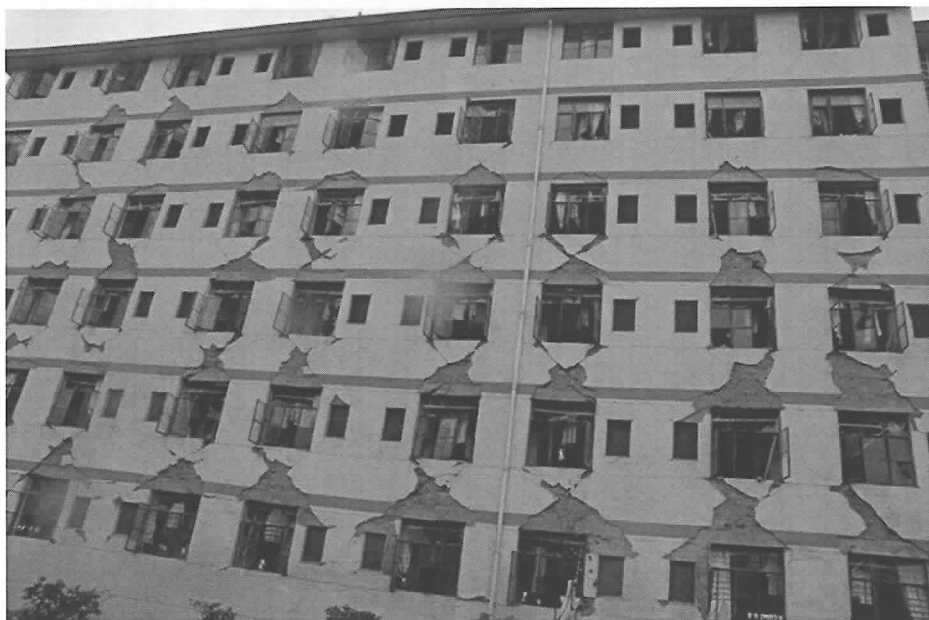
Fig.18. Destruction of masonry structure in Hanwang

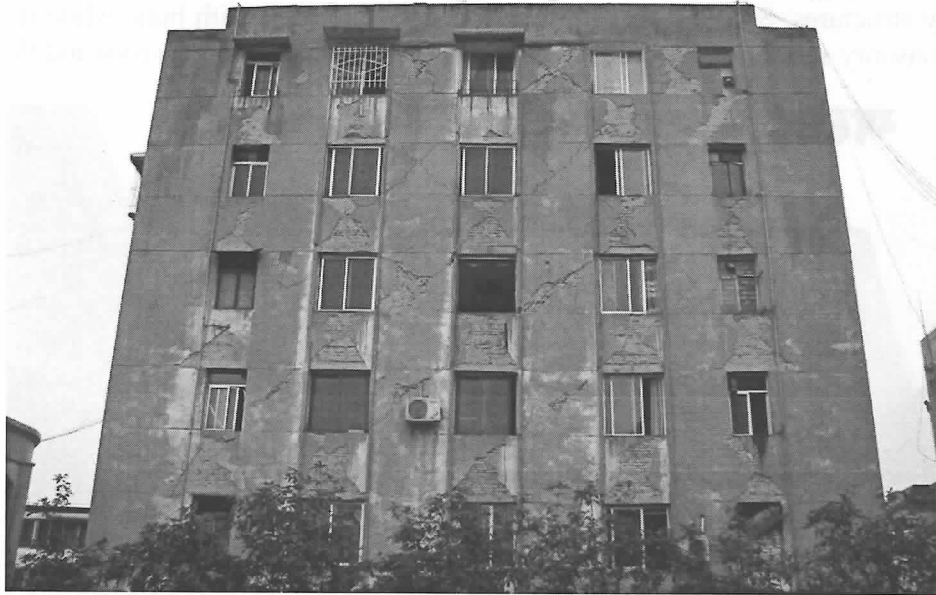
Fig.19. Destruction of masonry structure in Mianzhu

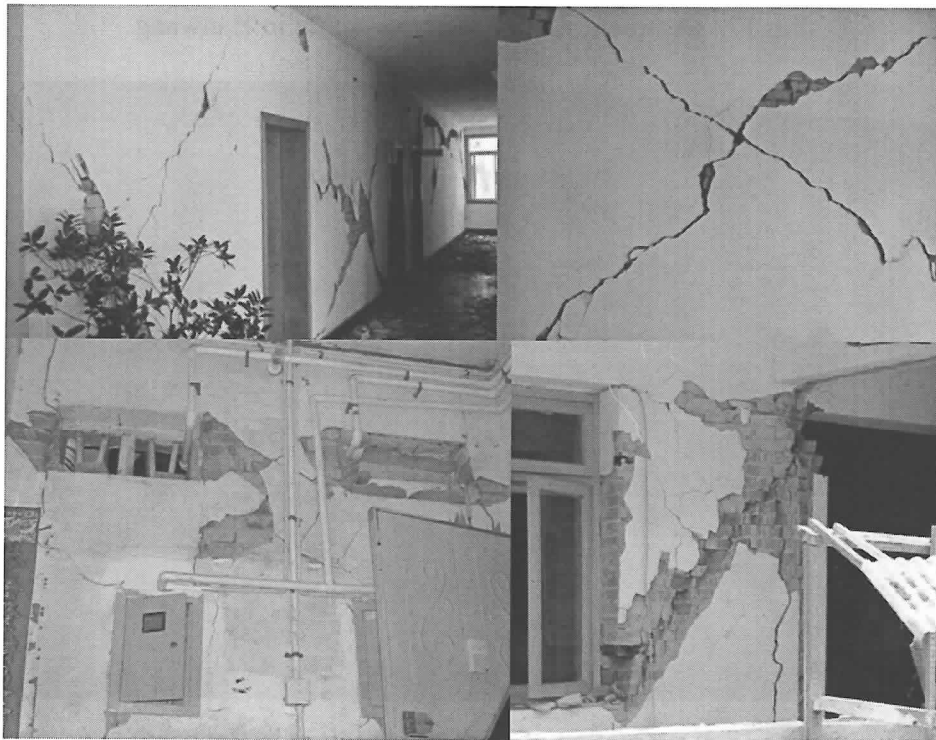
Fig.20. Destruction of the wall forms in Mianzhu

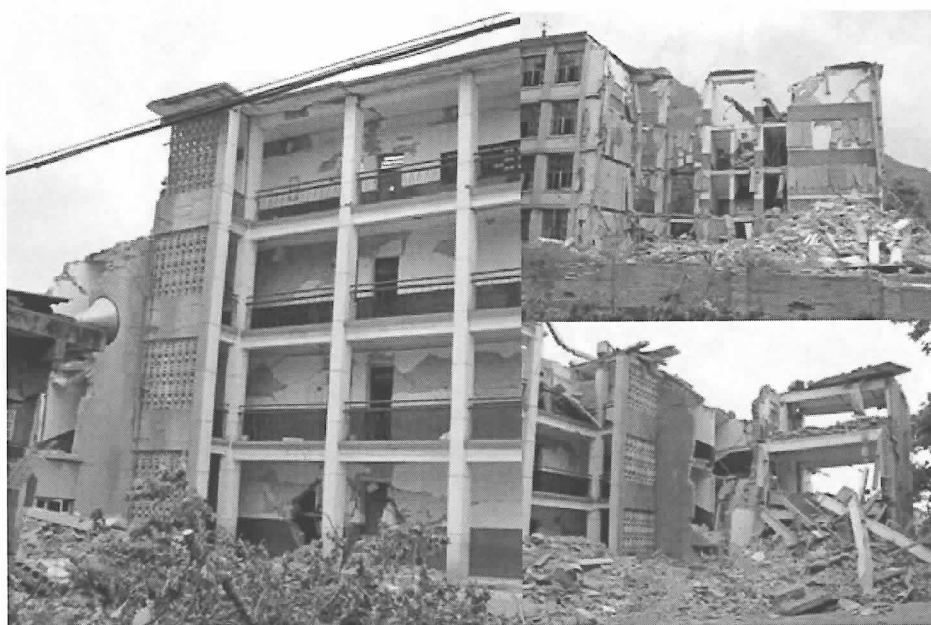
Fig.26. Destruction of masonry structure in Hanwang

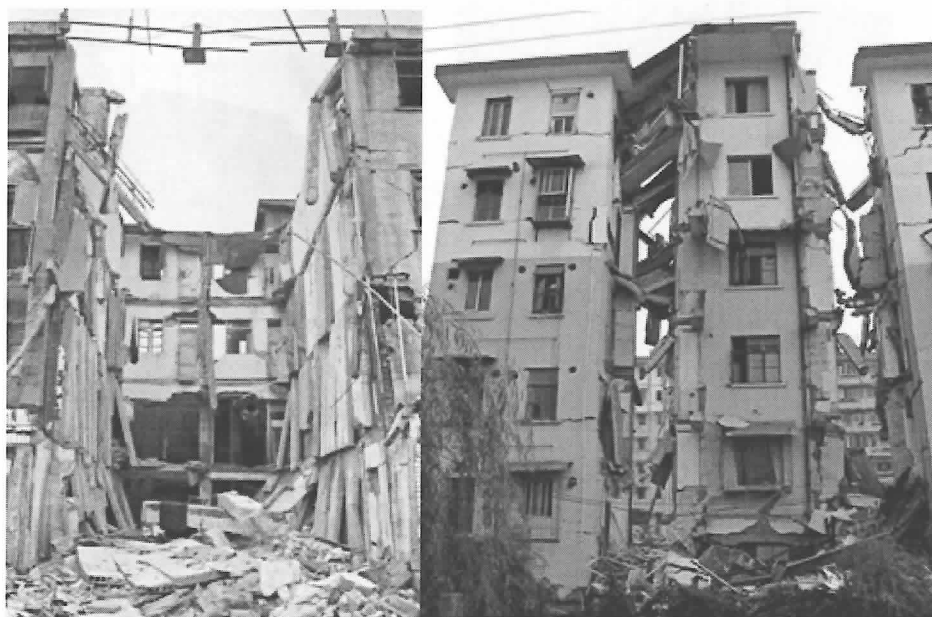
Fig.27. Destruction of masonry structure in Hanwang

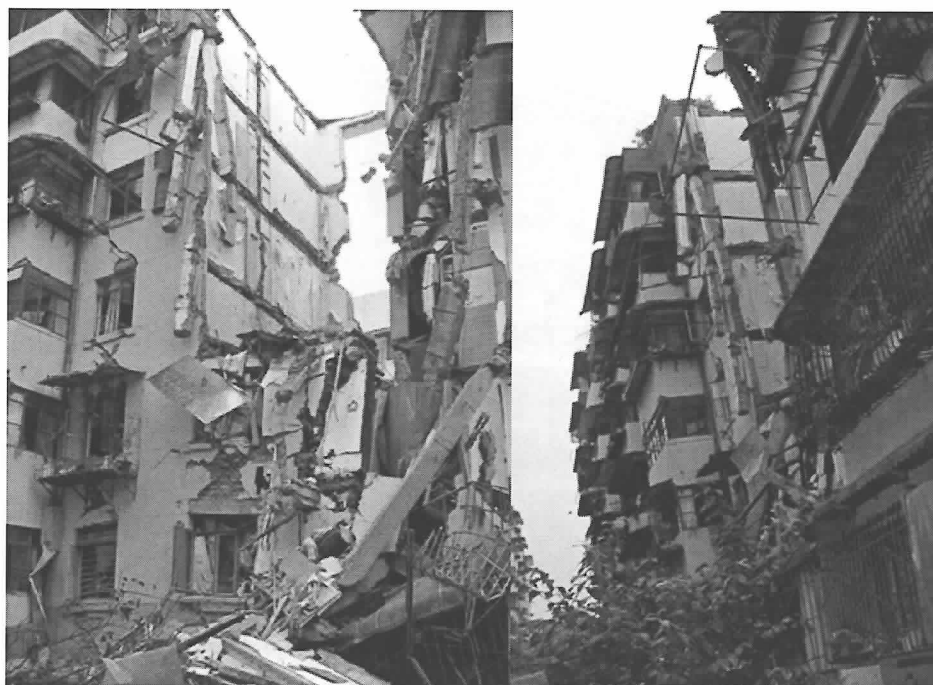
Fig.28. Destruction of masonry structure in Hanwang

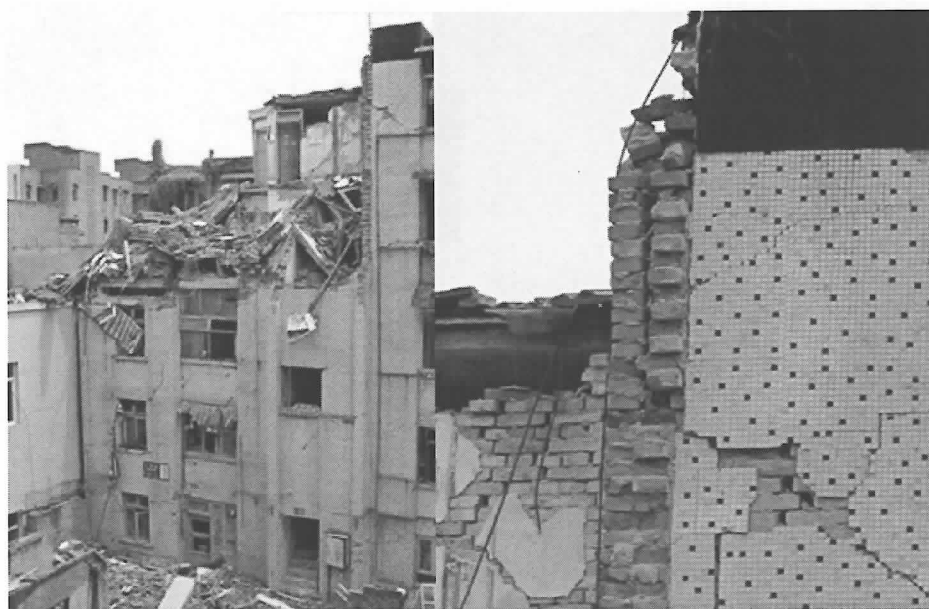
Fig.30. Corner damage caused by the stiffness change of a building in Mianzhu

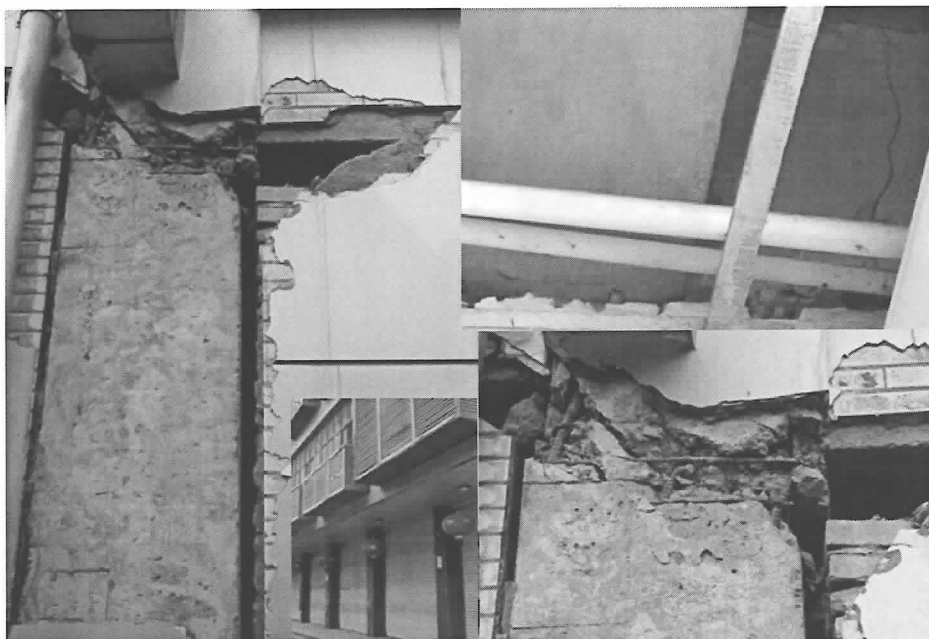
Fig.36. Beam and column damage of frame structure in Mianzhu

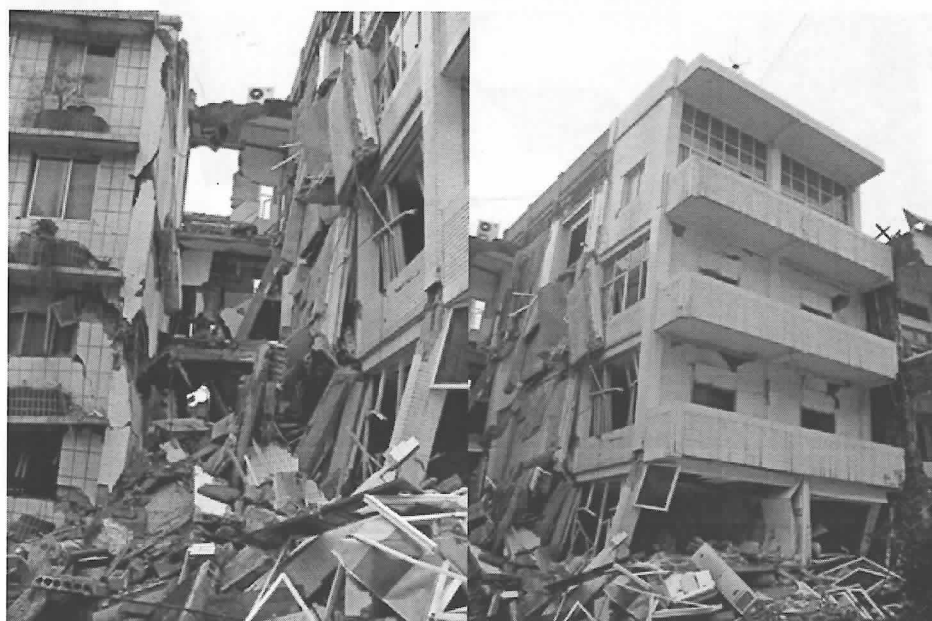
Fig.38. Damage of frame structure with precast slab floor in Mianzhu

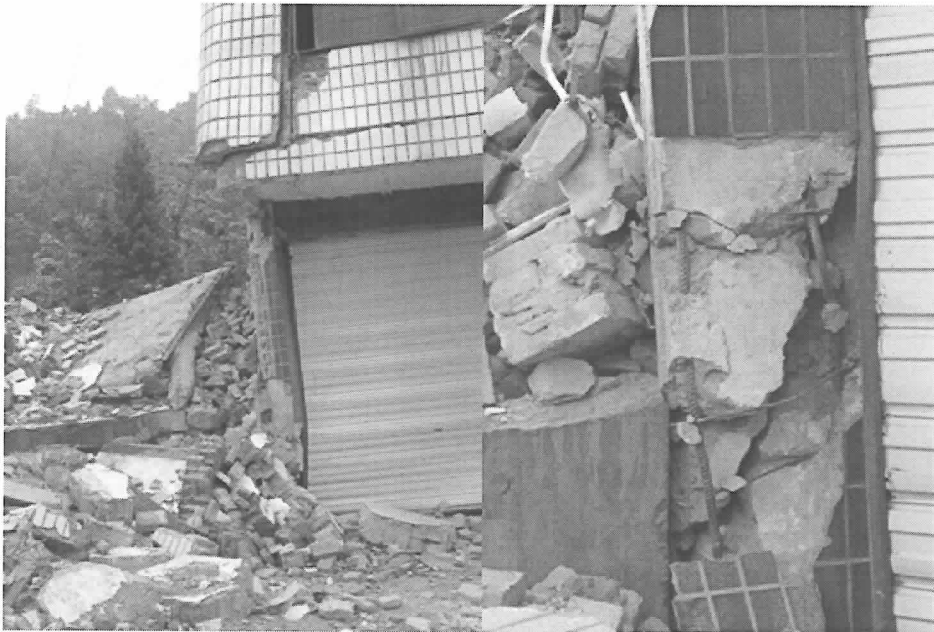
Fig.43. Column damage of frame structure in Jinhua

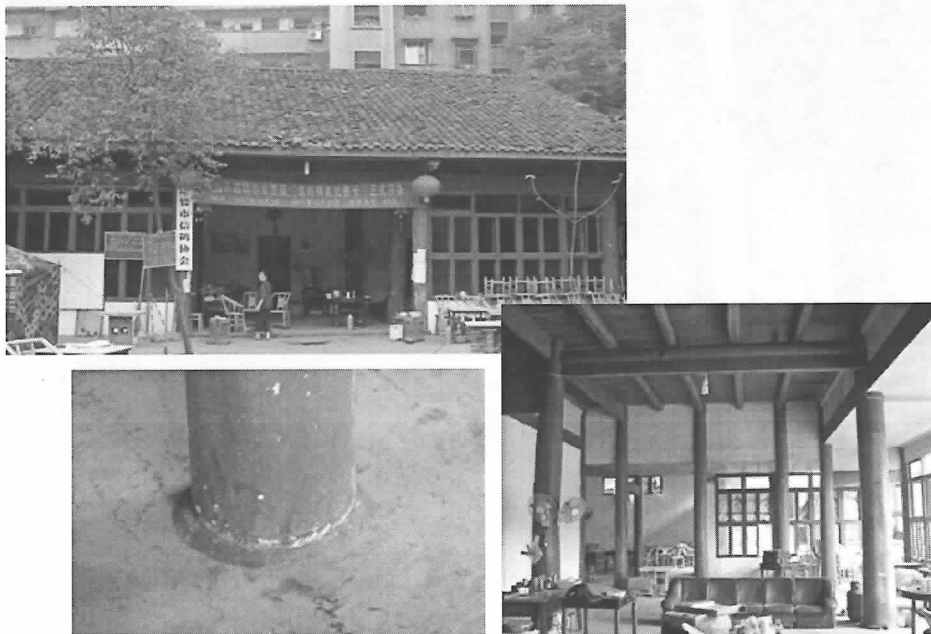
Fig.44. Column displacement of wooden structure in Mianzhu

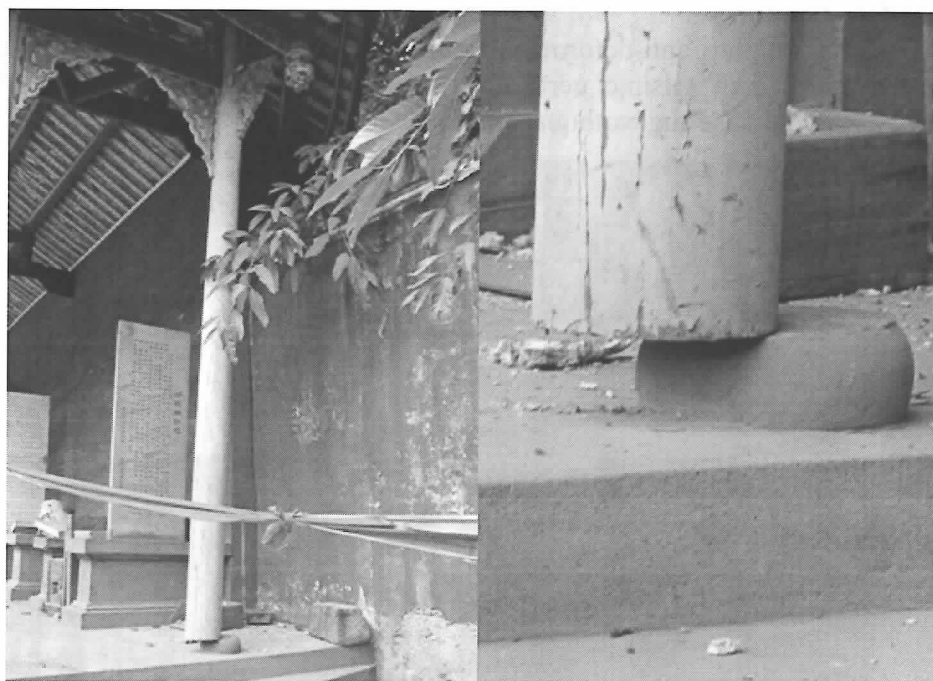
Fig.46. Column displacement of wooden structure in Mianzhu

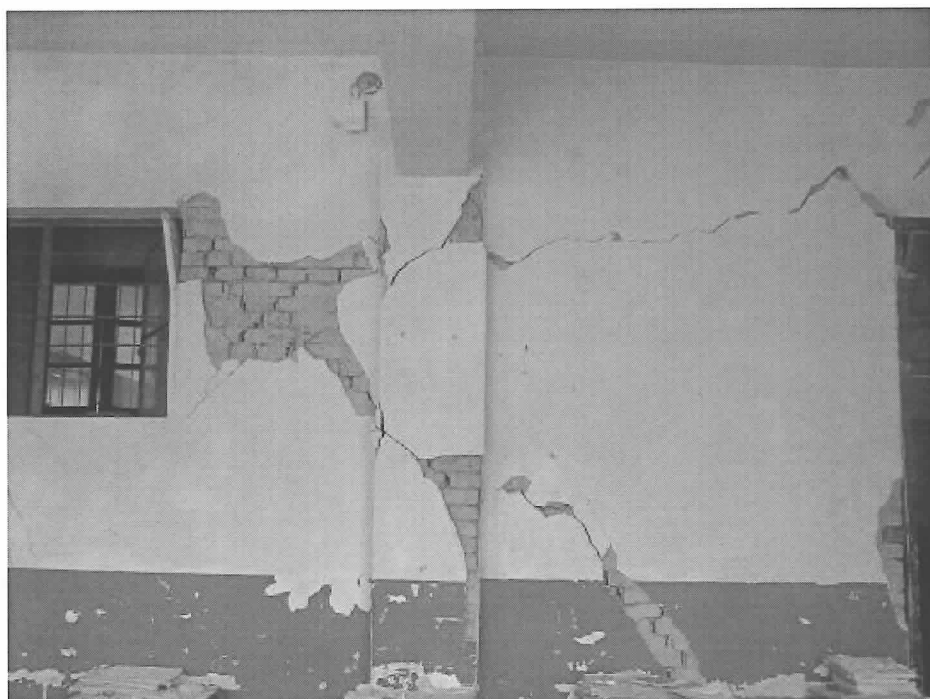
Fig.60. Destruction of brick columns under the beam

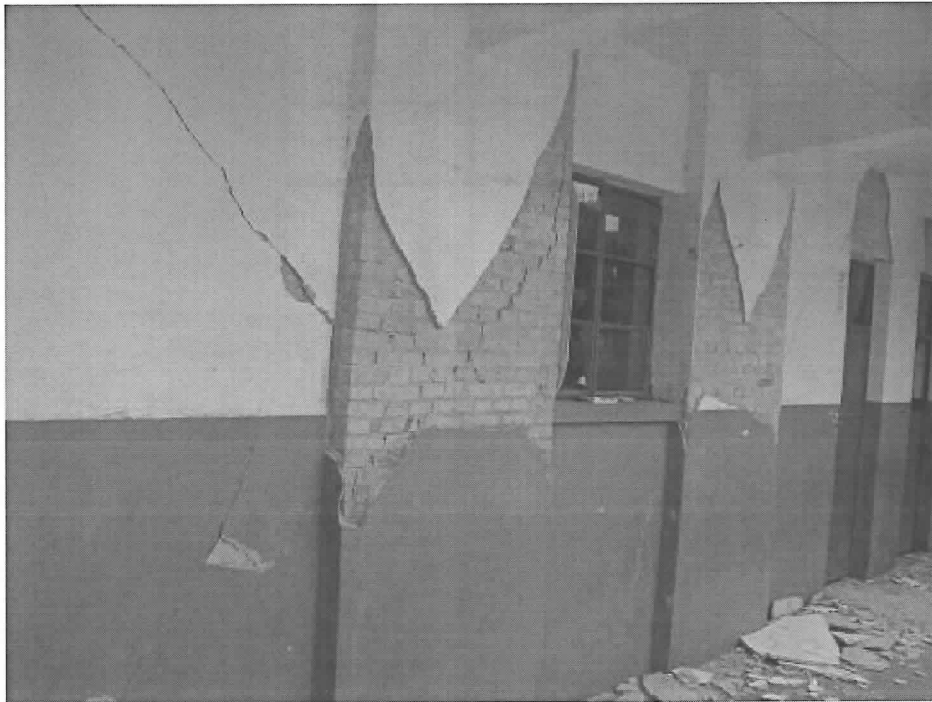
Fig.63. Destruction of brick columns under the beam

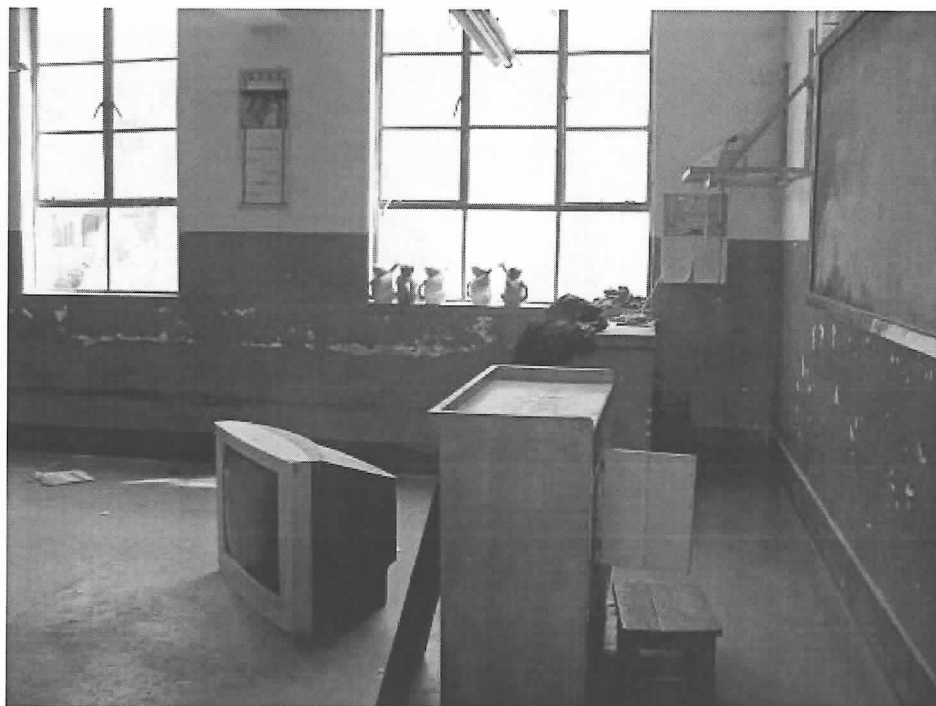
Fig.65. TV set was thrown down by the earthquake

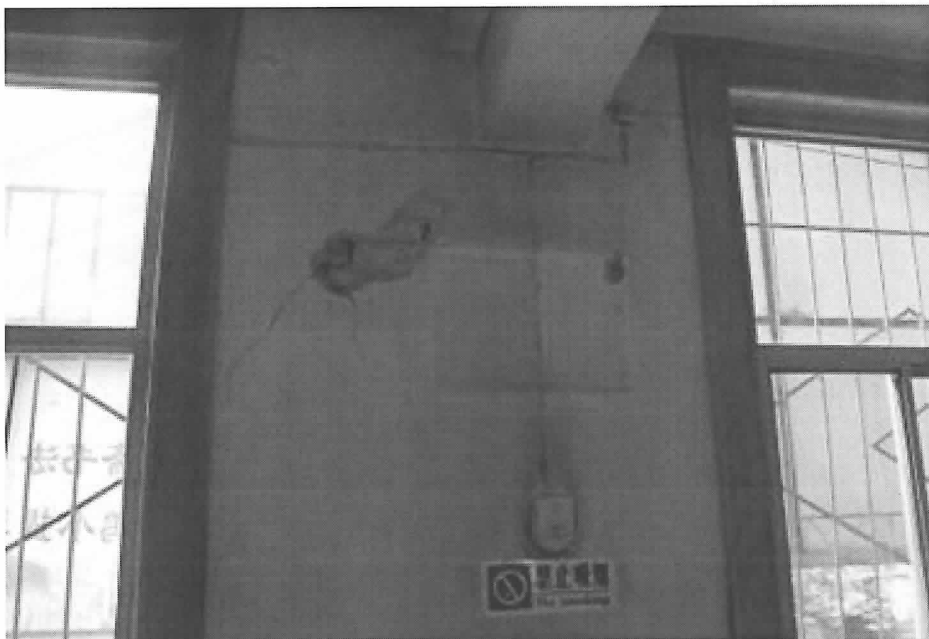
Fig.78. Bearing wall damage under beam

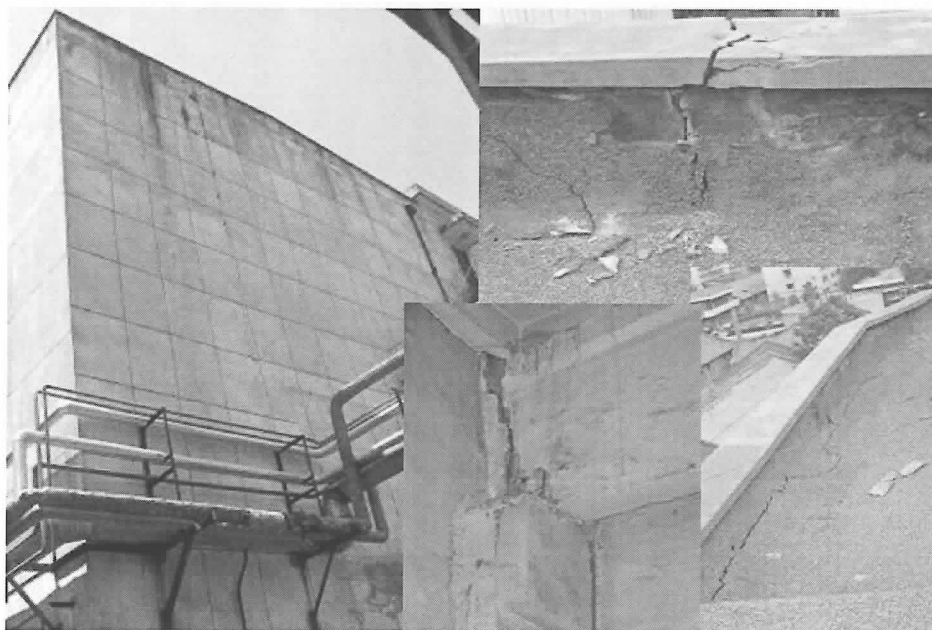
Fig.88. Vertical cracks in the gable and roof beam damage of boiler room workshop

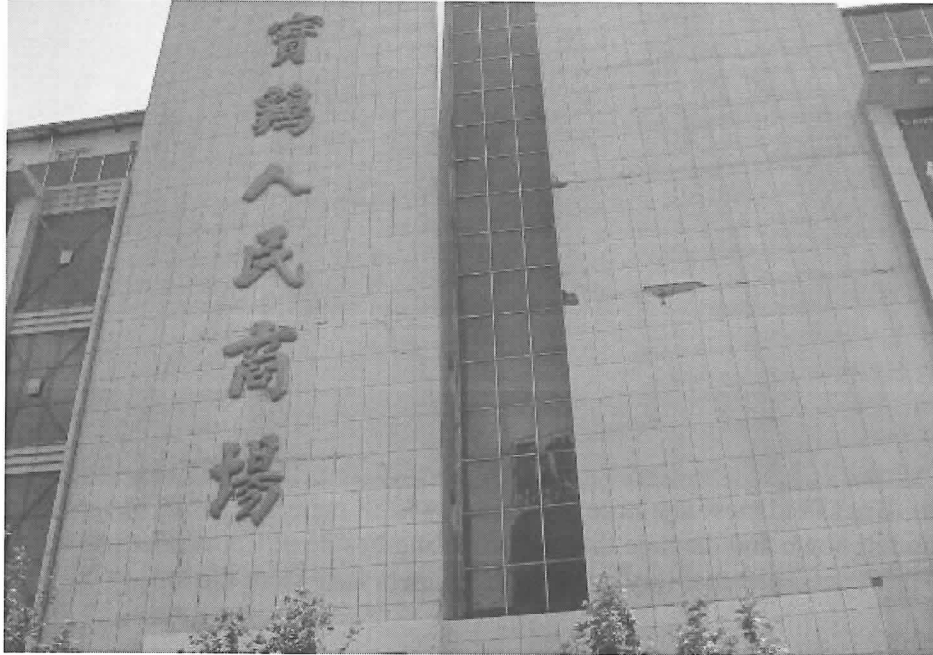
Fig.96. Shopping mall wall decoration damage in Baoji city

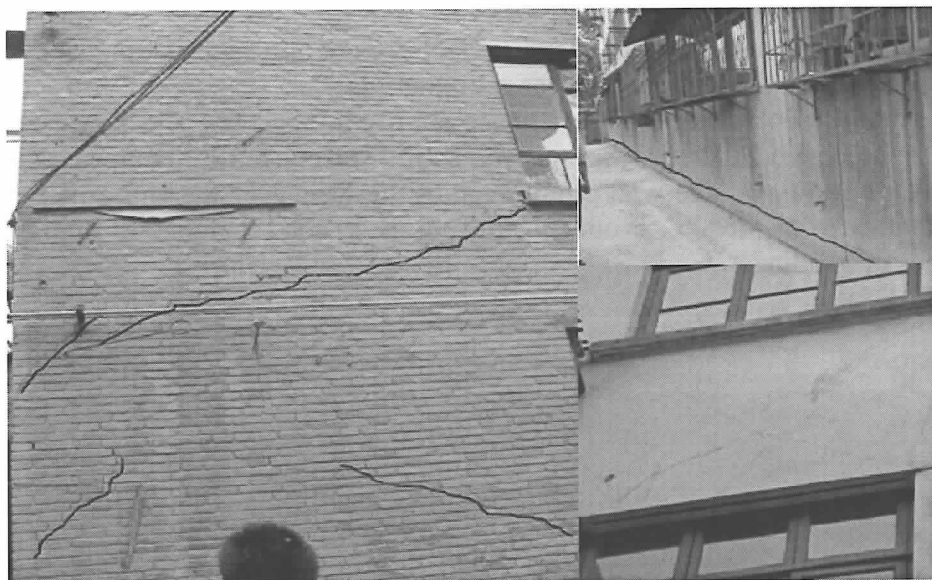
Fig.114. Cracks of brick outer wall

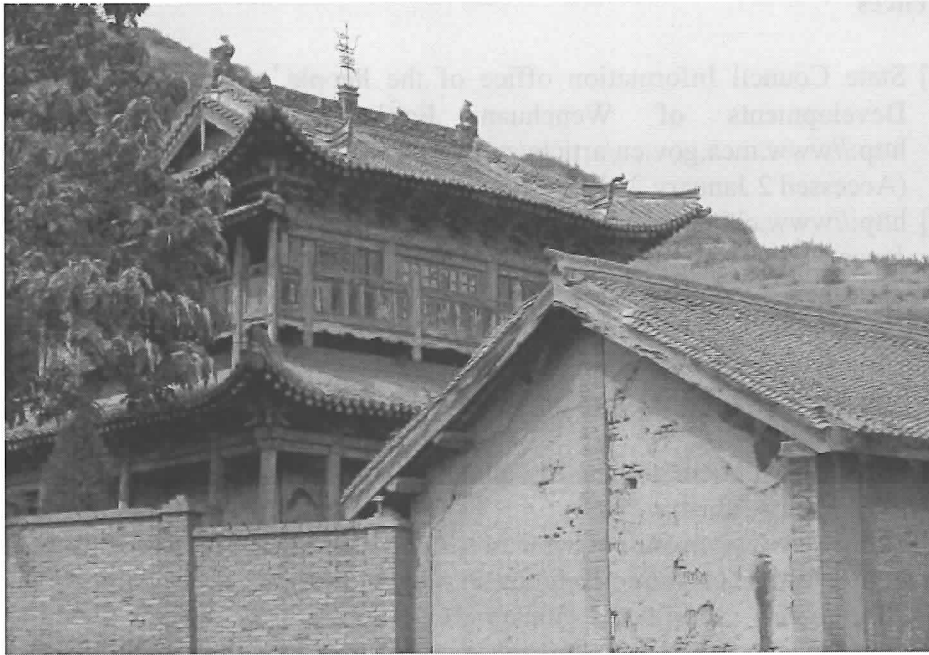
Fig.118. A wooden structure Taoist temple main shrine

The building shown in Fig.118 is a two-story wooden structure loft, and built in 1825. It is 12 meters length, 6 meters width and 10 meters height. It is also surrounded by rammed earth wall mixed with wheat straw in the first floor. The load supported by wooden structure, and the wall don't bear the weight of the wall. The whole building without any tilt, the inner wall has a vertical crack, the width is about 2mm, and there are two vertical cracks in outer wall, the width of about 2mm.
